Week of July 29 to August 5 D0 Summary

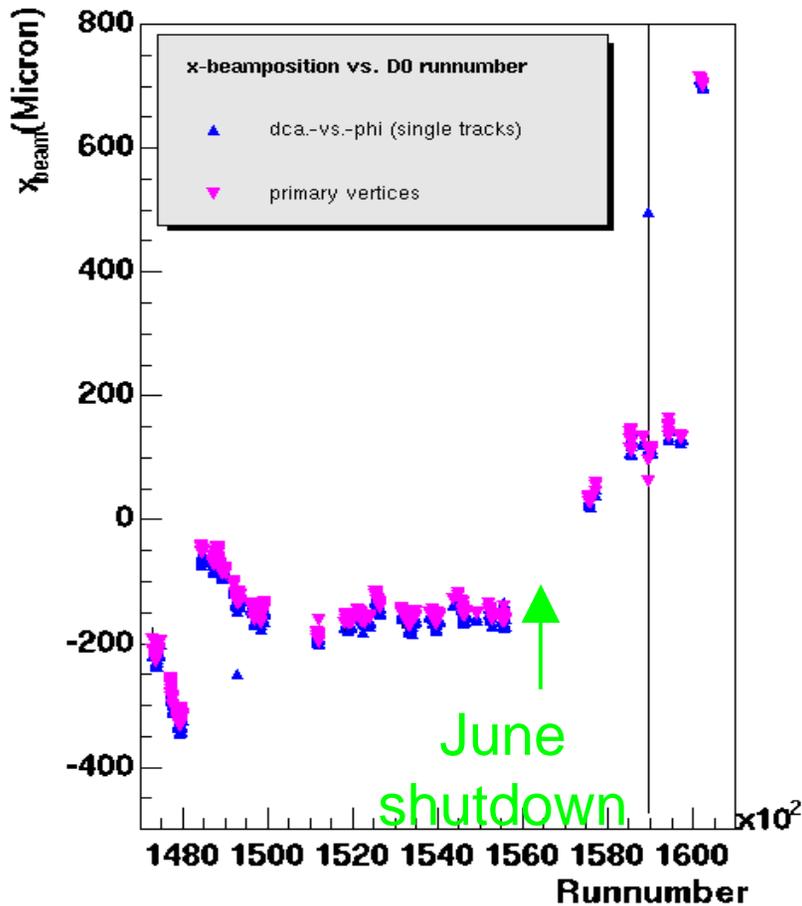
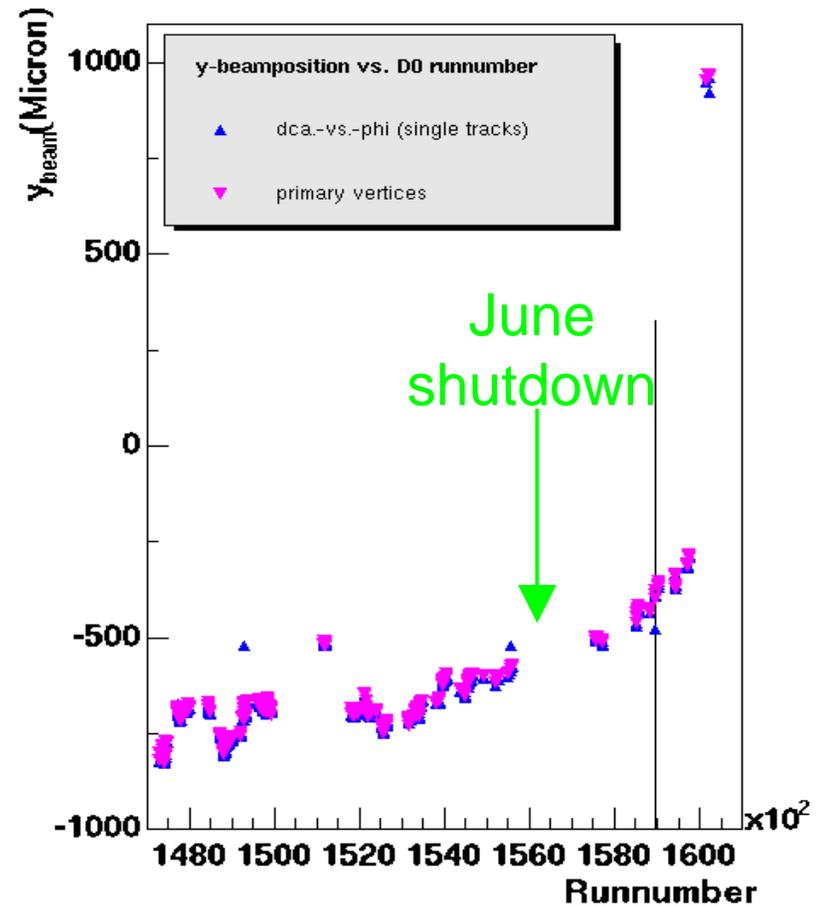
Beam Position

Beam position is stable since July 20th jump. Numbers for correction of beam location are agreed upon with BD. To be corrected on 08.06.02.

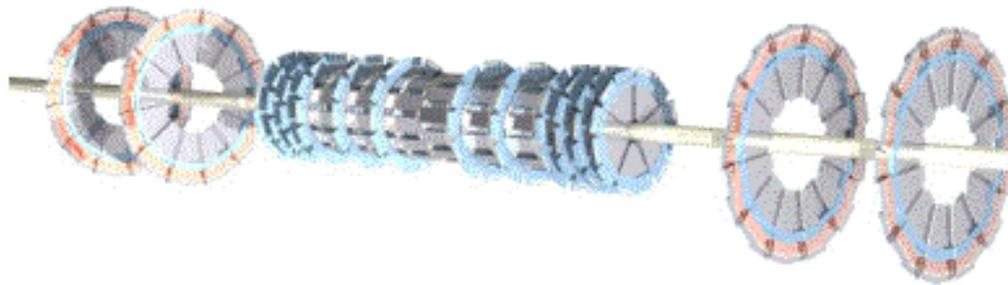
SMT Radiation Dose

- Dose estimate is based on “finger counters”
 - ◆ diodes located inside silicon detector volume
 - ◆ calibrated using mip response and TLD badges
- For inner silicon layer located at ~3cm from beam axis
 - ◆ dose per pb-1
 - ▲ 0.4-0.6 krad
 - ◆ total for ~70pb-1 delivered
 - ▲ ~35 krad from collisions
 - ▲ ~3 krad from shot setups
 - ◆ total dose
 - ▲ ~40krad (~6 krad at radius of 8cm)
- For expected Run II a luminosity of ~3fb-1
 - ◆ ~1.5Mrad expected (at 3cm)
 - ◆ reasonable number as D0 silicon can handle 1+ Mrad

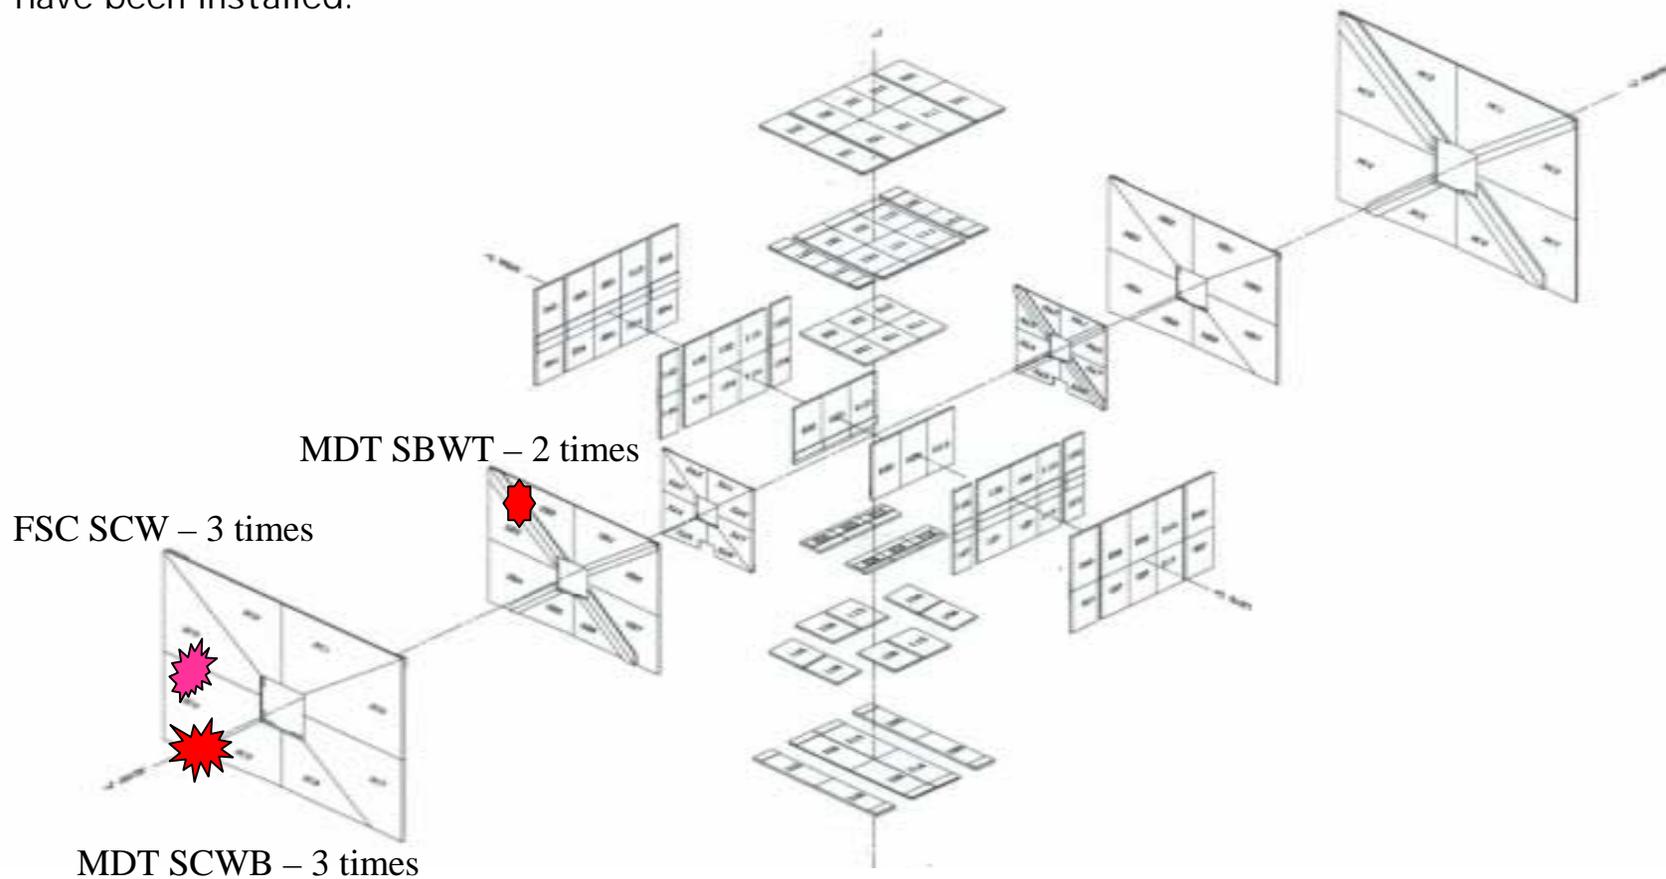
The Mysterious Corner

- There are 44 VME crates used to readout muon detectors located in different locations in the collision hall
- We observed rare, but steady failures of LVPS in the muon crates
 - ◆ about once a month
 - ◆ requires ~2 hours access to replace failed supply
 - ◆ usually wipes ~25% of muon coverage for the store LVPS failed

- * All failures concentrated in one corner (!?)
- * Nothing specific in terms of temperature, humidity, etc.
- * Failure rate is at least ~5 higher then Vicor expectations.
- * While higher does are not expected in this area, TLD badges have been installed.
