Data Taking Jan 26 – Feb 1

Silicon Saga

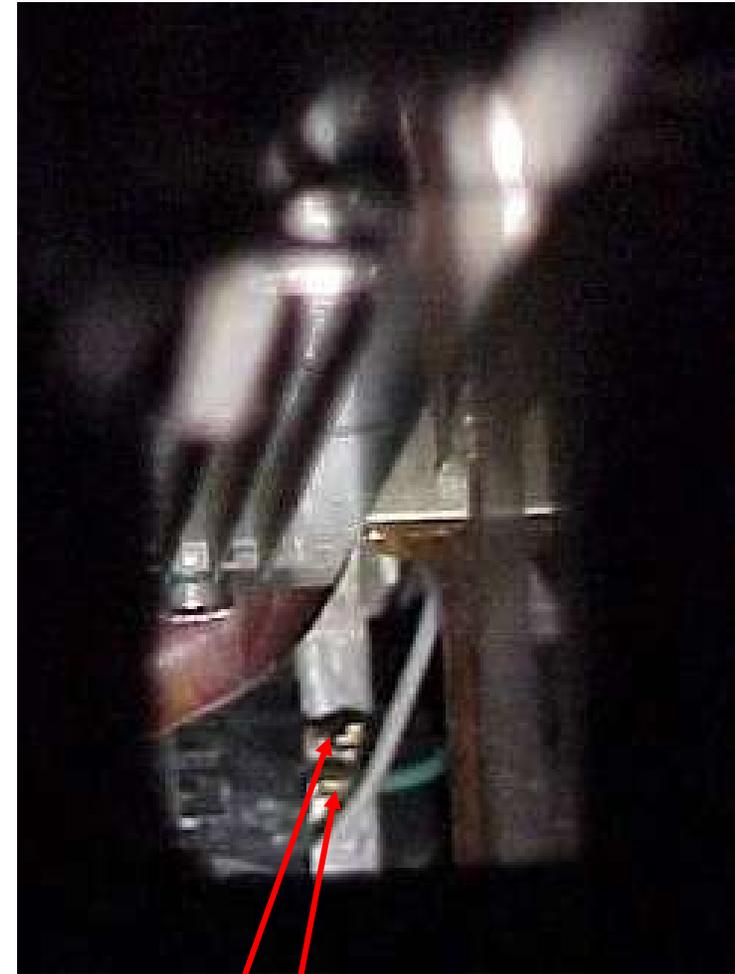
- Beginning on **Thursday** around 6pm, we observed frequent (~ once per hour) *trips of the Silicon power supplies on the East side* (water drip detection)
- After several attempts to recover, the Silicon was left off, we requested an access, and continued to take data without half of the Silicon detectors
- Access started **Friday 6:30 am**. We expected one shift to complete the work (cathedral area)
- Experts quickly discovered that *trips were the result of a malfunction of the water drip detection system* (loose connections). Fix took about 5 hours – multiple layers of Silicon cables complicated the work. Bypassed the drip sensor, since water in that crate is not flowing following an earlier (real) water leak.
- **Friday 2pm**: Ready to start closing the detector, beginning to power up Silicon

Connectors not fully seated

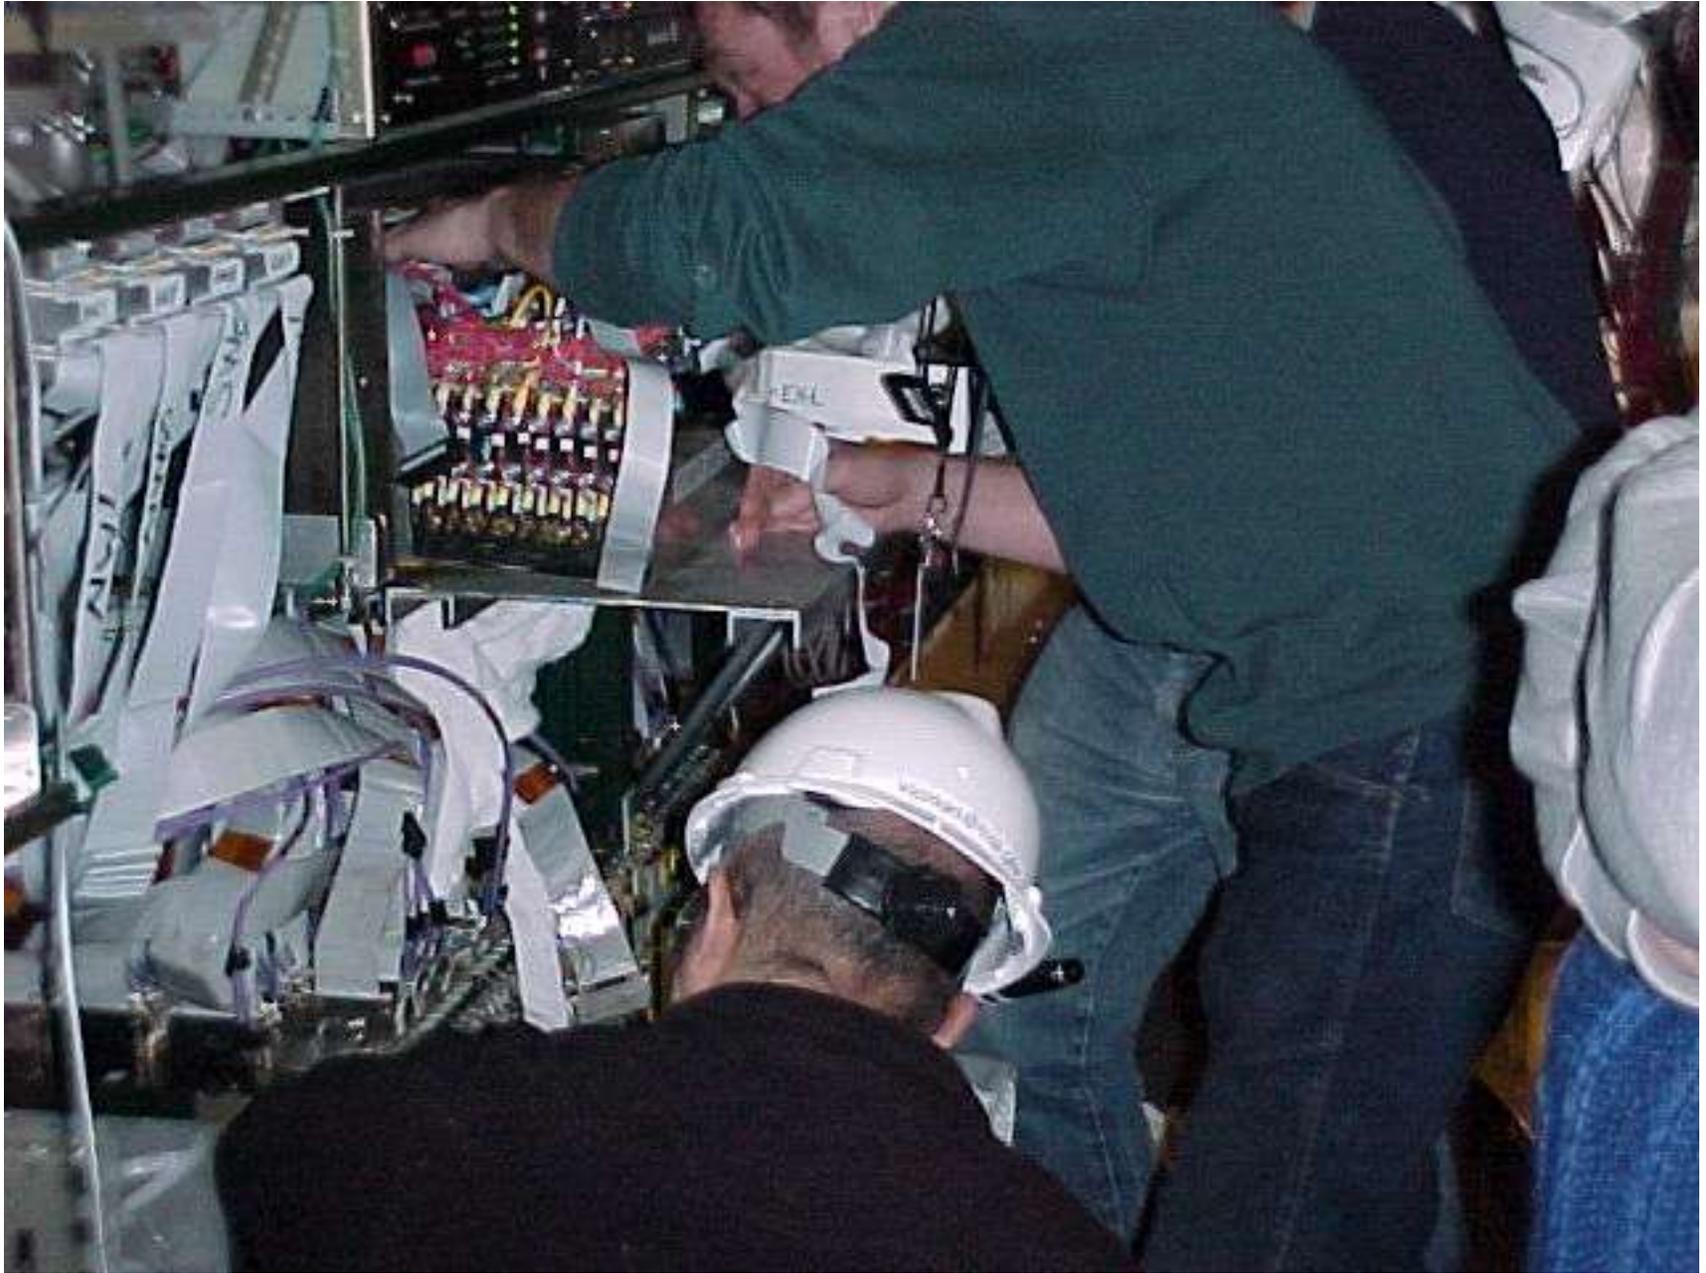
- On power-up, **failed on one of the power supplies on the West side**. Had no choice but to open up the West side as well
- After opening, discovered a **real water leak**. Found water accumulation in the power supply, rust, and apparently water had dripped on one of the interface boards located below the power supply, causing it to fail. Water leak was too small to trip the drip detectors

- The leak was quickly fixed, and it was attempted to dry the power supply in place. Gave up after 1.5 hours
- A **spare power supply was installed**, only to find that it was not holding as well. Suspicion that boards in the crate might be responsible, but couldn't find anything conclusive within the next 2 hours

- **Friday 7pm...** it's getting late – technicians have been around for more than 12 hours. Called MCR for search & secure, sending tech crew home
- Before S&S team arrived, swapped in another (not fully tested) spare power supply – this one worked!
