# Shutdown Completion

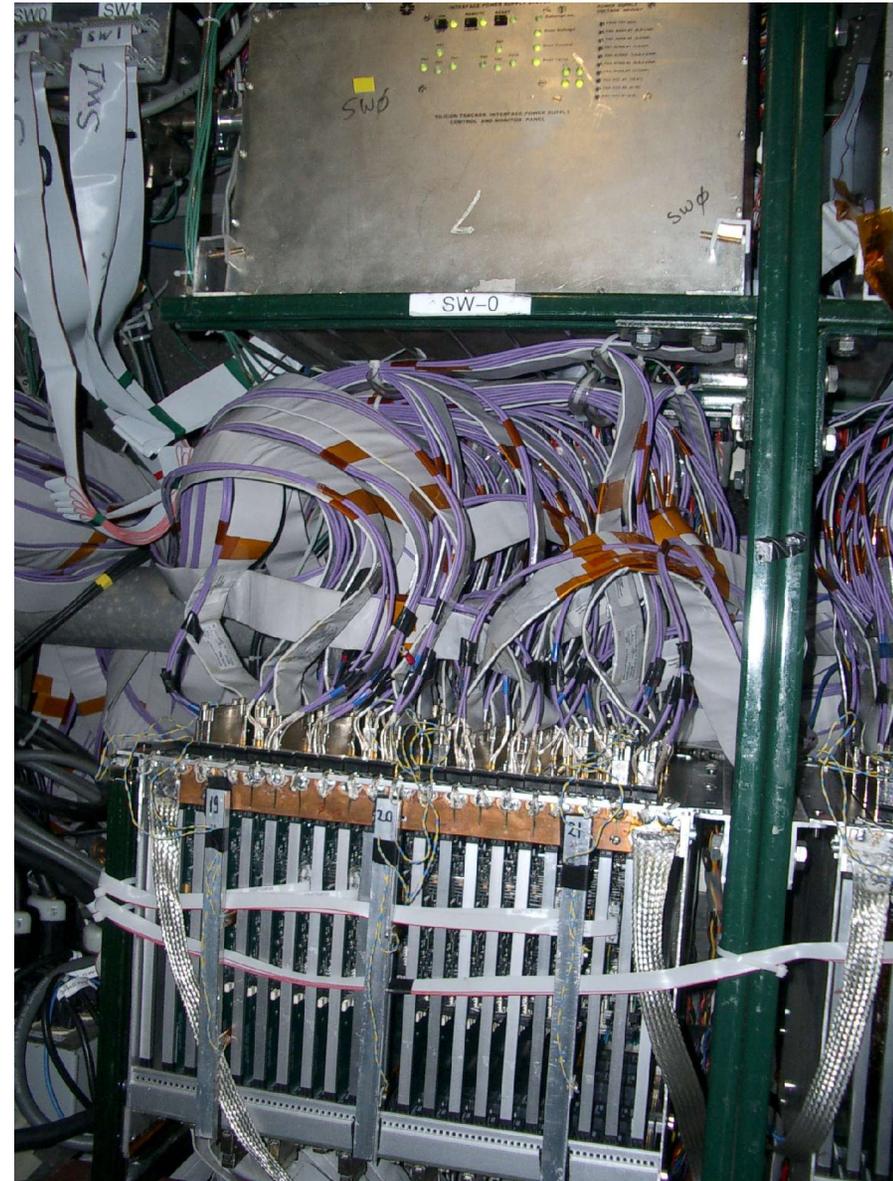
- Thursday evening, **one of the interface board power supplies in the West cathedral area failed**
- **Opened West CF** (North and South EF irons open all week) Friday morning
  - ◆ Replaced power supply
  - ◆ This was the “untested spare” we had to install 7 weeks ago as a consequence of a water leak

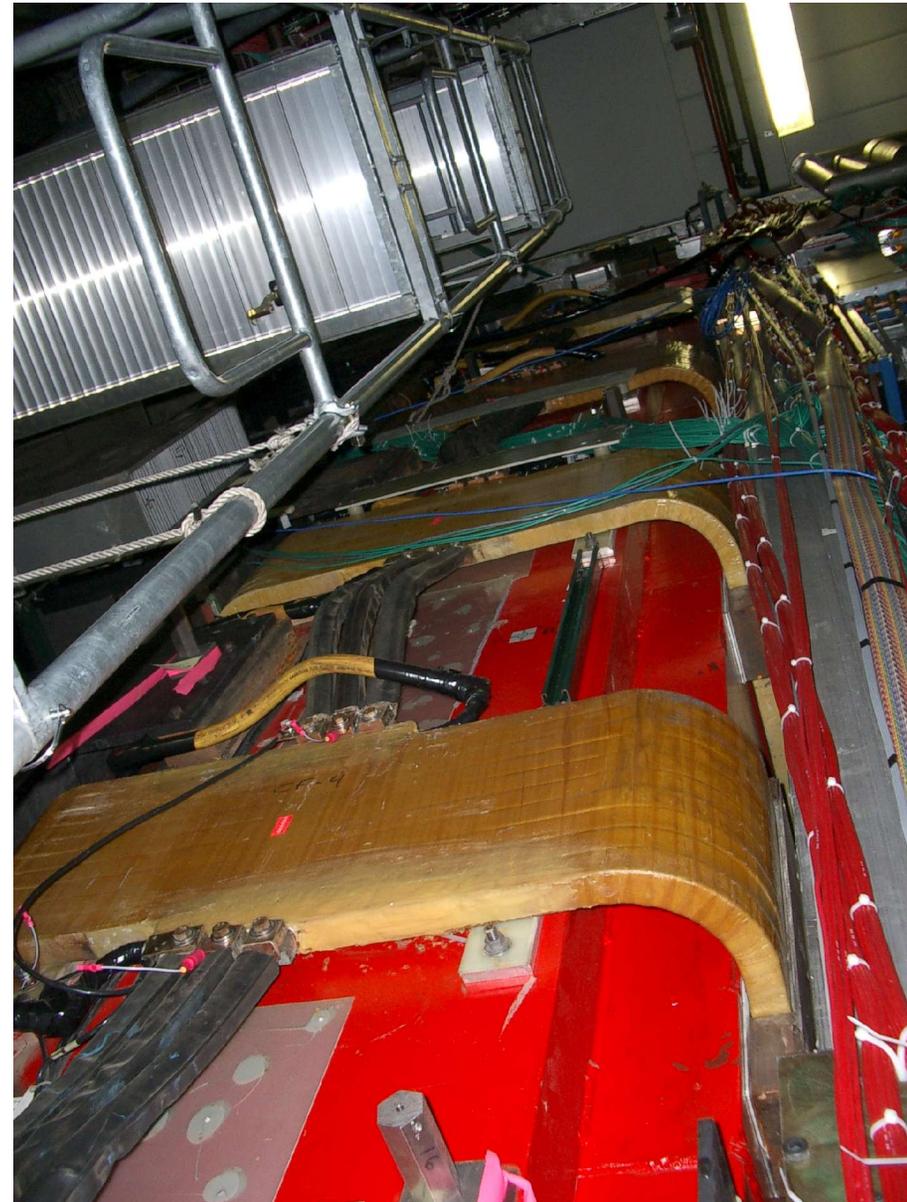
- Attempt to **reproduce / understand toroid related noise** (Monday)
  - ◆ Tried to raise humidity
  - ◆ Run magnet up to 2500A (normal operating point is 1500A)
  - ◆ **No noise observed**
- **Prevent future occurrence of noise**
  - ◆ All magnet connection bolts were torqued to 55 foot pounds
    - Some were quite low – one required about 1.5 turns to get to 55 foot pounds
  - ◆ Measured west CF taps (10 coils) with  $\mu\Omega$  meter
    - Resistances ranged from 5 to 11  $\mu\Omega$
    - One was 27  $\mu\Omega$  (65 W at 1500A) – low torque, took  $\frac{3}{4}$  turn to get to 55 ft pounds
  - ◆ Installed voltage taps on the West side

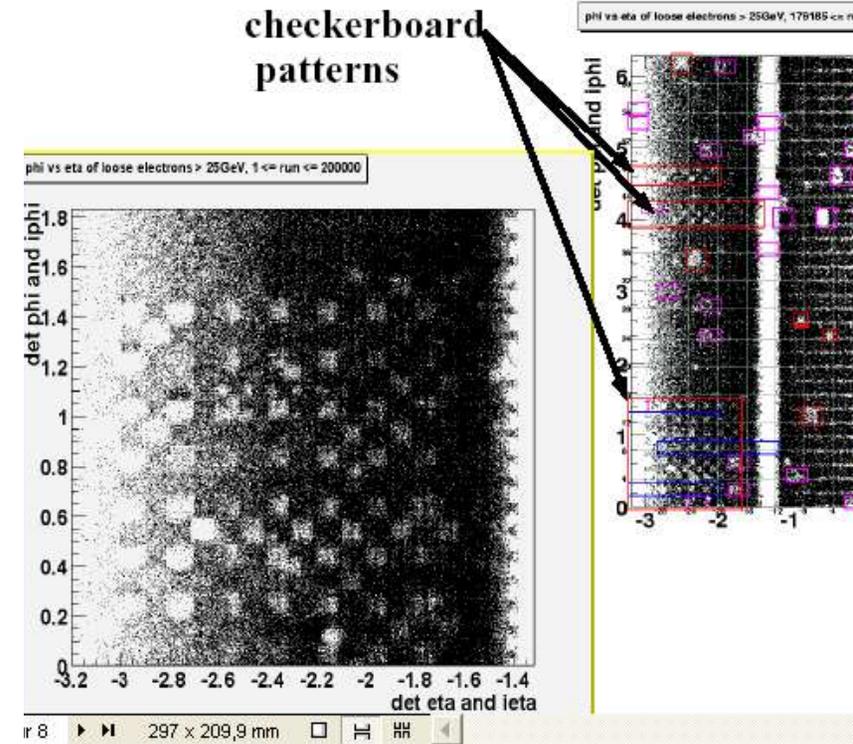
$\eta/\phi$  distribution of all candidate EM objects:

- “Checkerboard problem” – resolved!
- Discrepancy between L1 and precision readout for high  $E_T$  EM objects in certain region of the calorimeter
- Can correct offline
- Discrepancies between reported gain and ADC counts
- Traced down to tight timing interval between arriving control signals
  - ◆ Relaxed timing in firmware
