Week in Review: 01/20/03 -01/26/03

Ron Moore – FNAL

- Found obstacle in AP-1 line
- Replacing corroded Tevatron dipole stands

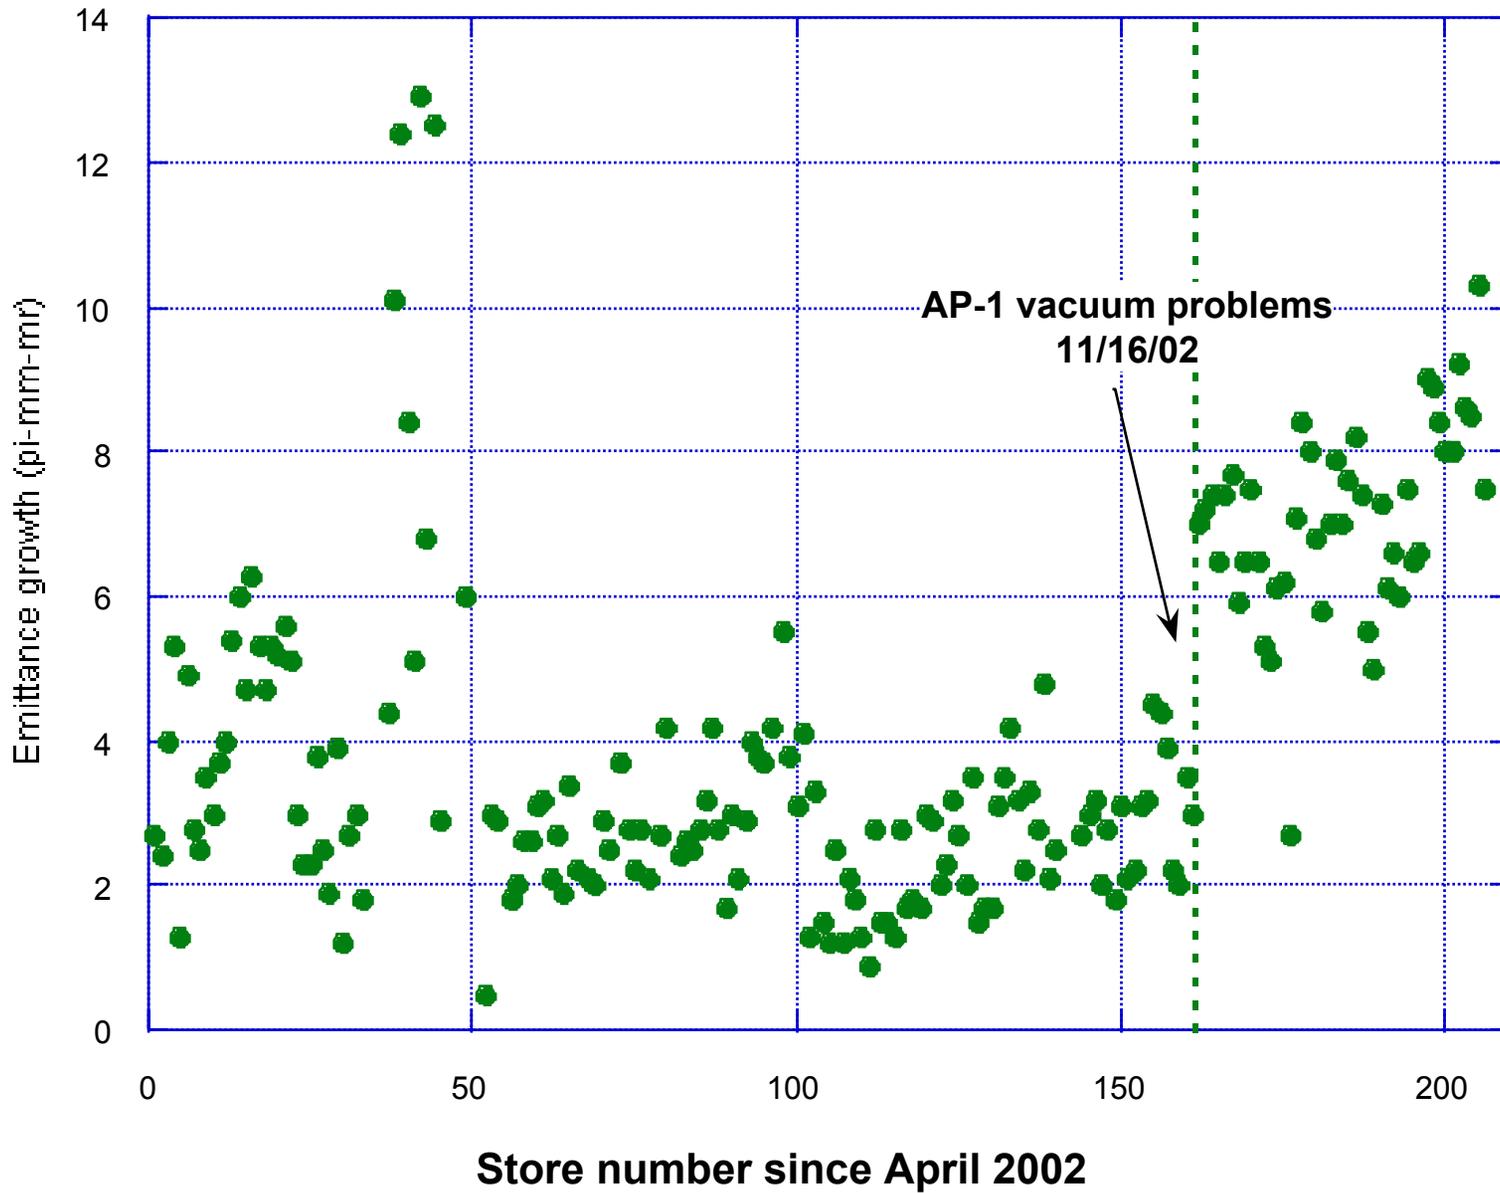
- After 11/17 beam accident that caused vacuum leak at TOR105, saw higher than usual losses nearby and higher emittance growth of pbars in region during shots
 - Pbar emittances increased $7-8\pi$ (up from 3π) between Acc and MI
- Opened AP-1 at SEM grid 103 on 12/3 – nothing seen, but SEM wire dangling at edge of aperture
 - Wire removed, but problem was unresolved

Pbar emittance growth between the Accumulator and M.I.

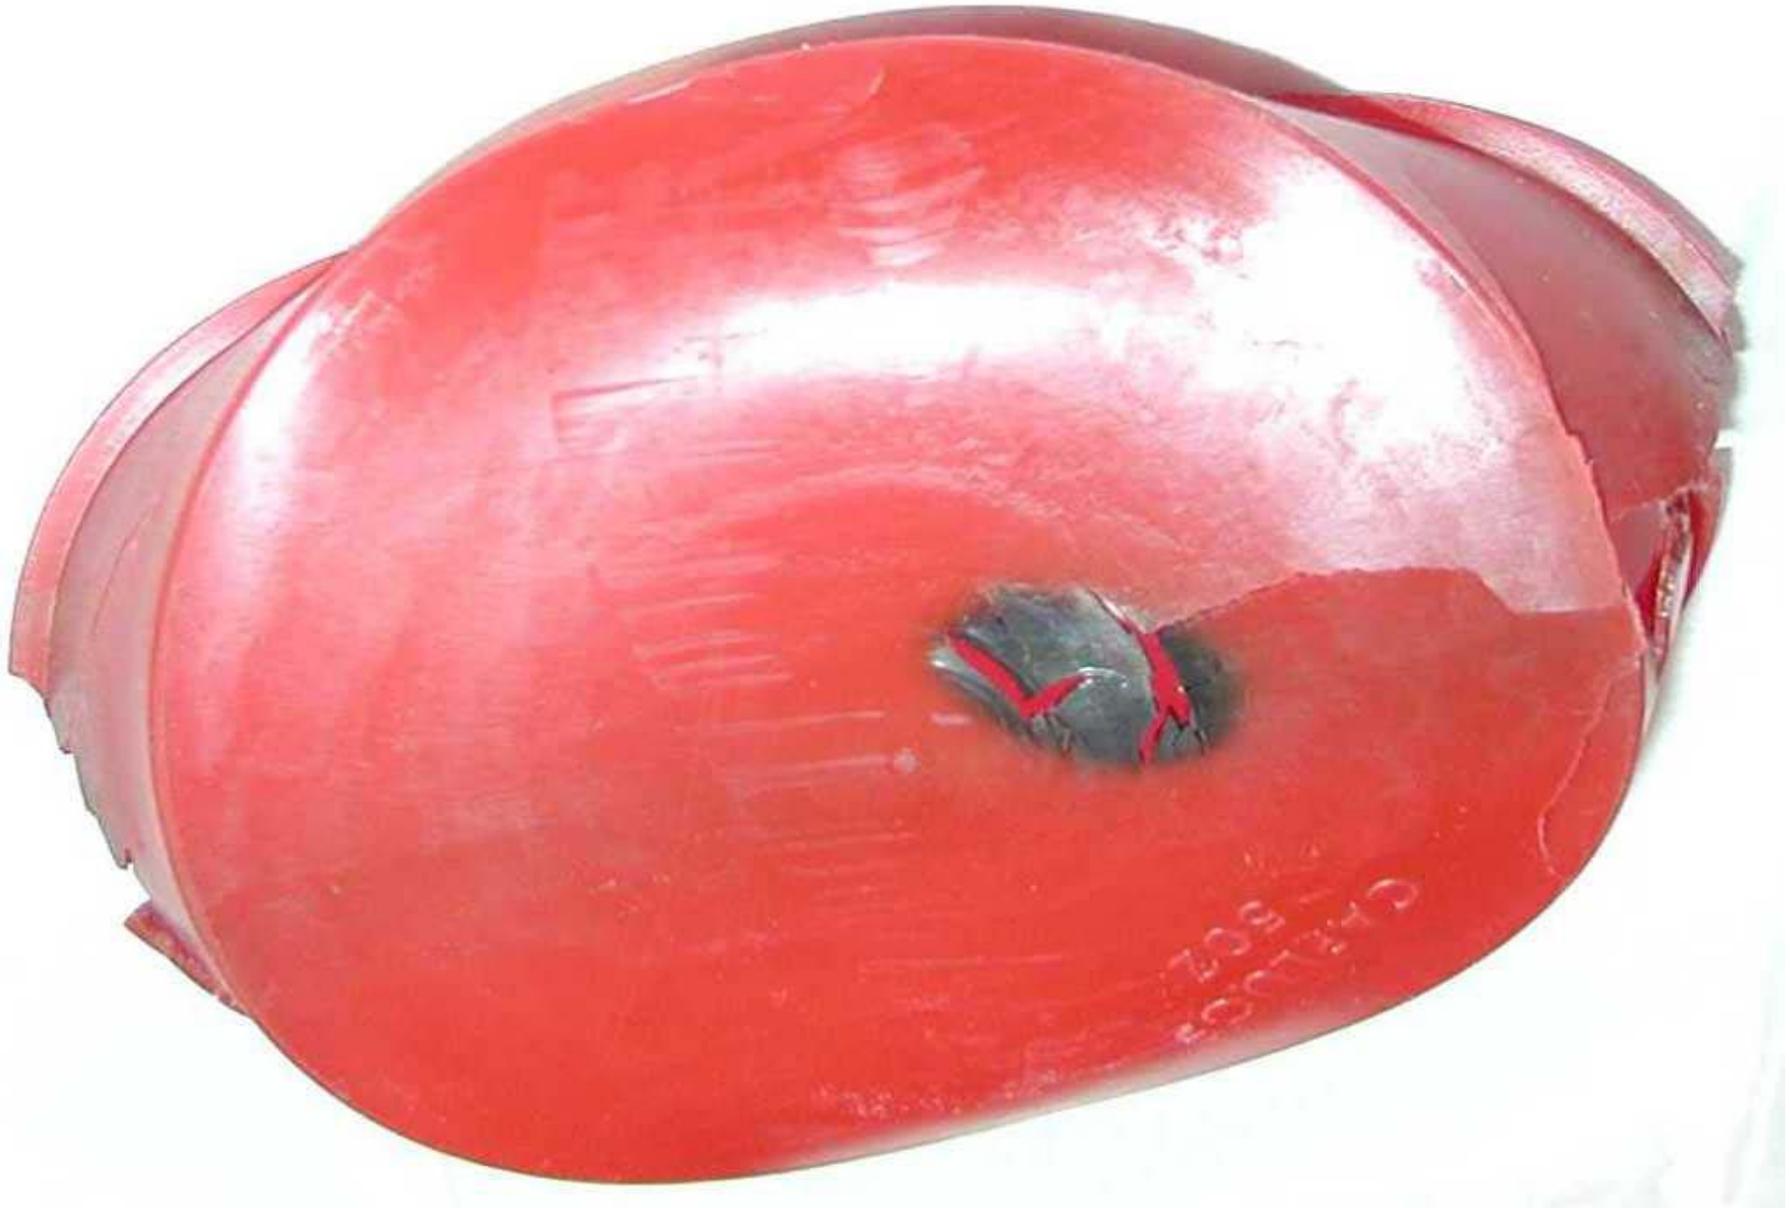
Plastic beampipe cap removed from AP-1 line on 1/21

Protons came out of page; pbars went into page

- Thought to have been there many years...
 - Hard to notice once hole was formed
- Red cap moved during vacuum incident in Nov.
 - Beam no longer through hole \Rightarrow problem appears
- After removal, expect reduced pbar emittance growth between Accumulator and Main Injector
 - Perhaps slightly smaller pbar emittances in Tev, too
 - No earth-shattering improvements expected

- Found and removed red plastic pipe cap in AP-1
 - Been there for a long time
 - Source of proton losses during stacking, pbar emittance growth during shots

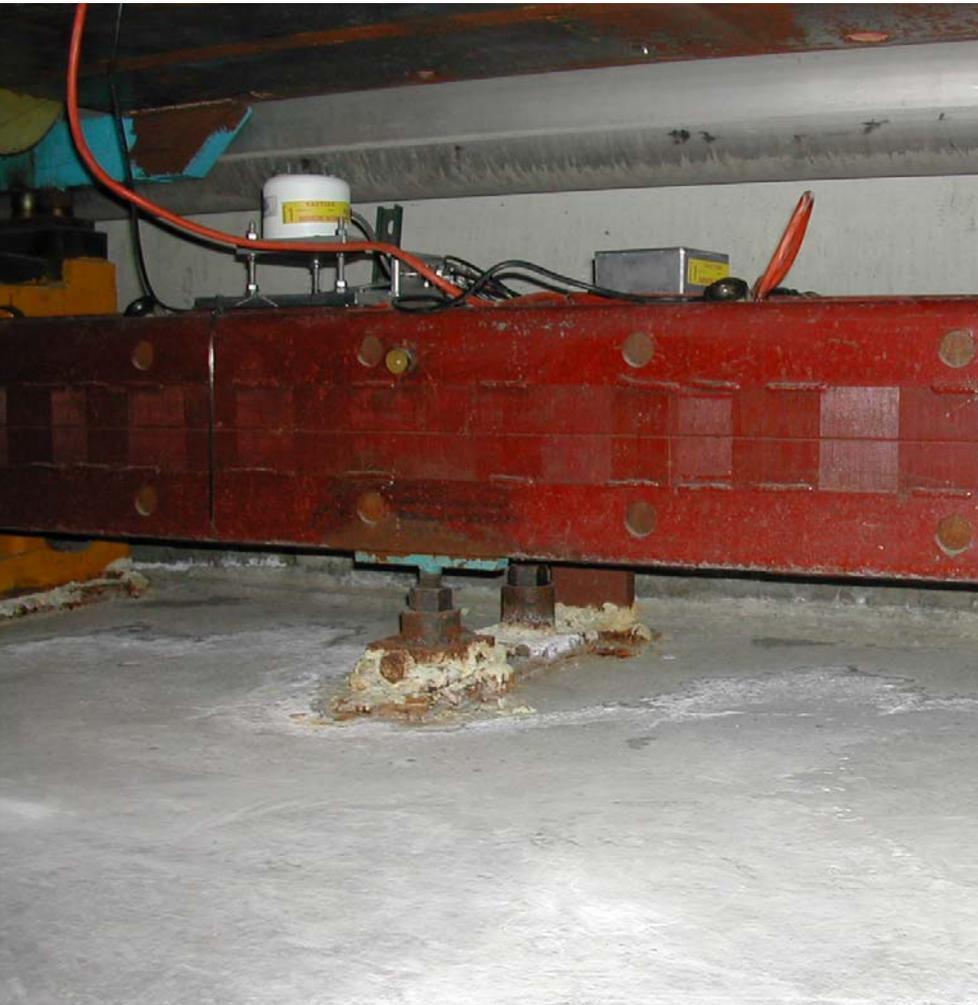
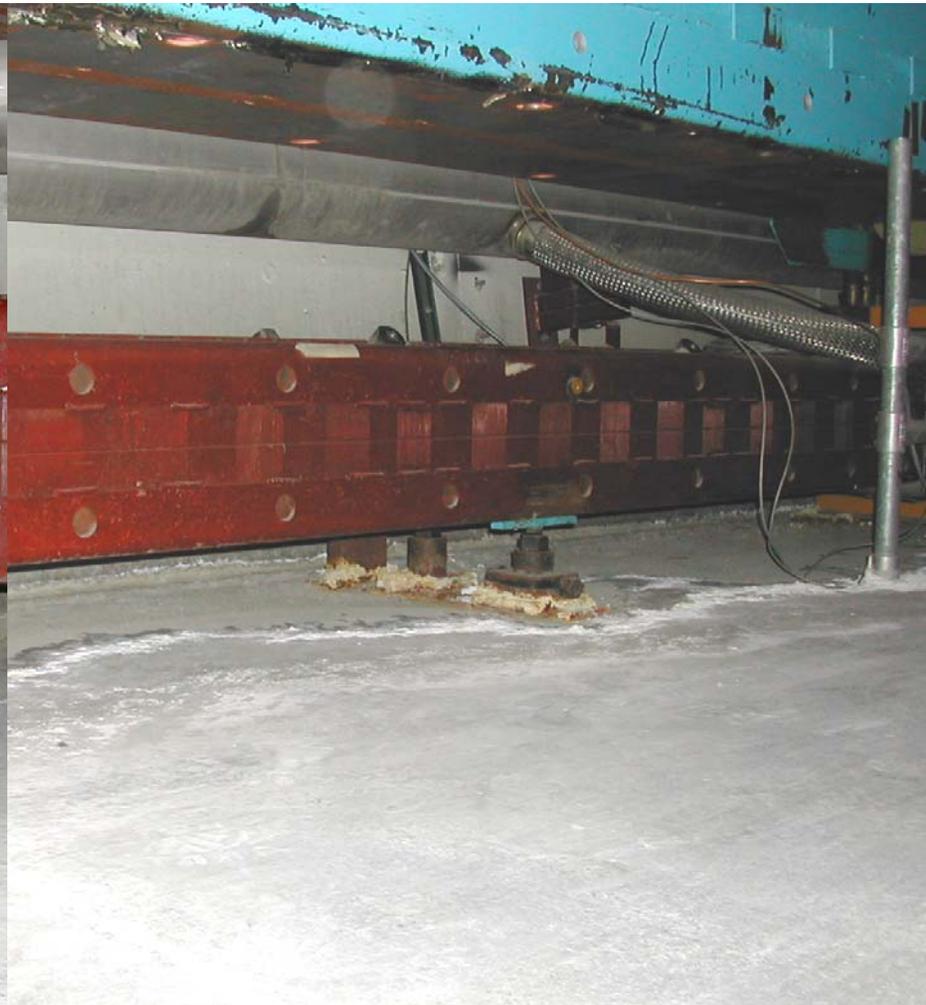
Tev A16-3 Dipole Photos

- Replacing stands for dipoles A16-3, A21-2, A21-3, A21-4
 - Stands appear very corroded – [safety issue](#)
- “Quick and dirty” mechanical measurements indicate significant dipole rolls; to be confirmed with optical survey
 - These rolls make the dipole correctors run harder, but not a big problem currently
 - At least one quad (not low- β) rolled significantly?
- Will just replace stands now; fix alignment later
- Catalog all magnet stands, roll measurements now
 - address stand replacement, alignment later

- Replacing stands of 4 Tevatron dipoles
 - Stands very corroded, posed a safety hazard
 - Catalog all other magnet stands for future work
