Status of Full Chain test at KSU

- Readout of L1-18 works with few bit errors
- Clocksignals bypassing the adapter card does not change readout
- Varying the clock cable length changes readout performance
- L1-13, our irradiated hybrid has developed erratic readout after a piece of debris shorted two neighboring wirebonds

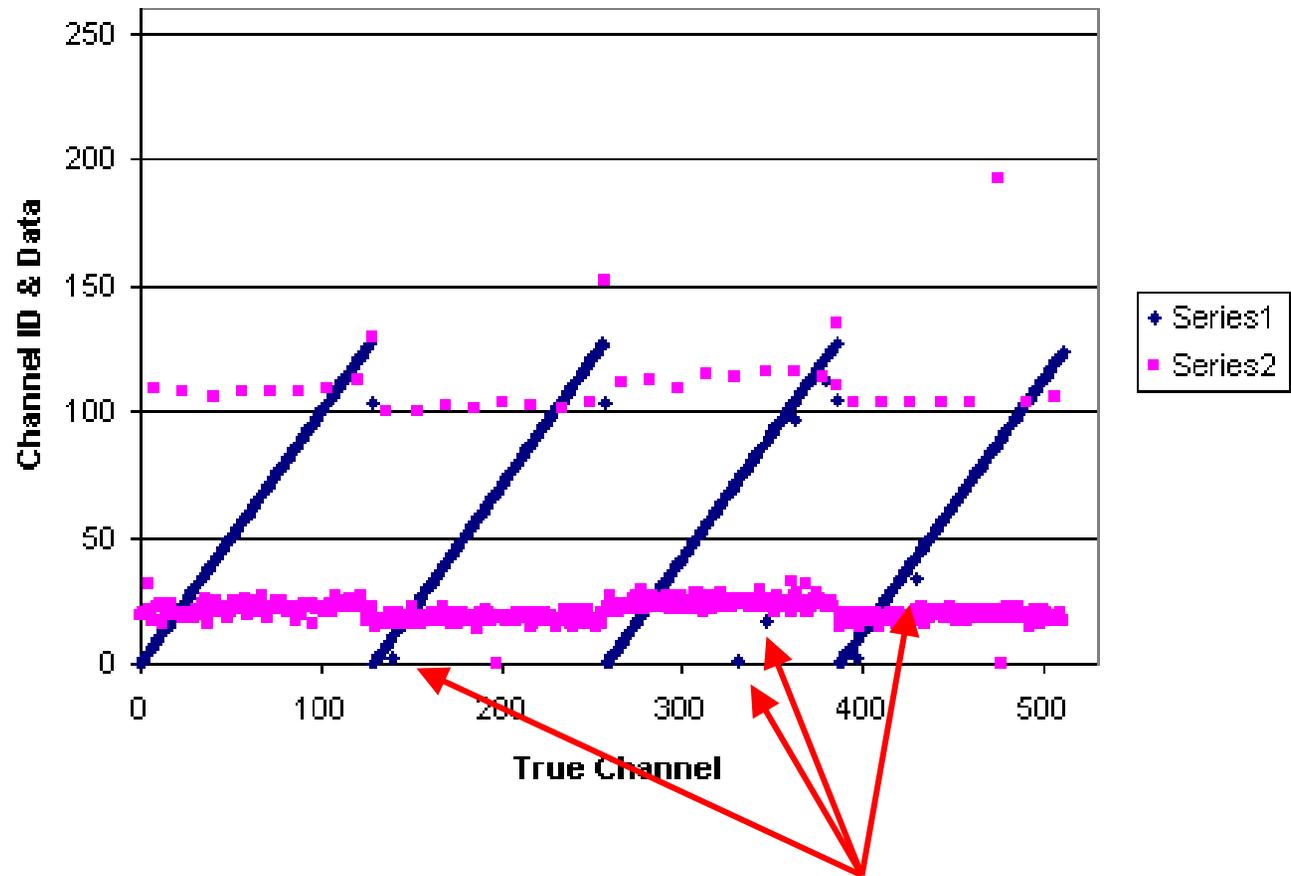
Full-Chain Readout with L1-18

Clock cable length
 $8+25=33$ feet

We are losing address bits

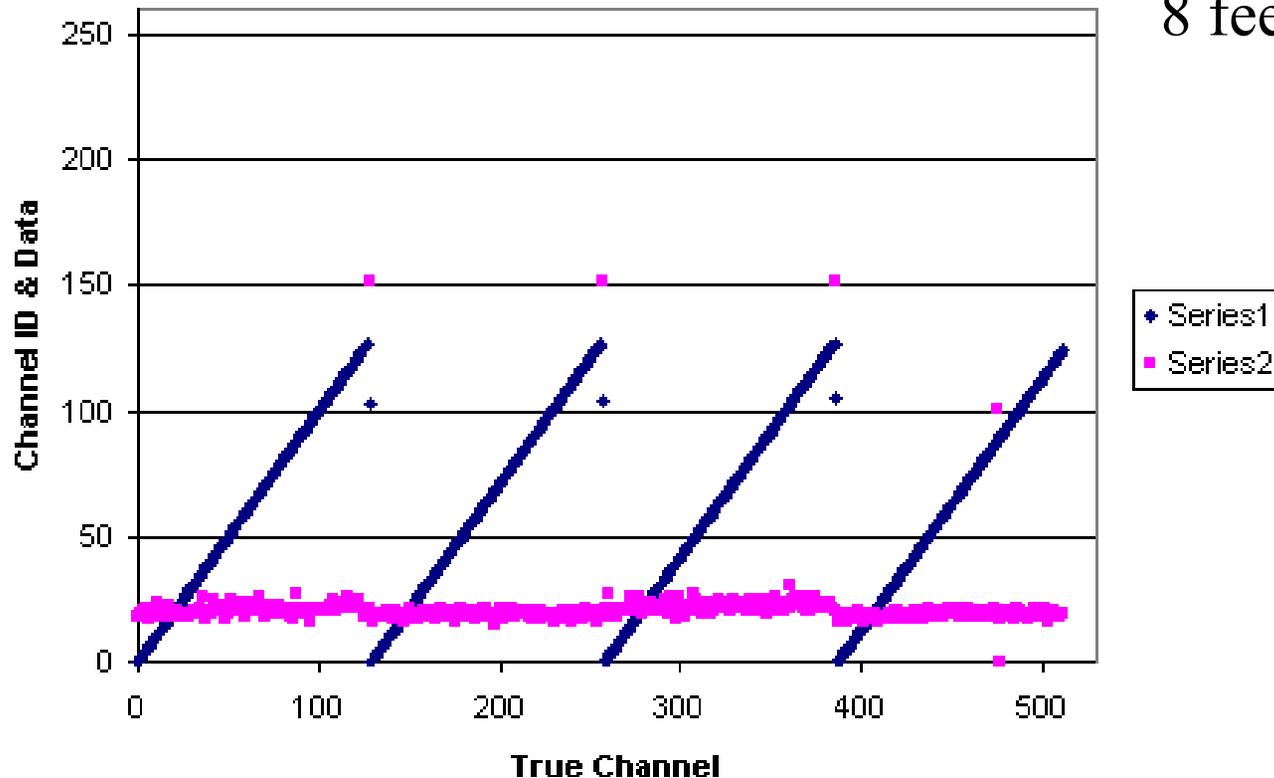
Full-Chain Readout with L1-18 with short Clock cable

Clock cable length
8 feet

Perfect address bits, **BUT NO SIGN OF CAL-INJECT !!!**
(Every 8th channel was turned on)
