SMT Longevity

Eric Kajfasz, Breese Quinn
May 29, 2003

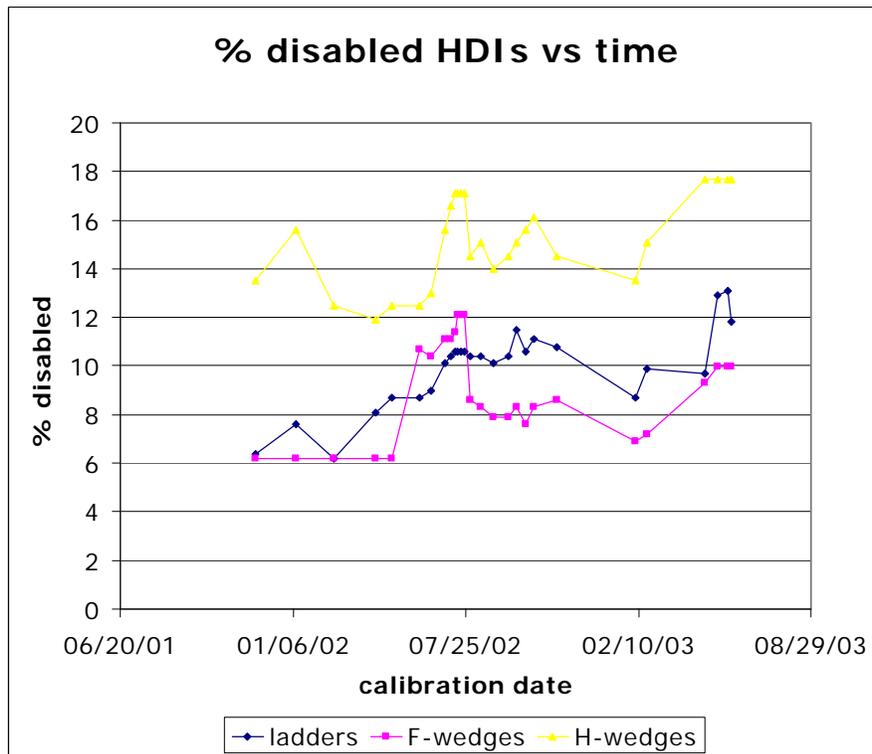
There are a few interesting features in the Figure 1 plot. The first major event is the sharp spike in disabled HDI’s around June, 2002. That time corresponds to a Tevatron shutdown period of a few weeks. An increase in disabled HDI’s during a shutdown does not imply that activity in and around the detector causes a rash of problems. More common is the effect that during such periods, there is more time available for thorough diagnosis of existing problems. For example, careful analysis of an HDI that has been generally operational could reveal that its data is irreversibly corrupted in a subtle way. The reduction in disabled HDI’s at the end of the January, 2003 shutdown is a case where the extra time for debugging resulted in the recovery of several disabled devices. This, of course, can only occur when the fault in a problem device occurs somewhere in the readout chain downstream from the external end of the low mass cable. It should be noted that it is extremely unlikely that the percentage of working HDI’s will ever improve beyond the levels attained at the beginning of February, 2003. Virtually all disabled HDI’s at that point were confirmed to have faults with inaccessible elements of the devices.

Figure 1. Percentage of disabled ladders, F wedges, and H wedges as a function of time.

Of some concern is the rise in the number of disabled HDI's over the last couple of months. It is particularly unclear how much of this recent rise represents actual failed devices. This is because shifter operation of the SMT has been somewhat altered since the end of the January, 2003 shutdown. Operational guidelines now encourage shifters to quickly disable any HDI giving problems during the run in order to avoid losing delivered luminosity. There has been less downtime which is typically used to determine if some disabled devices are ready to be re-enabled for data taking. In particular, it is expected that some of the ladders responsible for the jump from 10% to 13% disabled will be recovered.

It is quite difficult to attempt an estimate of disabled devices by 2009 based on this information alone. Under different sets of assumptions, Figure 1 could extrapolate to figures anywhere between 13% and 100%. The lower bound of 13% represents the current situation which is perfectly acceptable. This conclusion is supported by the distribution of disabled ladders in the barrels which is shown in Figure 2. There one can see that the pattern of unused HDI's is nearly random. There is a small level of clustering due to specific failure modes such as a problem with a Sequencer card or biasing which can group devices near to each other geographically. Even so, 13% disabled HDI's has not resulted in any loss of fiducial volume and only local reduction of tracking efficiencies on the order of 3%-5%². However, it is probable that just twice the current

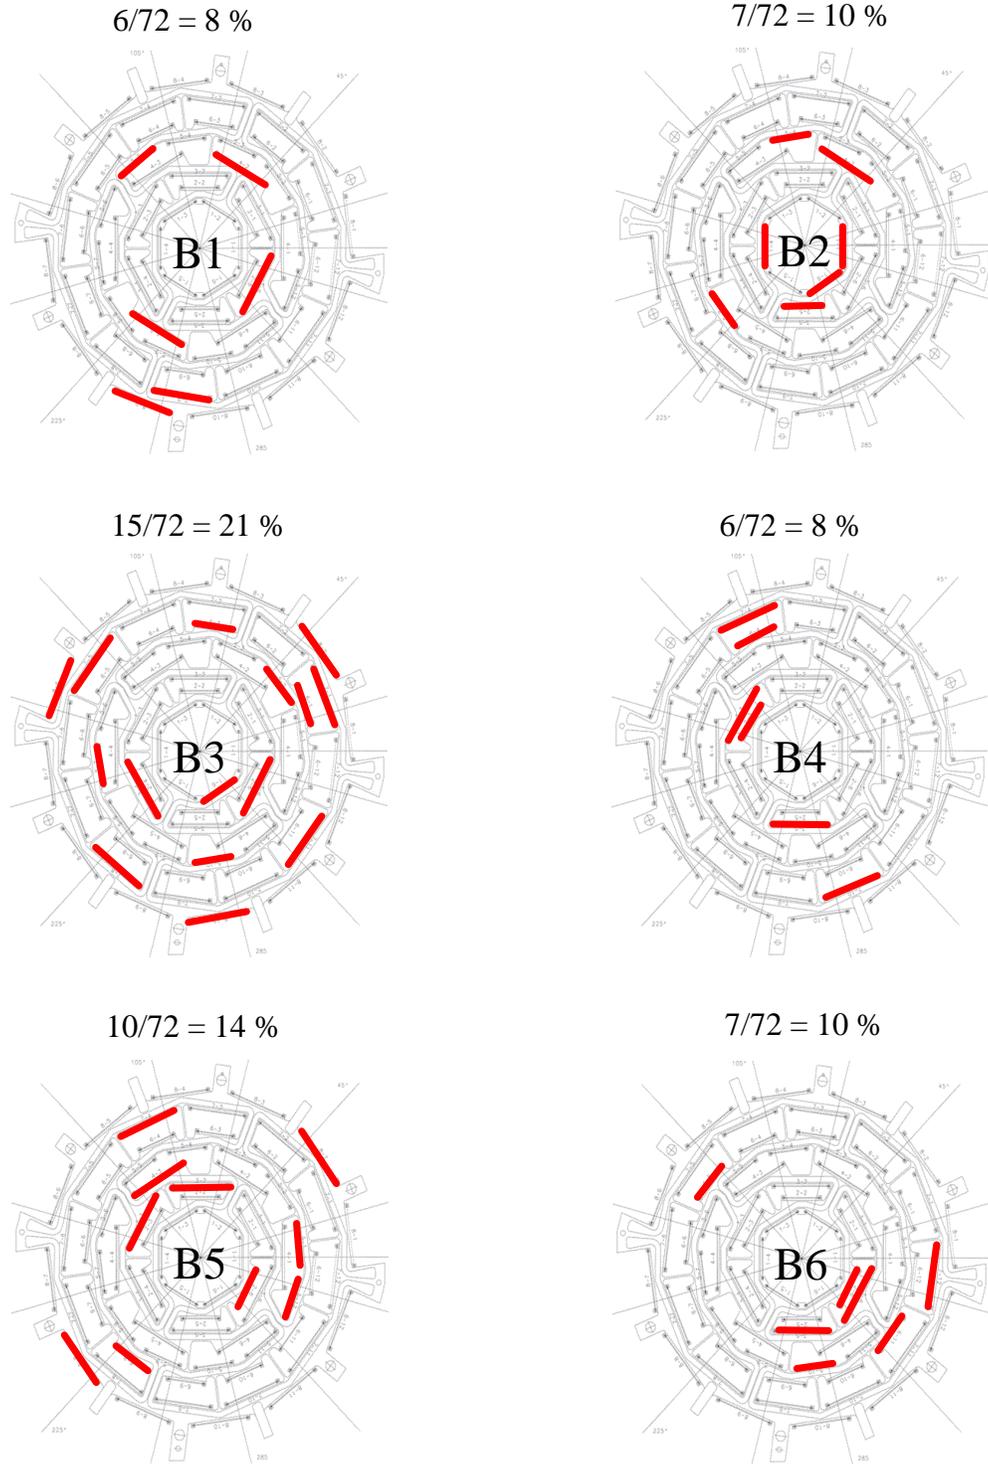
Figure 2. Fraction and location of the disabled ladders on the 6 barrels as of 5/27/03.

level of disabled HDI's could drastically alter that situation, possibly leaving the detector blind to small regions of f-?.

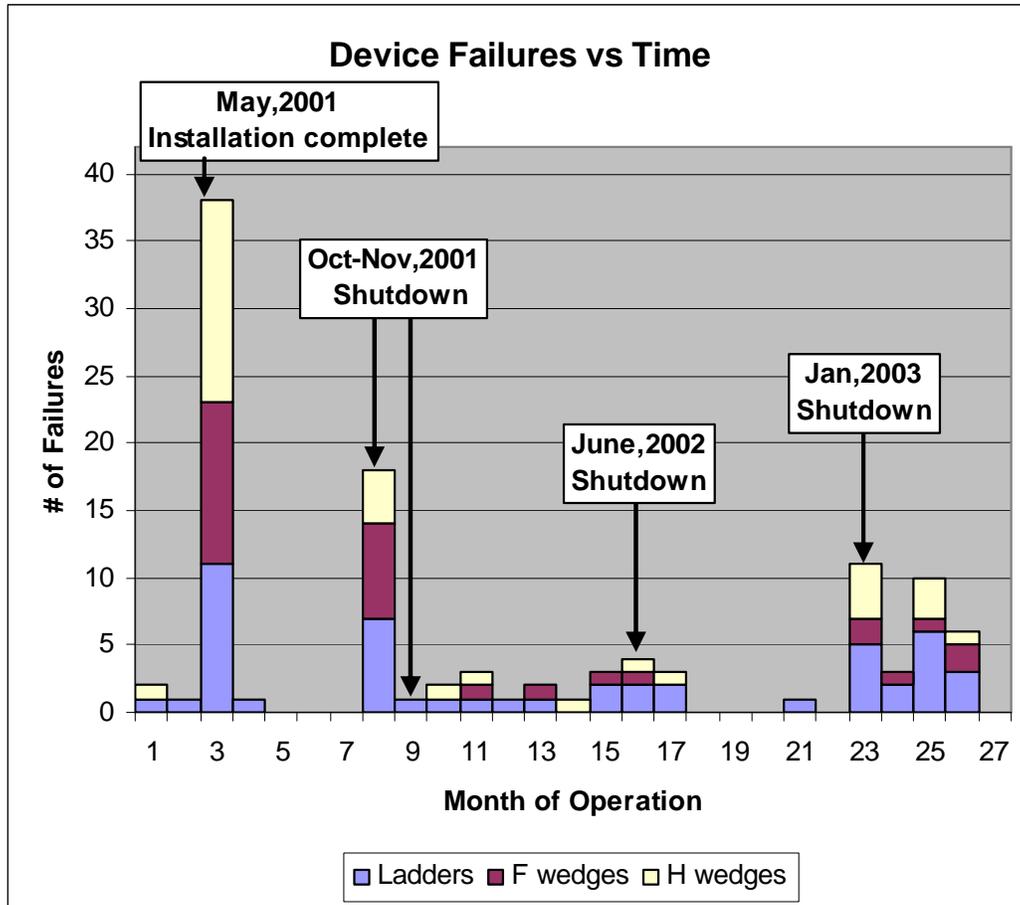
A time profile of failed HDI's is given in Figure 3. Each failed HDI is entered in the month of operation in which it first exhibited a failure mode for which it had to be disabled. Some clear points emerge from this profile. The first is that there was 4.6% infant mortality upon completion of SMT installation. The second is that even though many problem devices have been recovered during shutdowns, most of the truly failed devices developed their problems during or near those same shutdowns. However, this observation is somewhat lessened when one considers the reason for the gaps in summer 2001 and fall 2002. Those gaps overlap with periods when the SMT Commissioning database was not functioning. This database is where changes in HDI status are typically recorded and from where the data for the time profile is taken. This means that the bins corresponding to the October, 2001 and January, 2003 shutdowns are somewhat artificially elevated due to the database getting 'caught up.' Several entries there likely belong in months during the database gaps.

If the spike in May, 2001 is infant mortality, then the spike at October, 2001 could be considered in-situ burn-in. Even considering the database gaps, the average rate of failure from June, 2001 through October, 2001 is 4.5 HDI's/month. This is twice the rate from November, 2001 through January, 2003 of 2.1 HDI's/month. The enhancement in March and April, 2003 is at least partly due to the operational changes discussed in section 2.1 and the likelihood that many of those entries are recently disabled HDI's which will be recovered.

If the infant mortality and burn-in periods are excluded, one can hazard a crude extrapolation of failed HDI's. Assuming that the most recent months are biased high, the failure rate of 2.1 HDI's/month would yield 18% disabled by 2006 and 27% disabled by 2009. If the last two months are fully included, the rate is 2.8 HDI's/month and the extrapolation is 20% by 2006 and 32% by 2009. However, these estimates assume that there are no specific limiting expected lifetimes of any device components.

Figure 3. HDI failures as a function of time. Each failed HDI is entered in the month of operation in which it first exhibited a disabling failure mode. Note that this plot does not include devices that were disabled at one time but have since been recovered.

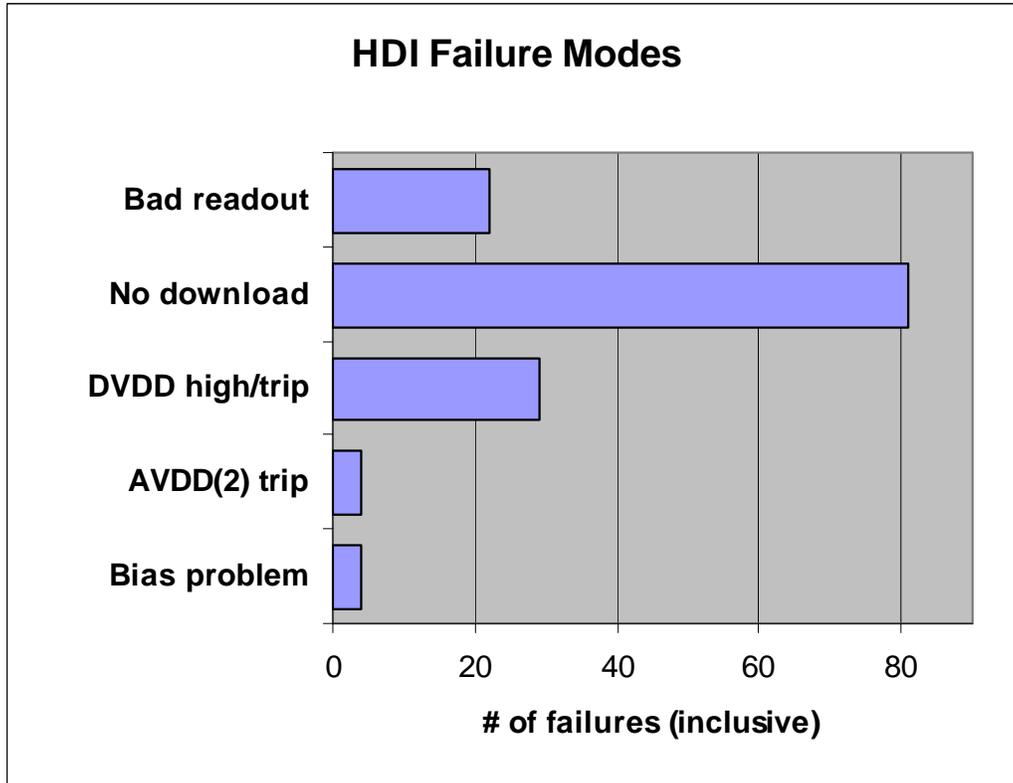
There are several recognized HDI failure modes. Figure 4 details the distribution of the most common ones. It is an inclusive distribution in that there are many double entries for devices that exhibit more than one failure mode. Inability to download the SVXIIe chips is by far the most common cause for the loss of an HDI. Frequently, this is accompanied by very high DVDD current draw, and sometimes it is preceded by the observation of bad readout from the HDI. Damage to the fragile clock cables is often

responsible for the loss of download functionality, although in many cases no specific cause for the problem can be identified because diagnosis would require access to the HDI.

Some type of problem with HDI readout is the next most common failure mode. This data corruption can take a variety of forms such as shorts of data lines to ground or missing chips in the readout. Anomalously high low voltage current draws are responsible for several lost HDI's, with the DVDD current more likely to be at fault than either AVDD or AVDD2. Fatal bias voltage problems are rare.

Figure 4. HDI failure modes. The graph is inclusive, i.e. HDI's that exhibited more than one failure mode have multiple entries.

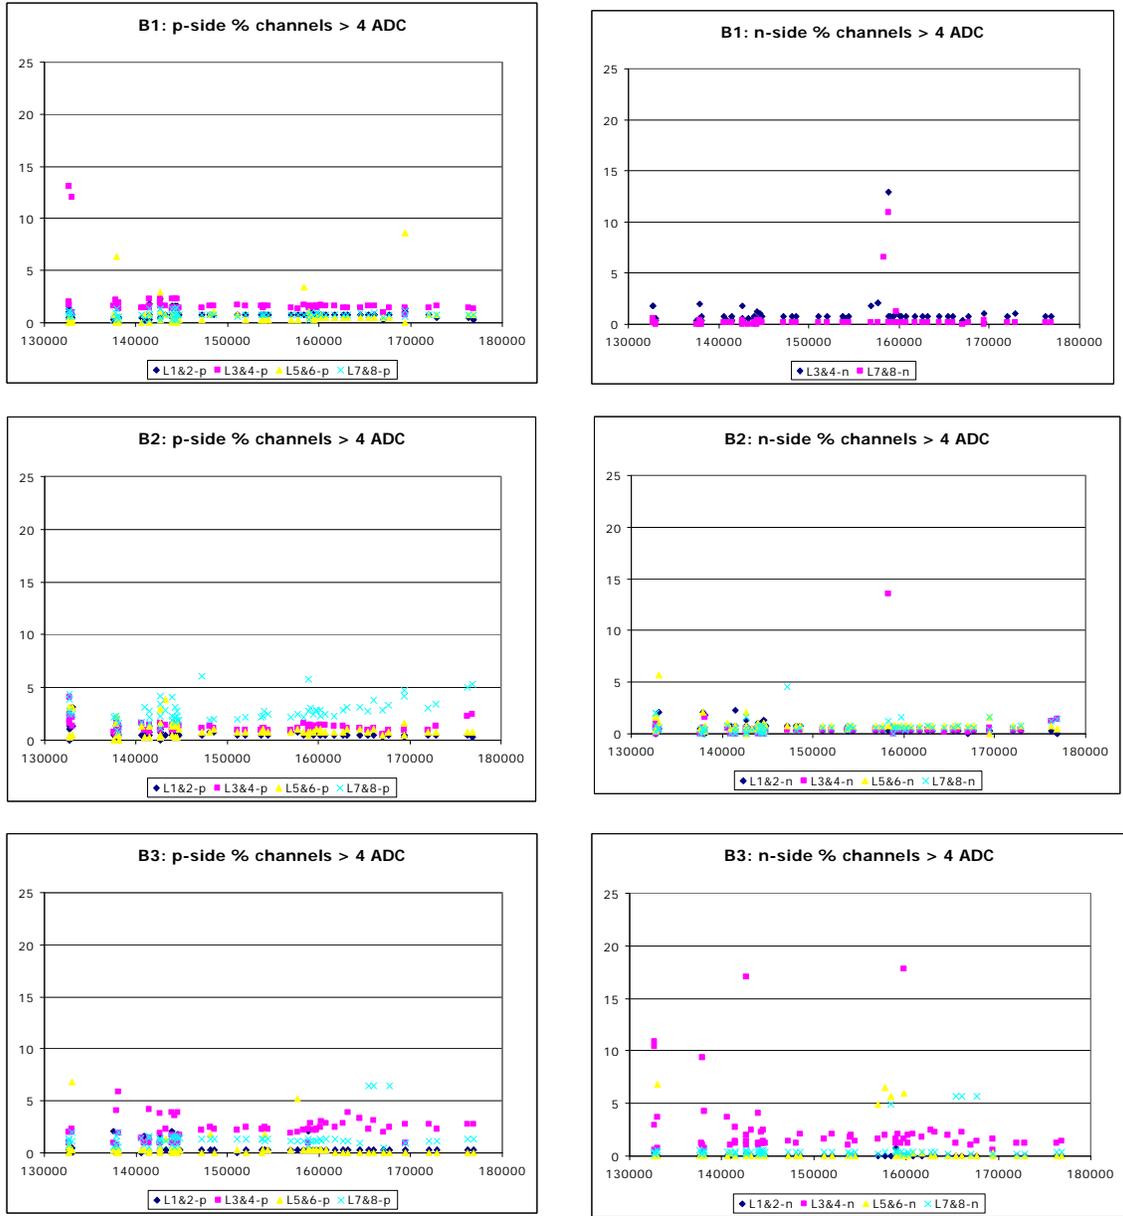
The noise situation for the barrels is shown in Figure 5 (north barrels) and Figure 6 (south barrels). In these graphs, the fraction of noisy strips on ladder p- and n-sides is plotted for layers 1+2, 3+4, 5+6, and 7+8 as a function of calibration run number (the runs span about 1.5 years). Noisy strips are defined as those with a noise level higher than 4 ADC counts (typical noise levels are between 1.5 and 2.5 ADC counts). The noisy strip fractions shown are quite low except for Barrel 5, Layer 3+4, n-side, which has about 10% noisy strips. This is due to a single ladder, B5-3-1.

Figure 5. North barrels fraction of noisy strips as a function of calibration run number (Run #130,000 = 10/01/2001, Run # 177,000 = 05/15/2003) with a noise threshold of 4 ADC counts.

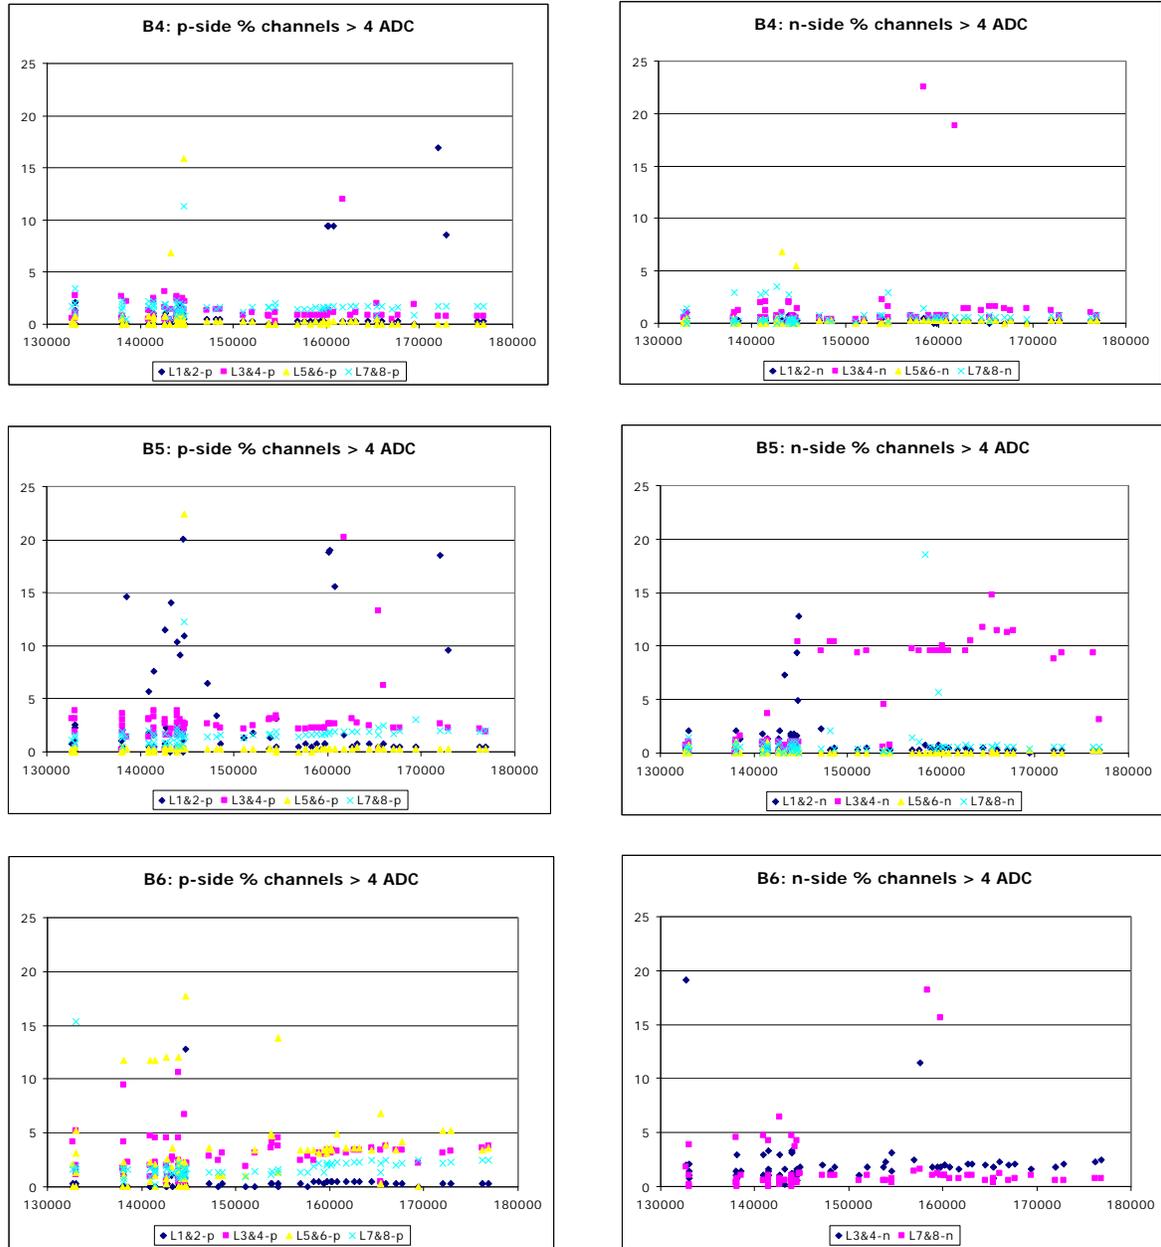
Figure 6. South barrels fraction of noisy strips as a function of calibration run number (Run #130,000 = 10/01/2001, Run # 177,000 = 05/15/2003) with a noise threshold of 4 ADC counts.

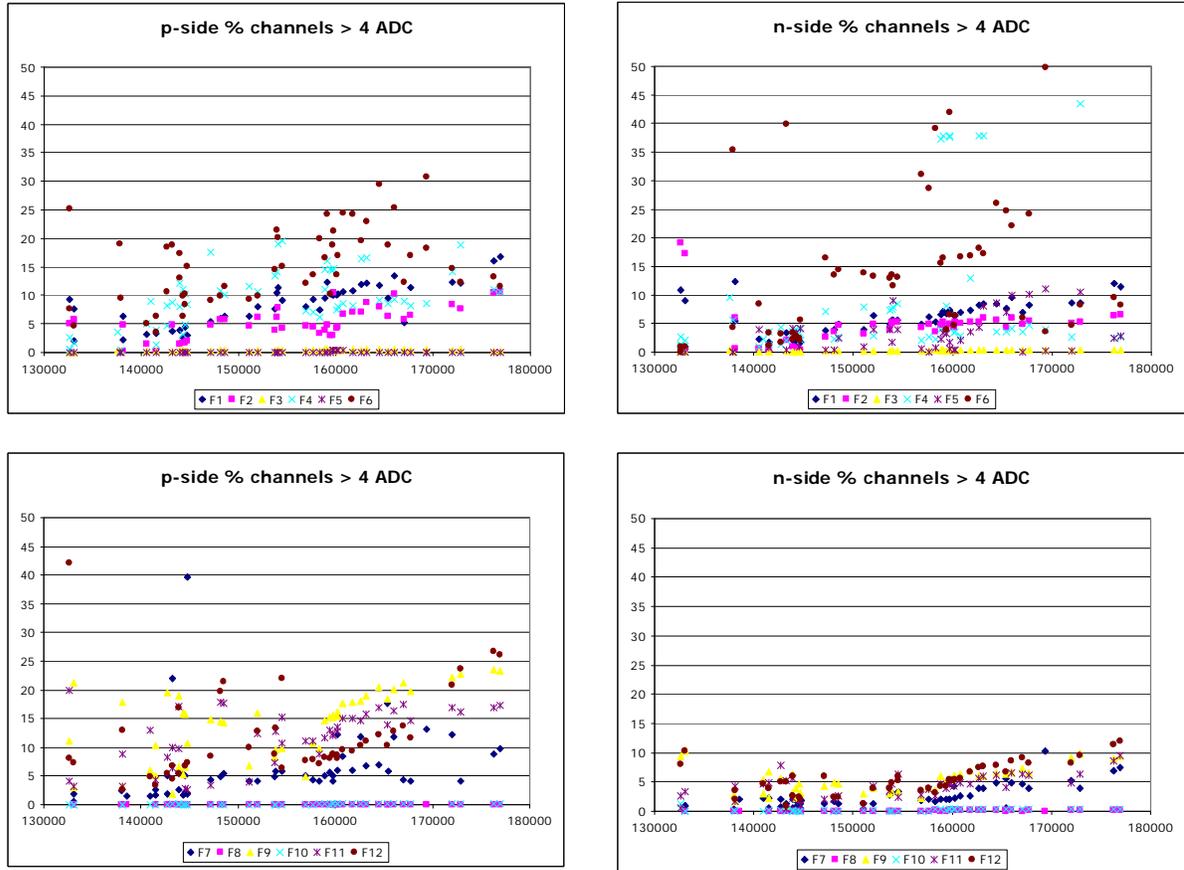
Noise in the F disks is shown in Figure 7 - Figure 9. The fraction of noisy strips on each F wedge p- and n-side is plotted as a function of calibration run number (the runs span about 1.5 years). In Figure 7, noisy strips are defined as those with a noise level higher than 4 ADC counts (typical noise levels are between 1.5 and 2.5 ADC counts). In Figure 8, noisy strips have more than 6 ADC counts and in Figure 9, the noise cut is 10 ADC counts. Two striking features are evident. One is that F disks 3, 5, 8, and 10, which are all made of Eurisy wedges, have very low noise. The other is that all of the other F

disks, which are made of Micron wedges, are characterized by high noisy strip fractions that are increasing with time, with F6 in particularly bad shape. This typical grassy noise has already required that some F wedges be disabled to avoid unacceptably high occupancies. If the F wedge grassy noise is not brought under control, the Micron F disks could become unusable within a few years.

Figure 7. F disks fraction of noisy strips as a function of calibration run number (Run #130,000 = 10/01/2001, Run # 177,000 = 05/15/2003) with a noise threshold of 4 ADC counts.

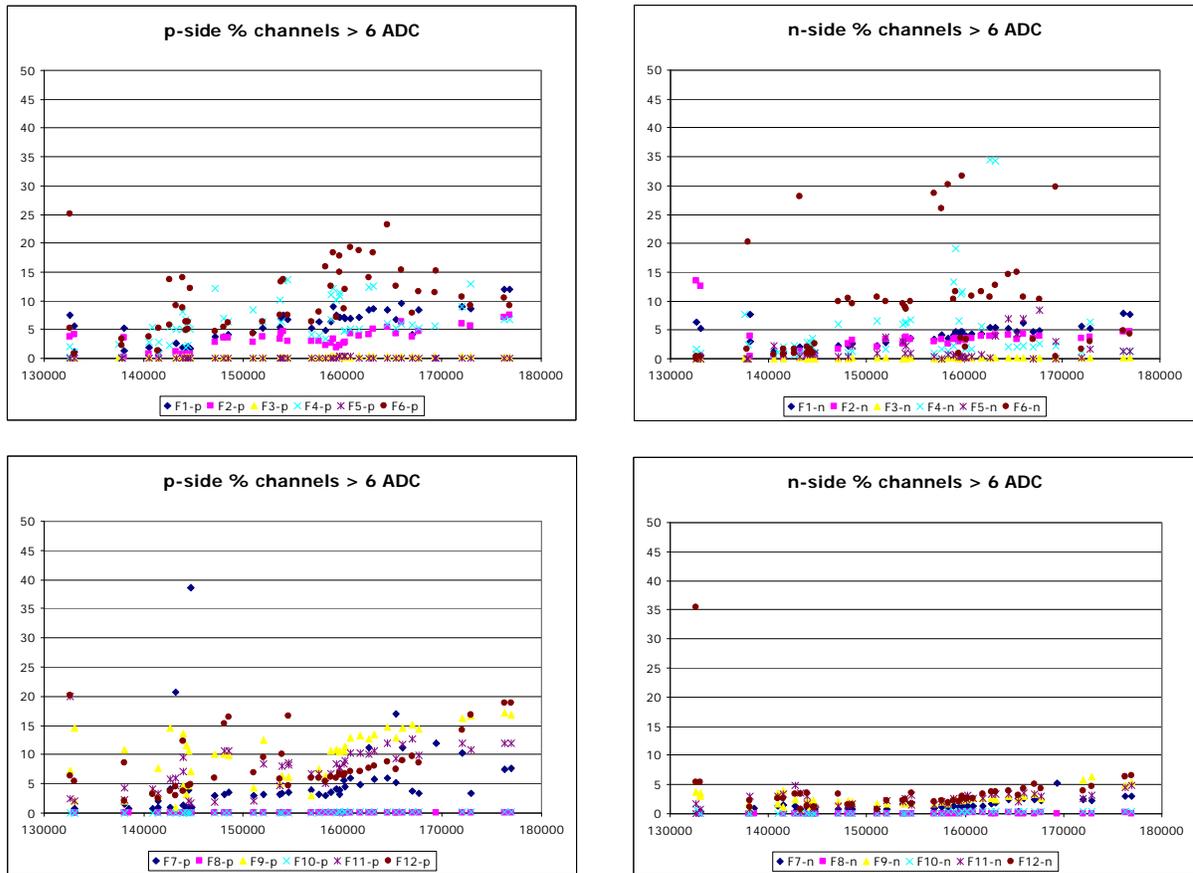
Figure 8. F disks fraction of noisy strips as a function of calibration run number (Run #130,000 = 10/01/2001, Run # 177,000 = 05/15/2003) with a noise threshold of 6 ADC counts.

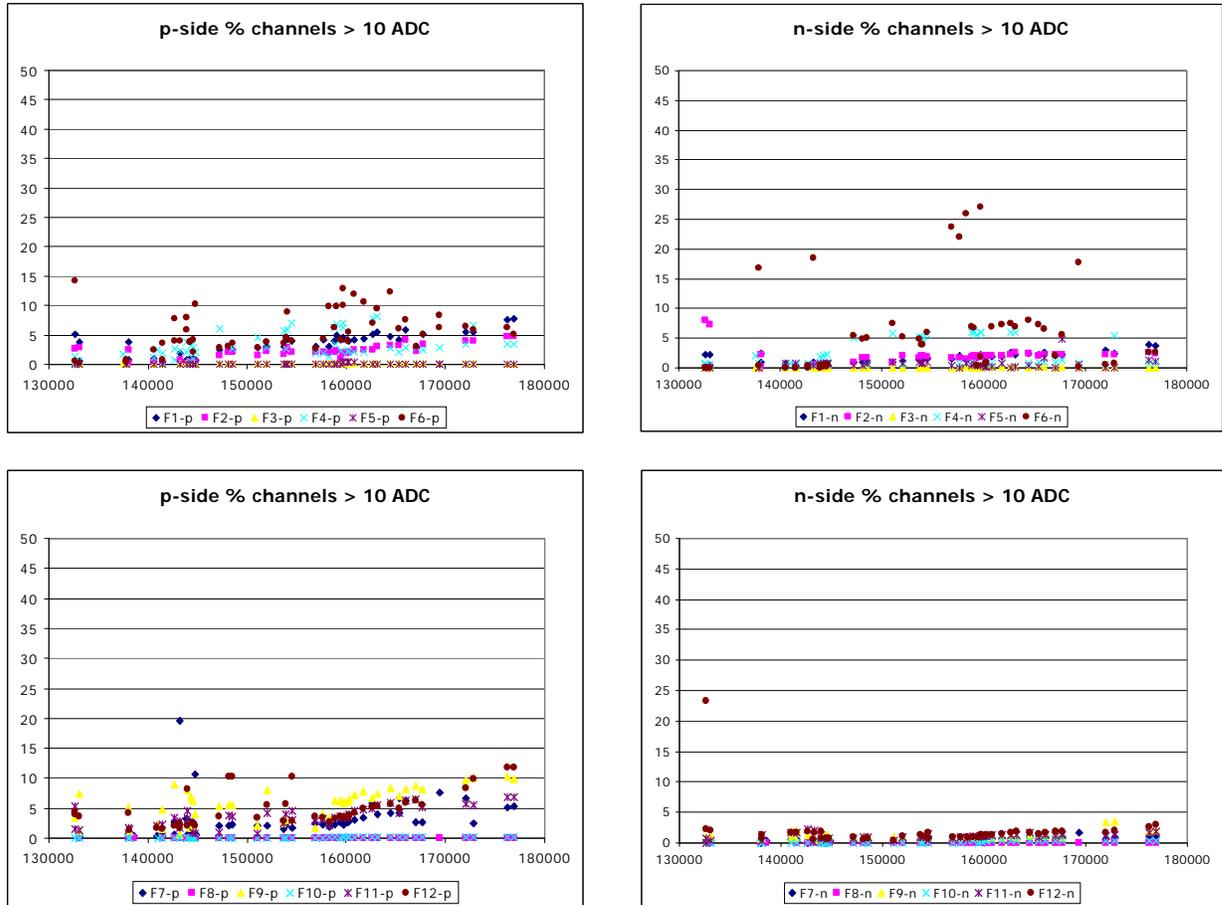
Figure 9. F disks fraction of noisy strips as a function of calibration run number (Run #130,000 = 10/01/2001, Run # 177,000 = 05/15/2003) with a noise threshold of 10 ADC counts.

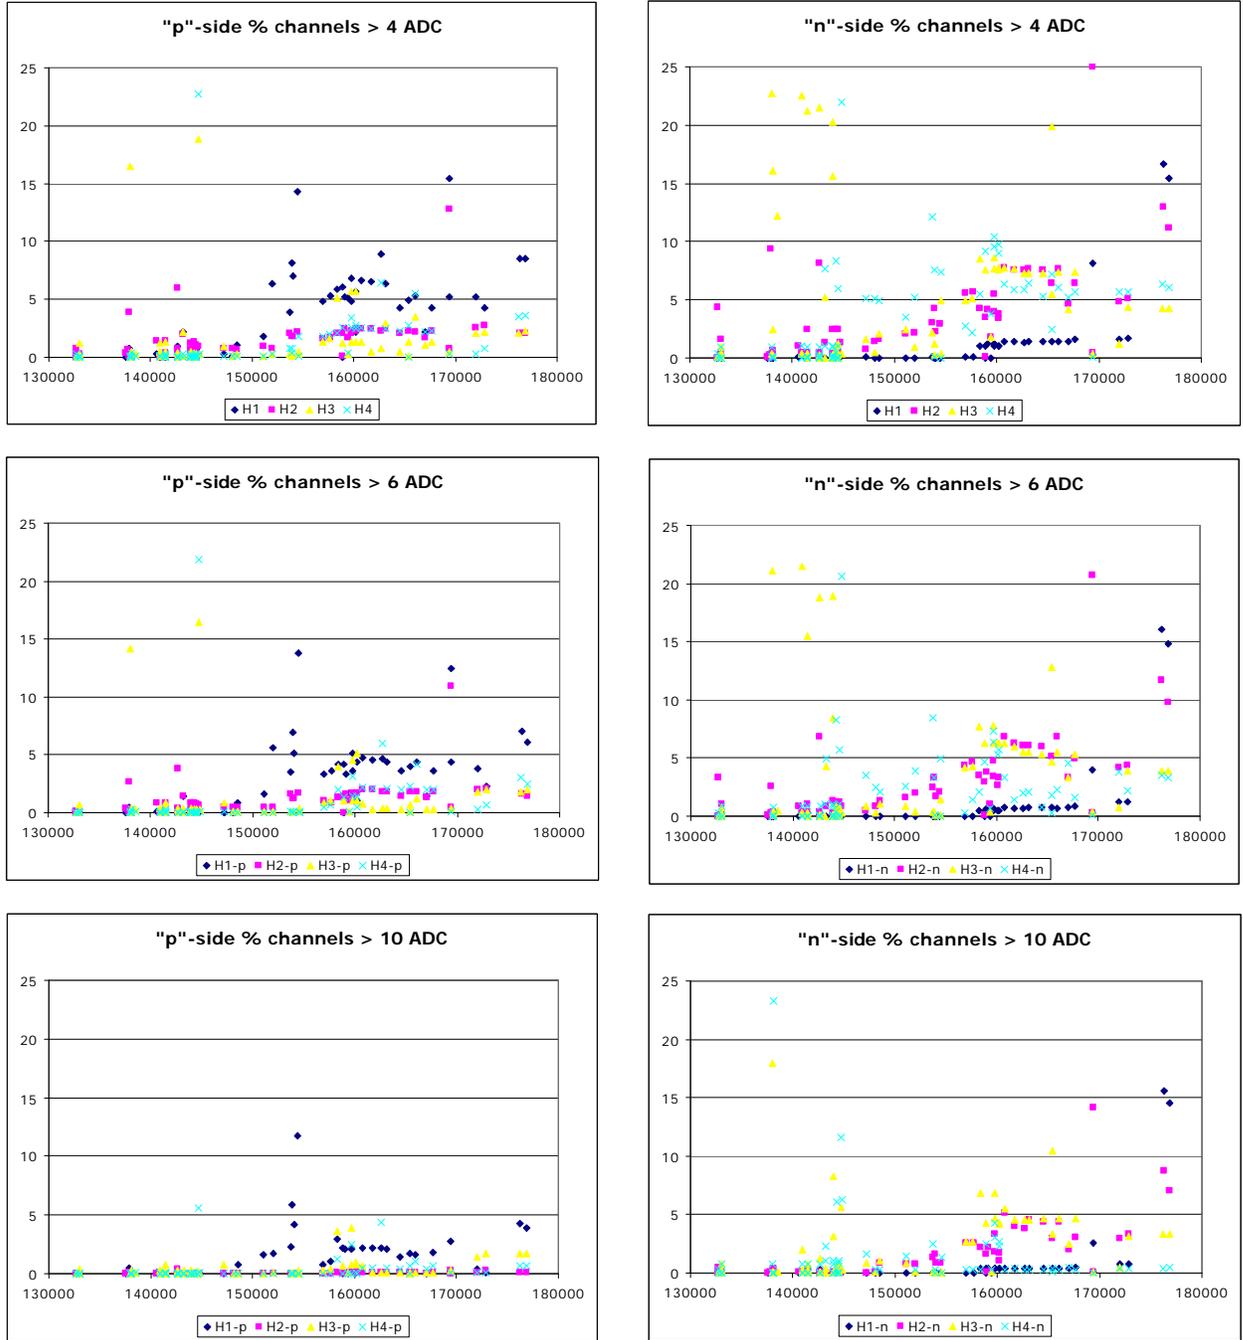
The H disk noise is shown in Figure 10. The fraction of noisy strips on each H wedge “p”- and “n”-side is plotted as a function of calibration run number (the runs span about 1.5 years) for noise thresholds of 4, 6, and 10 ADC counts (typical noise levels are between 1.5 and 2.5 ADC counts). It seems that for all H disks there is a significant step function change in the noise environment that occurs at the June, 2002 shutdown. The percentage of noisy strips jumps by a few percent after the shutdown. This increase is not understood. The H disk noise appears fairly stable otherwise.

Figure 10. H disks fraction of noisy strips as a function of calibration run number (Run #130,000 = 10/01/2001, Run # 177,000 = 05/15/2003) with noise thresholds of 4, 6, and 10 ADC counts.
