SMT Longevity

Eric Kajfasz, Breese Quinn
May 29, 2003

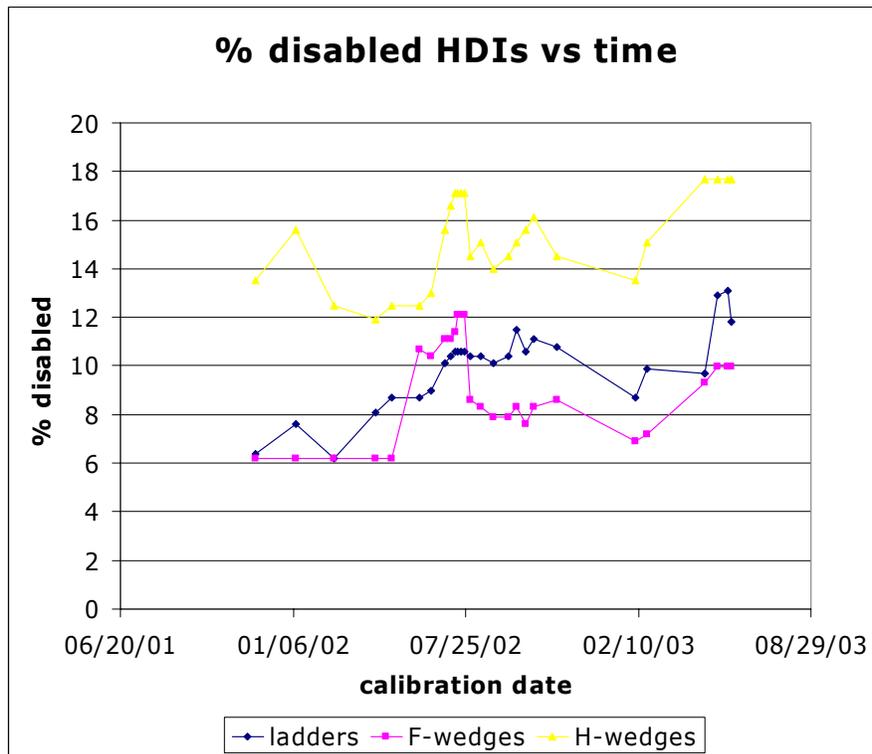
One way to see a “snapshot” of the general health of the SMT is to look at the percentage of HDI’s that have been disabled over time. This is shown in Figure 1 going back to the end of 2001. Separate curves are displayed for barrel ladders, F disk wedges and H disk wedges. Disabled HDI’s encompass those that have been certified dead and irreparable as well as more recent trouble devices that have been turned off pending comprehensive attempts at diagnosis and repair.

There are a few interesting features in the Figure 1 plot. The first major event is the sharp spike in disabled HDI’s around June, 2002. That time corresponds to a Tevatron shutdown period of a few weeks. An increase in disabled HDI’s during a shutdown does not imply that activity in and around the detector causes a rash of problems. More common is the effect that during such periods, there is more time available for thorough diagnosis of existing problems. For example, careful analysis of an HDI that has been generally operational could reveal that its data is irreversibly corrupted in a subtle way. The reduction in disabled HDI’s at the end of the January, 2003 shutdown is a case where the extra time for debugging resulted in the recovery of several disabled devices. This, of course, can only occur when the fault in a problem device occurs somewhere in the readout chain downstream from the external end of the low mass cable. It should be noted that it is extremely unlikely that the percentage of working HDI’s will ever improve beyond the levels attained at the beginning of February, 2003. Virtually all disabled HDI’s at that point were confirmed to have faults with inaccessible elements of the devices.

Figure 1. Percentage of disabled ladders, F wedges, and H wedges as a function of time.

Of some concern is the rise in the number of disabled HDI's over the last couple of months. It is particularly unclear how much of this recent rise represents actual failed devices. This is because shifter operation of the SMT has been somewhat altered since the end of the January, 2003 shutdown. Operational guidelines now encourage shifters to quickly disable any HDI giving problems during the run in order to avoid losing delivered luminosity. There has been less downtime which is typically used to determine if some disabled devices are ready to be re-enabled for data taking. In particular, it is expected that some of the ladders responsible for the jump from 10% to 13% disabled will be recovered.

It is quite difficult to attempt an estimate of disabled devices by 2009 based on this information alone. Under different sets of assumptions, Figure 1 could extrapolate to figures anywhere between 13% and 100%. The lower bound of 13% represents the current situation which is perfectly acceptable. This conclusion is supported by the distribution of disabled ladders in the barrels which is shown in Figure 2. There one can see that the pattern of unused HDI's is nearly random. There is a small level of clustering due to specific failure modes such as a problem with a Sequencer card or biasing which can group devices near to each other geographically. Even so, 13% disabled HDI's has not resulted in any loss of fiducial volume and only local reduction of tracking efficiencies on the order of 3%-5%². However, it is probable that just twice the current

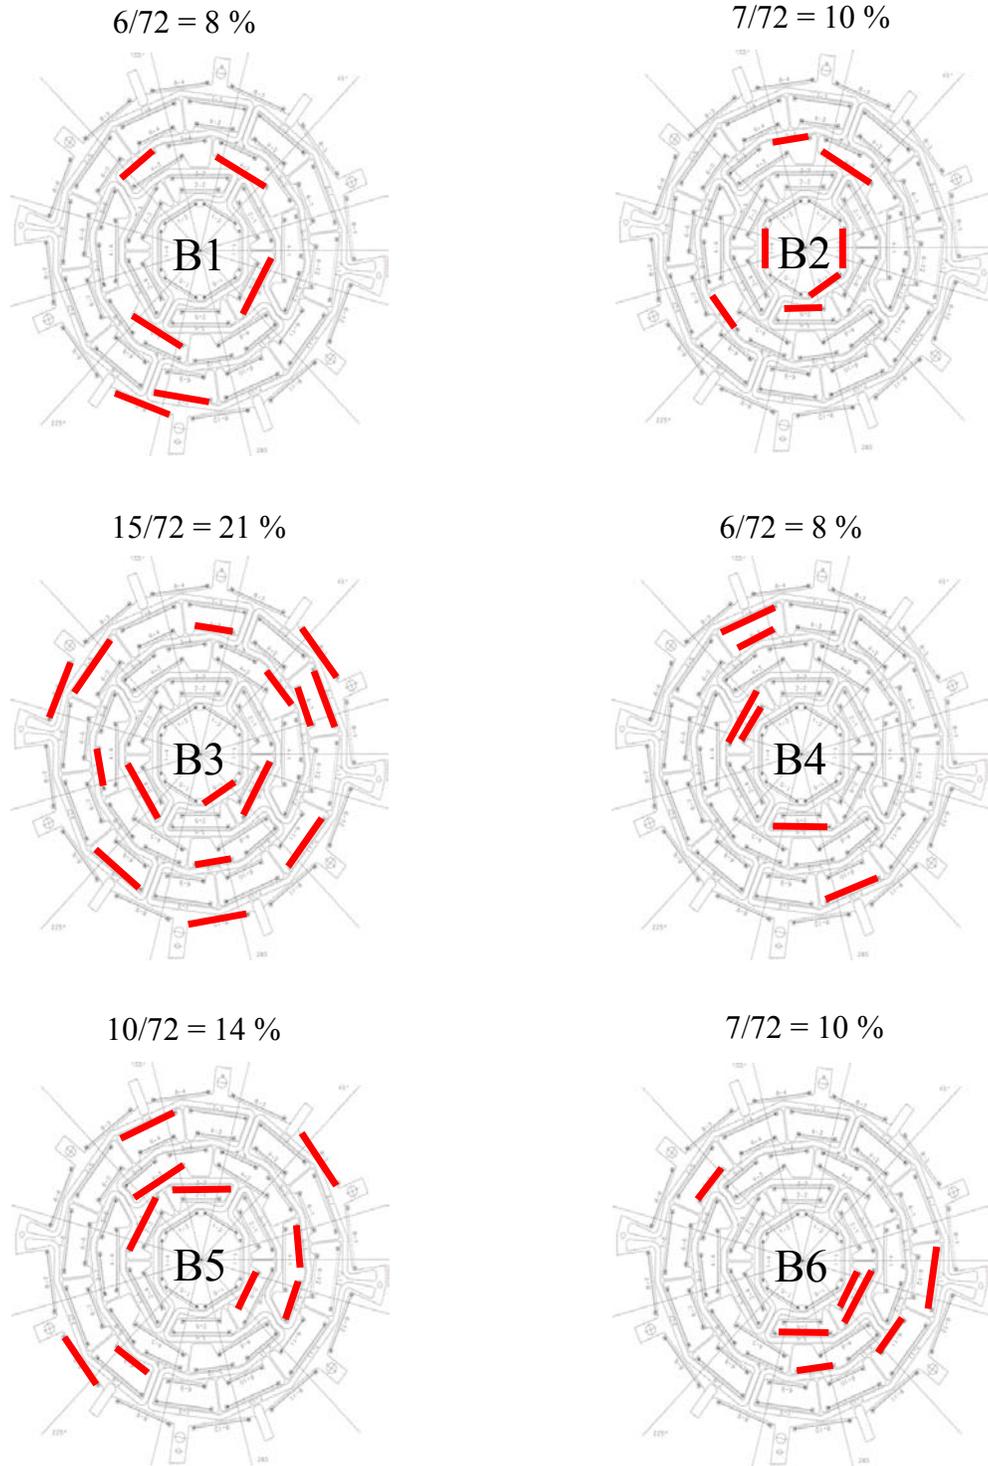
Figure 2. Fraction and location of the disabled ladders on the 6 barrels as of 5/27/03.

level of disabled HDI's could drastically alter that situation, possibly leaving the detector blind to small regions of φ - η .

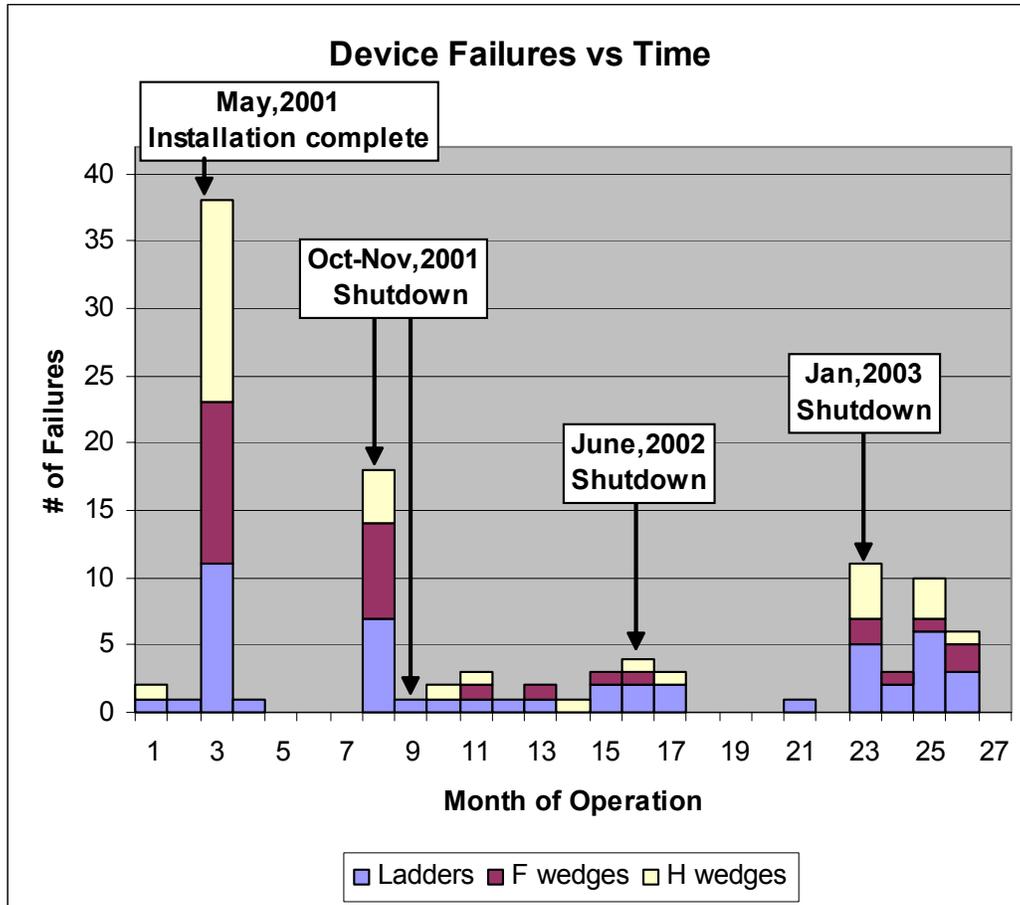
A time profile of failed HDI's is given in Figure 3. Each failed HDI is entered in the month of operation in which it first exhibited a failure mode for which it had to be disabled. Some clear points emerge from this profile. The first is that there was 4.6% infant mortality upon completion of SMT installation. The second is that even though many problem devices have been recovered during shutdowns, most of the truly failed devices developed their problems during or near those same shutdowns. However, this observation is somewhat lessened when one considers the reason for the gaps in summer 2001 and fall 2002. Those gaps overlap with periods when the SMT Commissioning database was not functioning. This database is where changes in HDI status are typically recorded and from where the data for the time profile is taken. This means that the bins corresponding to the October, 2001 and January, 2003 shutdowns are somewhat artificially elevated due to the database getting 'caught up.' Several entries there likely belong in months during the database gaps.

If the spike in May, 2001 is infant mortality, then the spike at October, 2001 could be considered in-situ burn-in. Even considering the database gaps, the average rate of failure from June, 2001 through October, 2001 is 4.5 HDI's/month. This is twice the rate from November, 2001 through January, 2003 of 2.1 HDI's/month. The enhancement in March and April, 2003 is at least partly due to the operational changes discussed in section 2.1 and the likelihood that many of those entries are recently disabled HDI's which will be recovered.

If the infant mortality and burn-in periods are excluded, one can hazard a crude extrapolation of failed HDI's. Assuming that the most recent months are biased high, the failure rate of 2.1 HDI's/month would yield 18% disabled by 2006 and 27% disabled by 2009. If the last two months are fully included, the rate is 2.8 HDI's/month and the extrapolation is 20% by 2006 and 32% by 2009. However, these estimates assume that there are no specific limiting expected lifetimes of any device components.

Figure 3. HDI failures as a function of time. Each failed HDI is entered in the month of operation in which it first exhibited a disabling failure mode. Note that this plot does not include devices that were disabled at one time but have since been recovered.

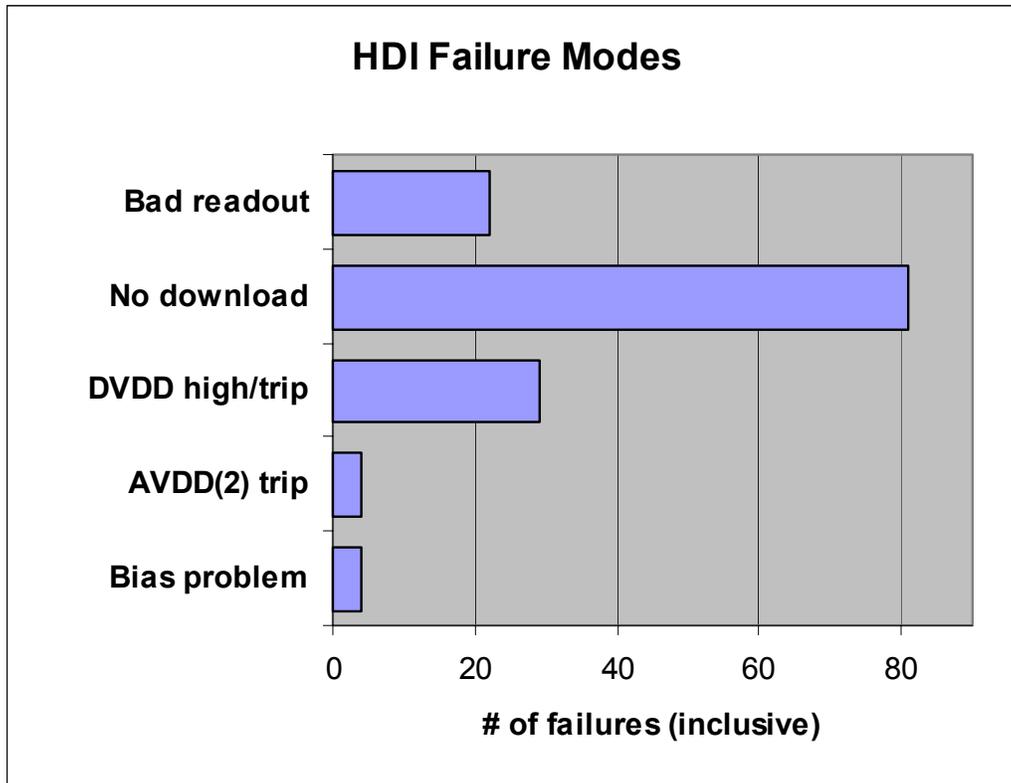
There are several recognized HDI failure modes. Figure 4 details the distribution of the most common ones. It is an inclusive distribution in that there are many double entries for devices that exhibit more than one failure mode. Inability to download the SVXIIe chips is by far the most common cause for the loss of an HDI. Frequently, this is accompanied by very high DVDD current draw, and sometimes it is preceded by the observation of bad readout from the HDI. Damage to the fragile clock cables is often

responsible for the loss of download functionality, although in many cases no specific cause for the problem can be identified because diagnosis would require access to the HDI.

Some type of problem with HDI readout is the next most common failure mode. This data corruption can take a variety of forms such as shorts of data lines to ground or missing chips in the readout. Anomalously high low voltage current draws are responsible for several lost HDI's, with the DVDD current more likely to be at fault than either AVDD or AVDD2. Fatal bias voltage problems are rare.

Figure 4. HDI failure modes. The graph is inclusive, i.e. HDI's that exhibited more than one failure mode have multiple entries.

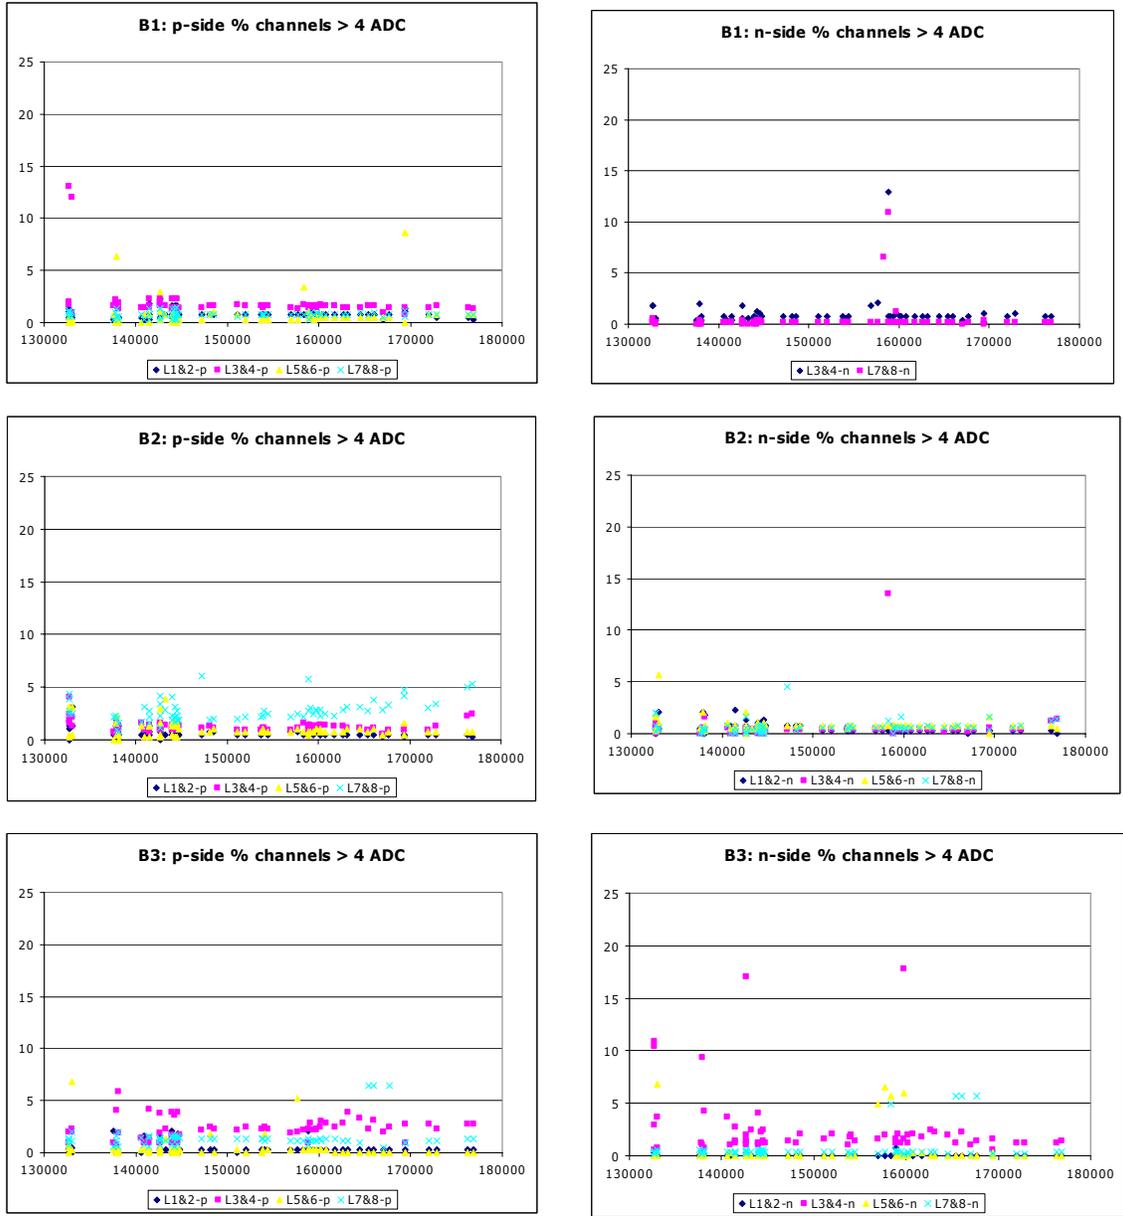
The noise situation for the barrels is shown in Figure 5 (north barrels) and Figure 6 (south barrels). In these graphs, the fraction of noisy strips on ladder p- and n-sides is plotted for layers 1+2, 3+4, 5+6, and 7+8 as a function of calibration run number (the runs span about 1.5 years). Noisy strips are defined as those with a noise level higher than 4 ADC counts (typical noise levels are between 1.5 and 2.5 ADC counts). The noisy strip fractions shown are quite low except for Barrel 5, Layer 3+4, n-side, which has about 10% noisy strips. This is due to a single ladder, B5-3-1.

Figure 5. North barrels fraction of noisy strips as a function of calibration run number (Run #130,000 = 10/01/2001, Run # 177,000 = 05/15/2003) with a noise threshold of 4 ADC counts.

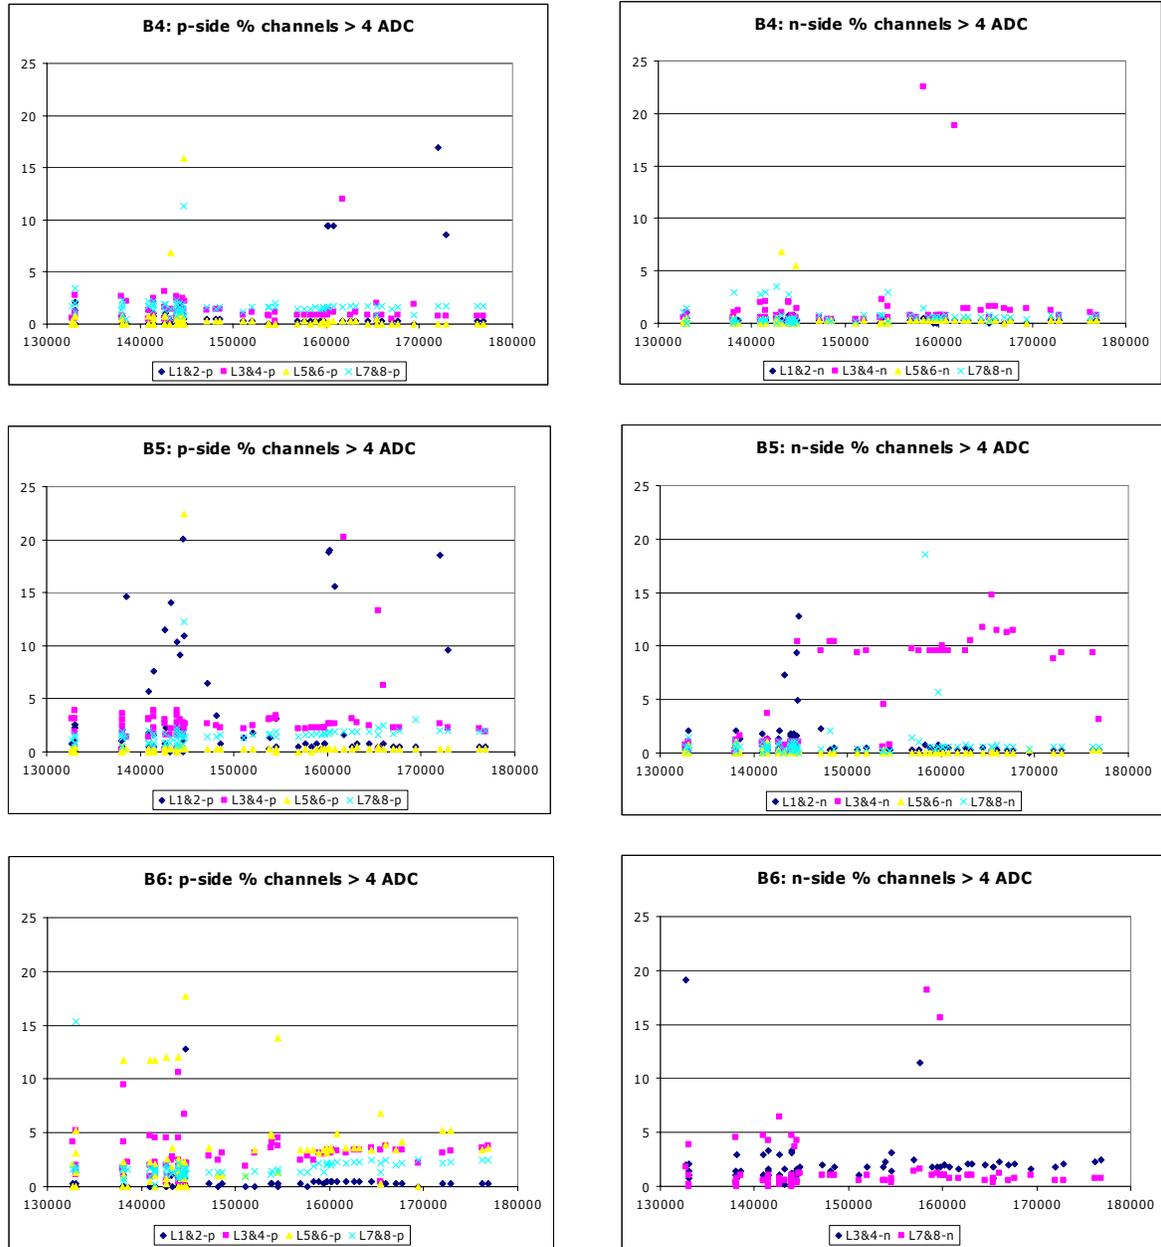
Figure 6. South barrels fraction of noisy strips as a function of calibration run number (Run #130,000 = 10/01/2001, Run # 177,000 = 05/15/2003) with a noise threshold of 4 ADC counts.

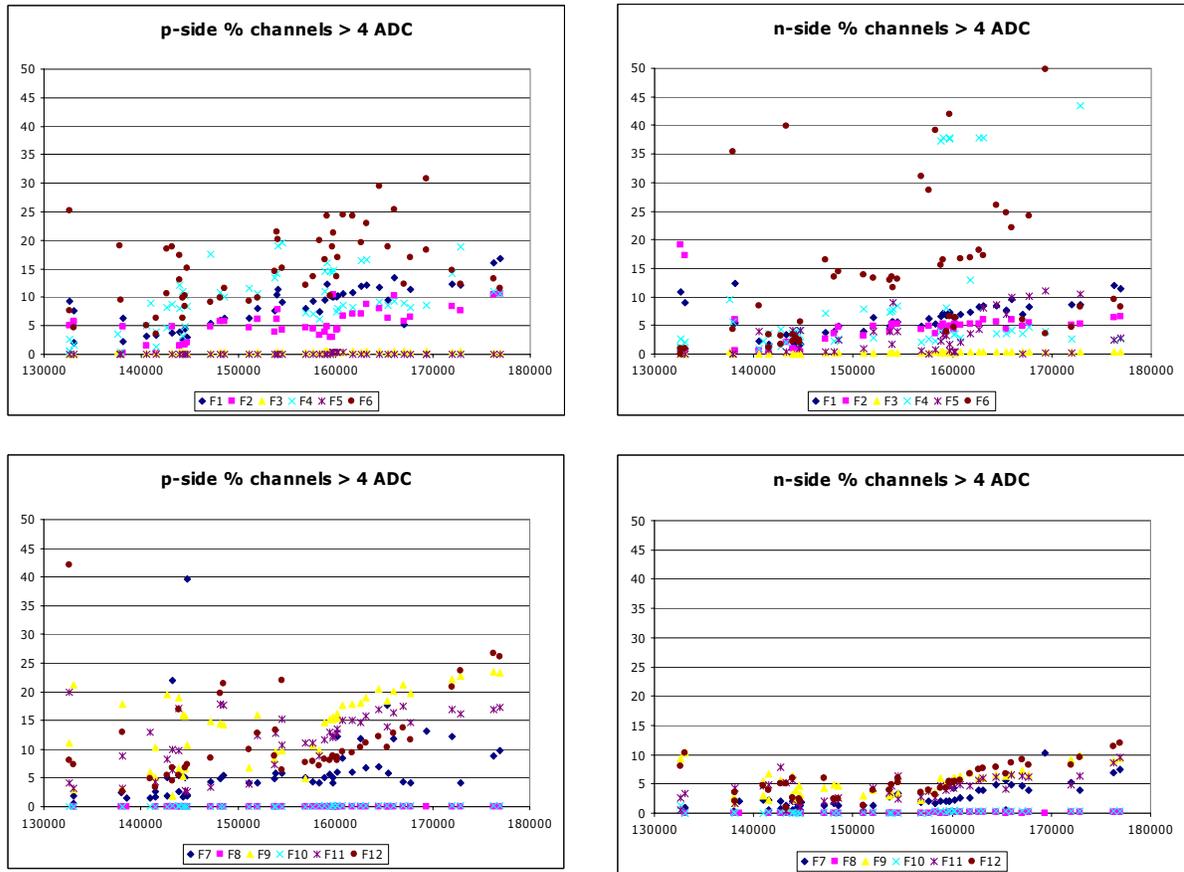
Noise in the F disks is shown in Figure 7 - Figure 9. The fraction of noisy strips on each F wedge p- and n-side is plotted as a function of calibration run number (the runs span about 1.5 years). In Figure 7, noisy strips are defined as those with a noise level higher than 4 ADC counts (typical noise levels are between 1.5 and 2.5 ADC counts). In Figure 8, noisy strips have more than 6 ADC counts and in Figure 9, the noise cut is 10 ADC counts. Two striking features are evident. One is that F disks 3, 5, 8, and 10, which are all made of Eurisy wedges, have very low noise. The other is that all of the other F

disks, which are made of Micron wedges, are characterized by high noisy strip fractions that are increasing with time, with F6 in particularly bad shape. This typical grassy noise has already required that some F wedges be disabled to avoid unacceptably high occupancies. If the F wedge grassy noise is not brought under control, the Micron F disks could become unusable within a few years.

Figure 7. F disks fraction of noisy strips as a function of calibration run number (Run #130,000 = 10/01/2001, Run # 177,000 = 05/15/2003) with a noise threshold of 4 ADC counts.

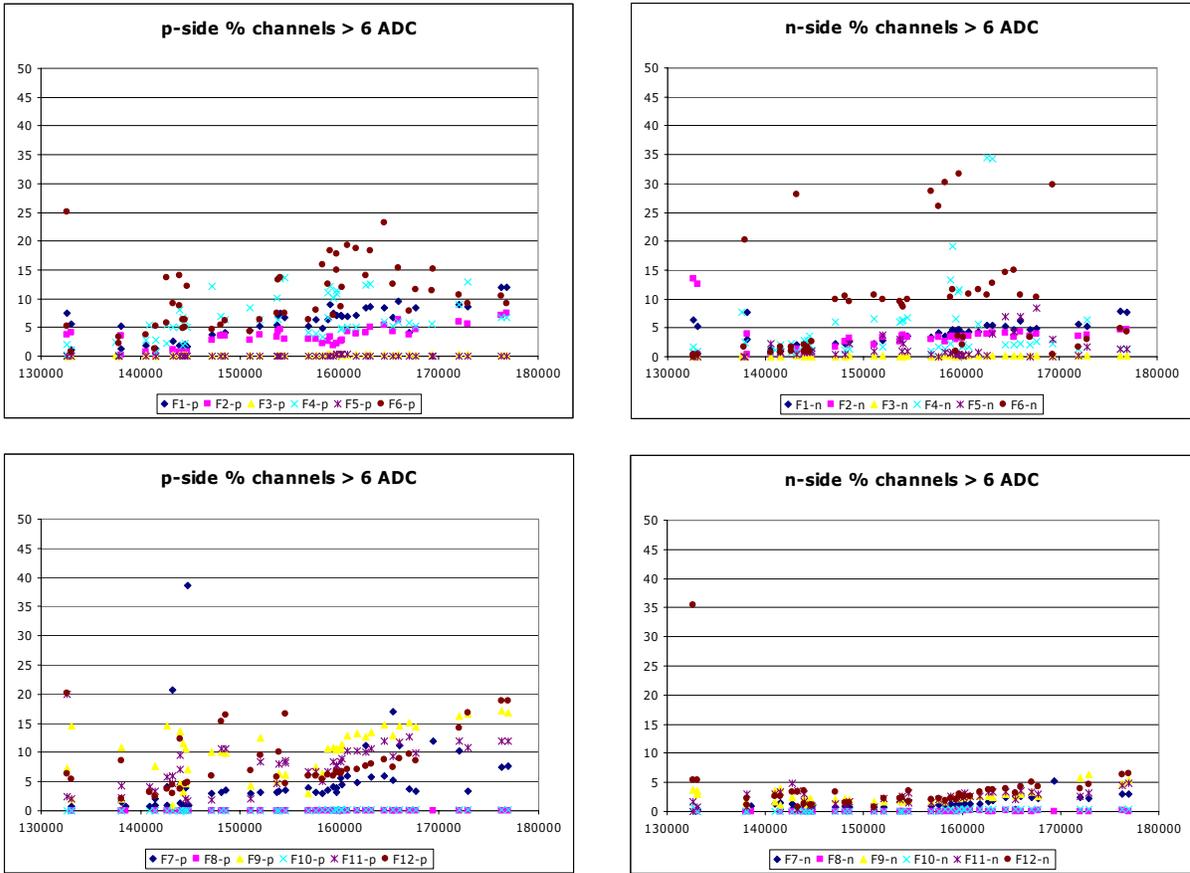
Figure 8. F disks fraction of noisy strips as a function of calibration run number (Run #130,000 = 10/01/2001, Run # 177,000 = 05/15/2003) with a noise threshold of 6 ADC counts.

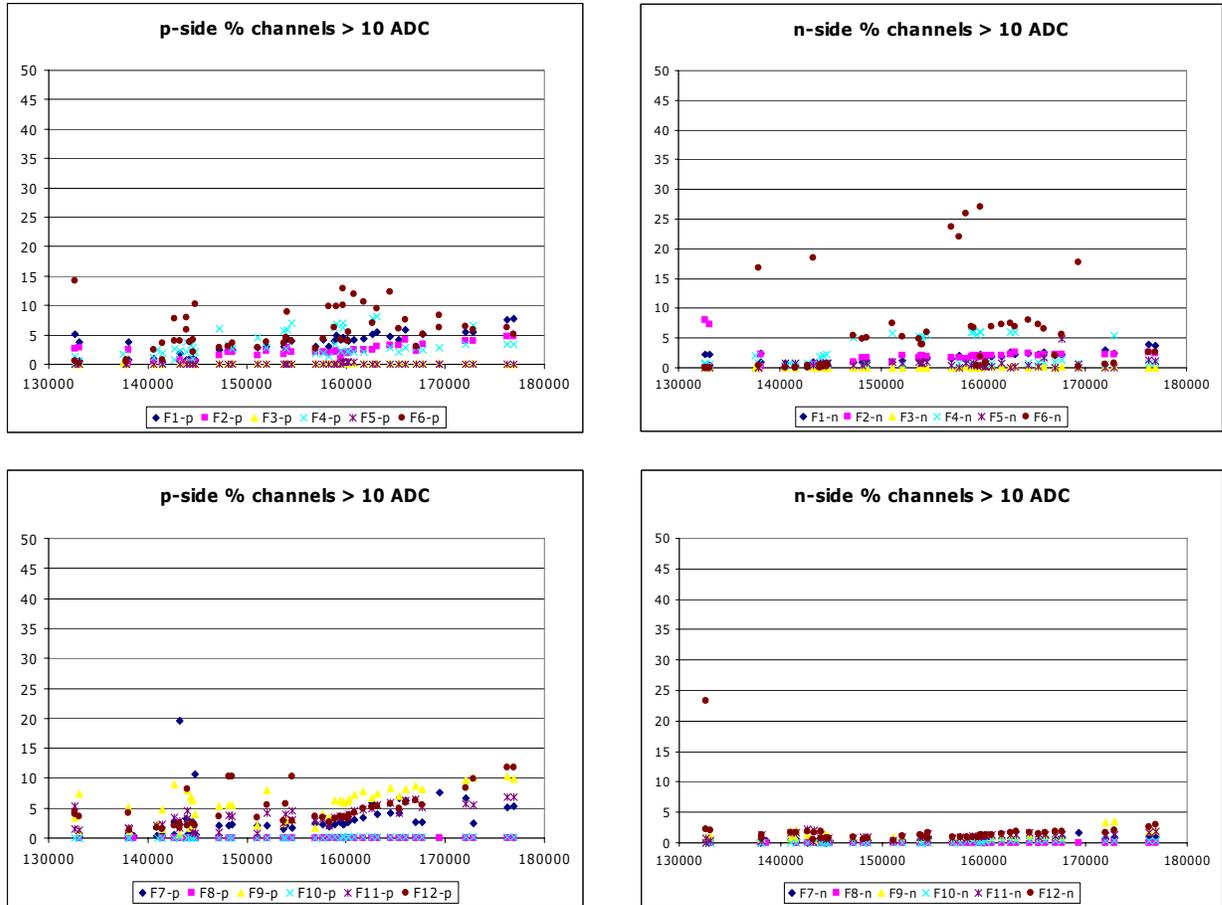
Figure 9. F disks fraction of noisy strips as a function of calibration run number (Run #130,000 = 10/01/2001, Run # 177,000 = 05/15/2003) with a noise threshold of 10 ADC counts.

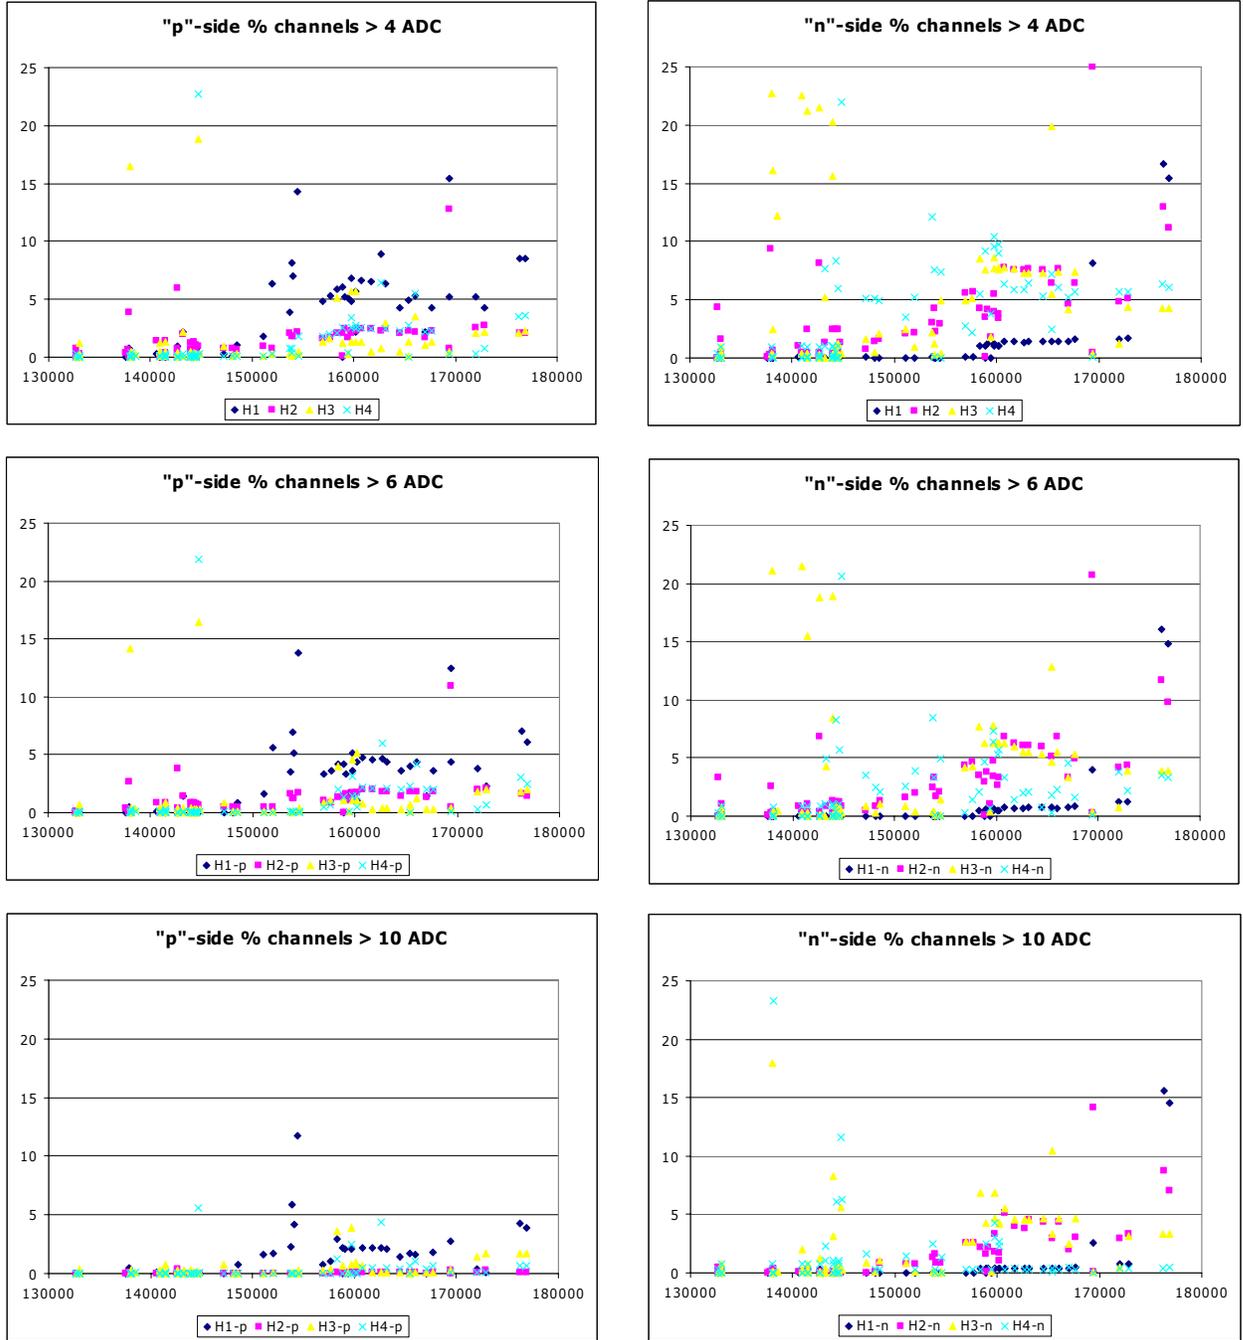
The H disk noise is shown in Figure 10. The fraction of noisy strips on each H wedge “p”- and “n”-side is plotted as a function of calibration run number (the runs span about 1.5 years) for noise thresholds of 4, 6, and 10 ADC counts (typical noise levels are between 1.5 and 2.5 ADC counts). It seems that for all H disks there is a significant step function change in the noise environment that occurs at the June, 2002 shutdown. The percentage of noisy strips jumps by a few percent after the shutdown. This increase is not understood. The H disk noise appears fairly stable otherwise.

Figure 10. H disks fraction of noisy strips as a function of calibration run number (Run #130,000 = 10/01/2001, Run # 177,000 = 05/15/2003) with noise thresholds of 4, 6, and 10 ADC counts.
