Noise at default

Summary

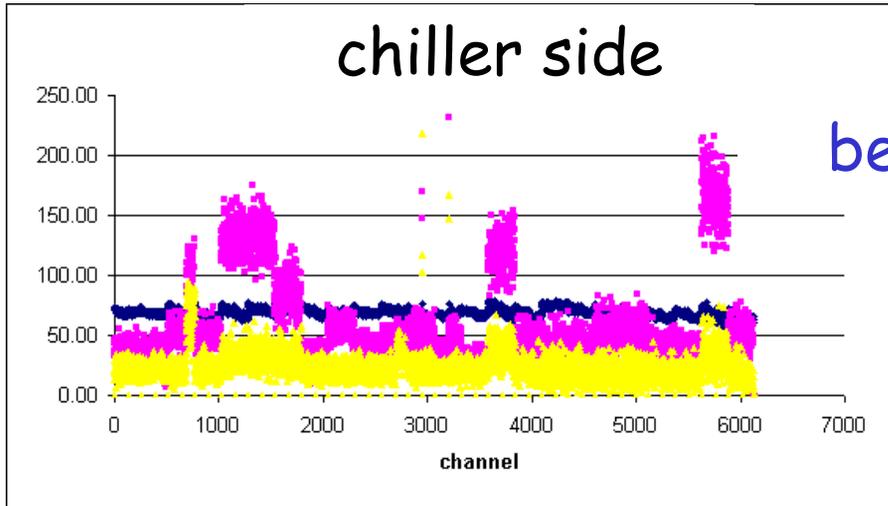
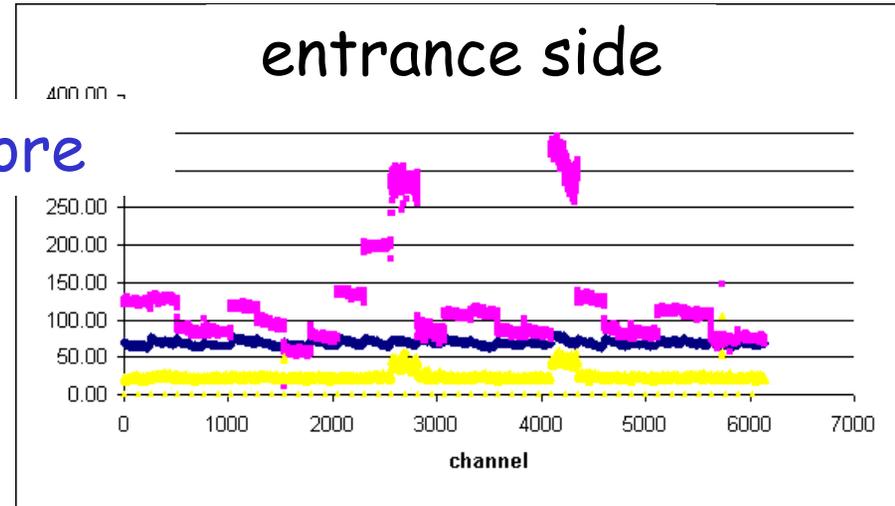
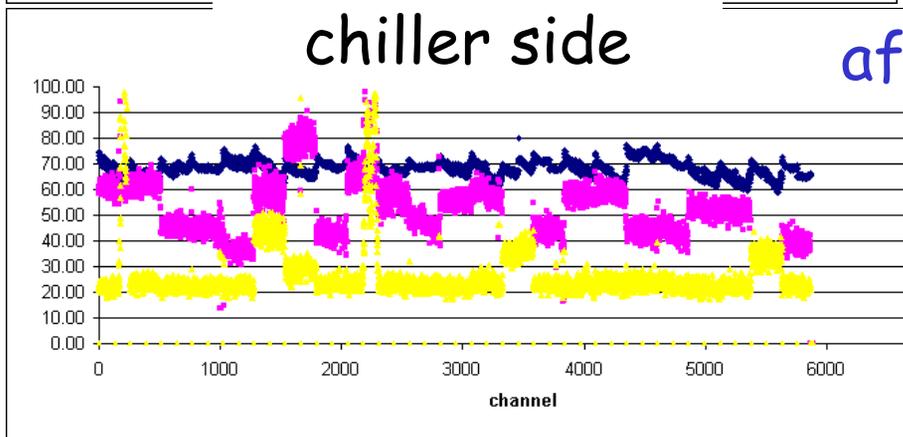
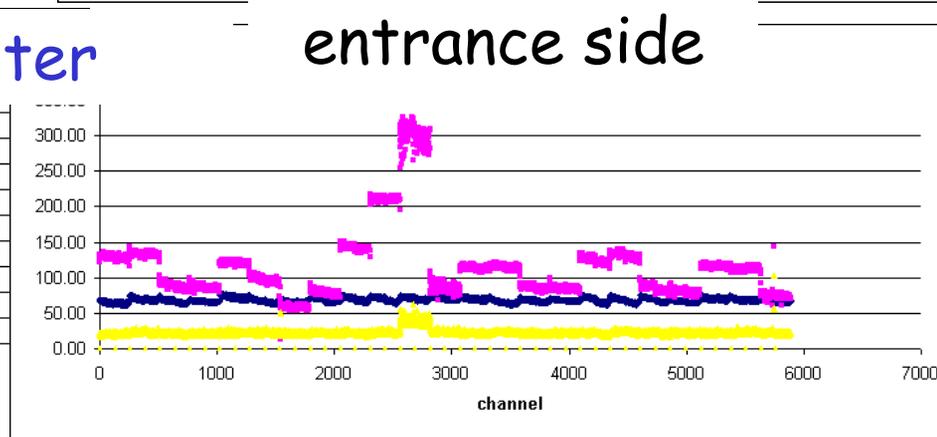
Rerouting power line

- No effect on entrance side
- Became worse on chiller side

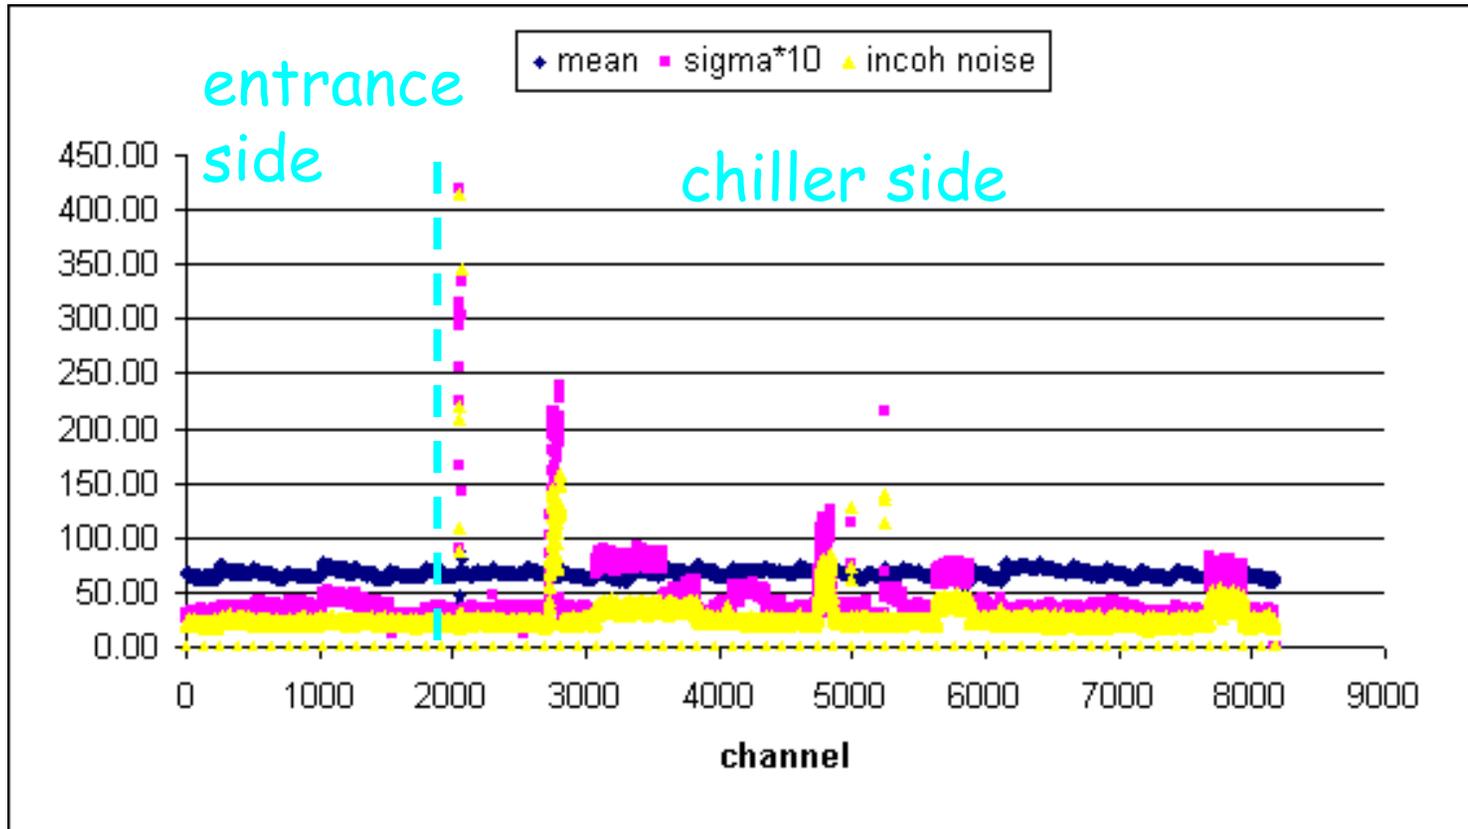
Shorted isolate and common GND

- Noise is gone --- consistent with the result at the electrical test structure

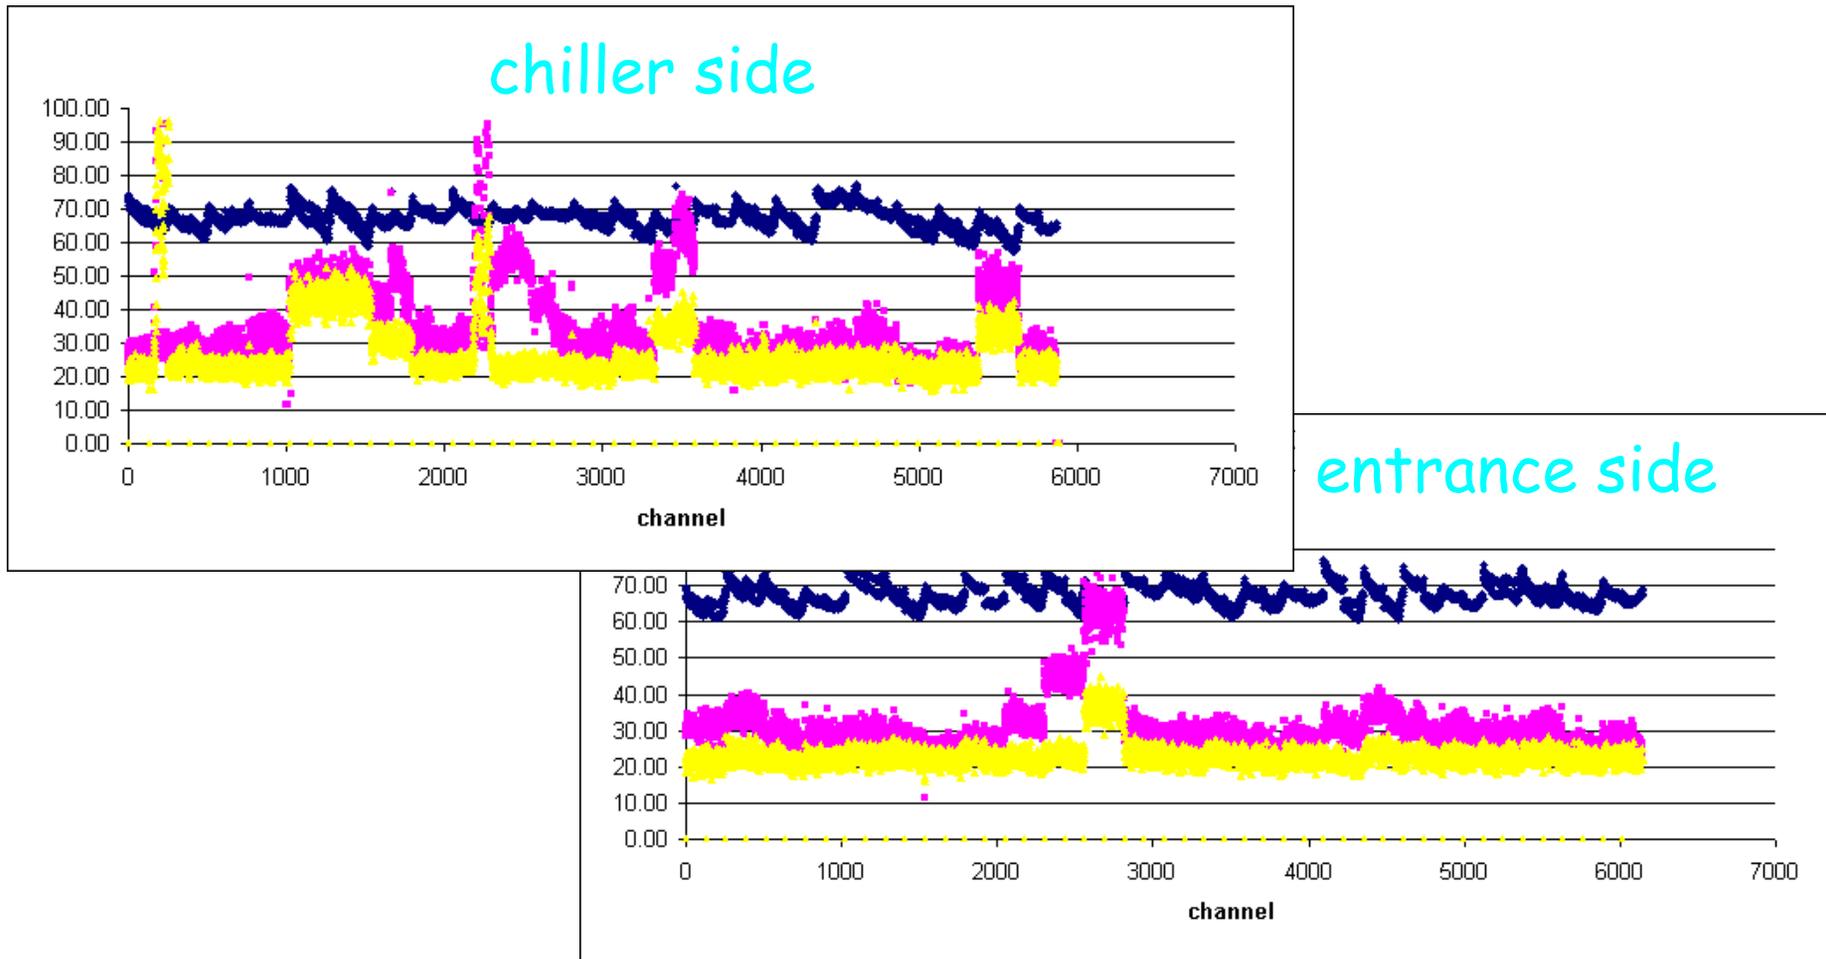
Ferrite into power line near AC

- Noise is reduced --- consistent with the result at the electrical test structure

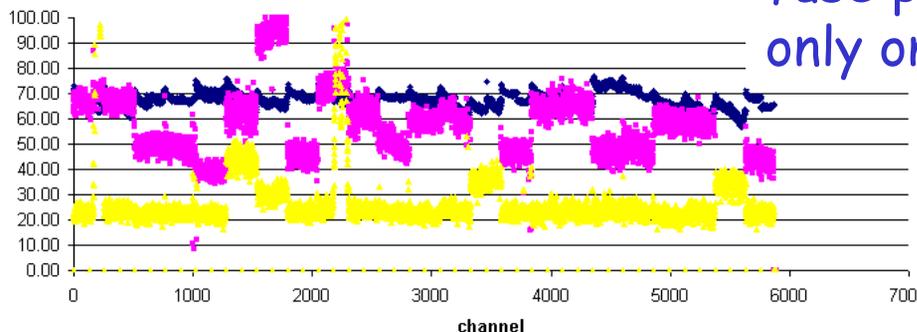
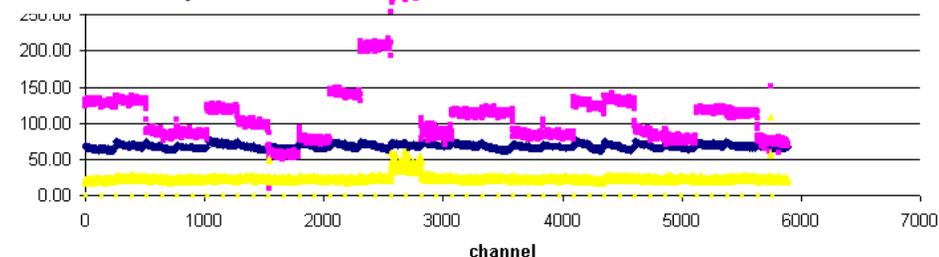
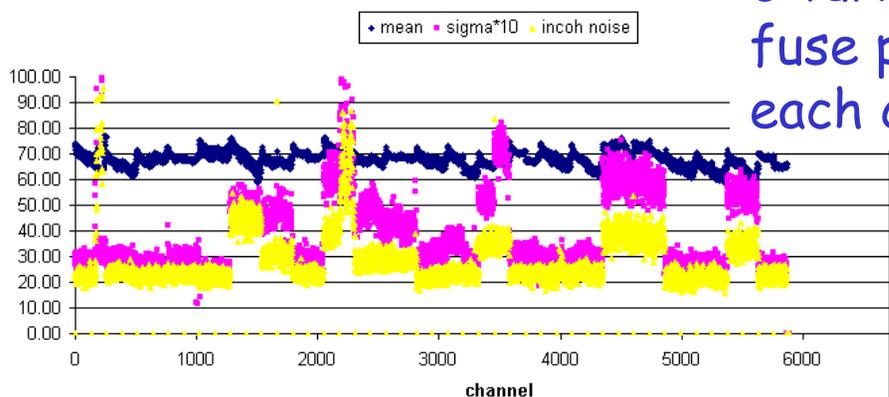
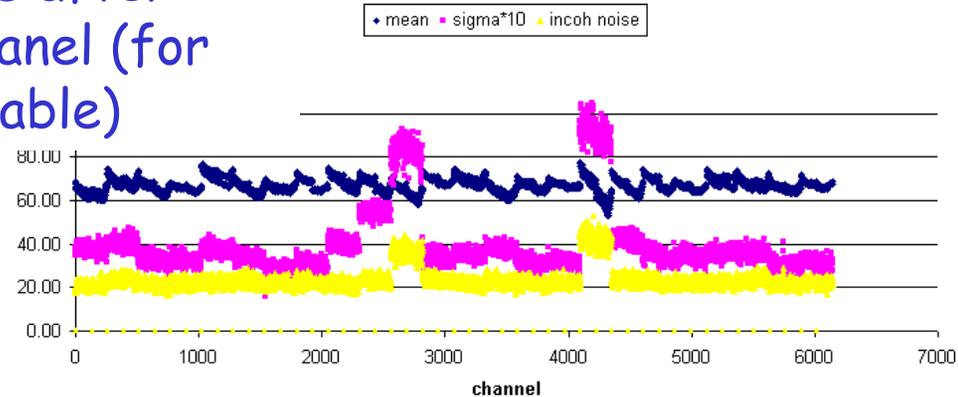
Where to put ferrite

- Ferrite seems to work after fuse panel (effectively number of turns is different)

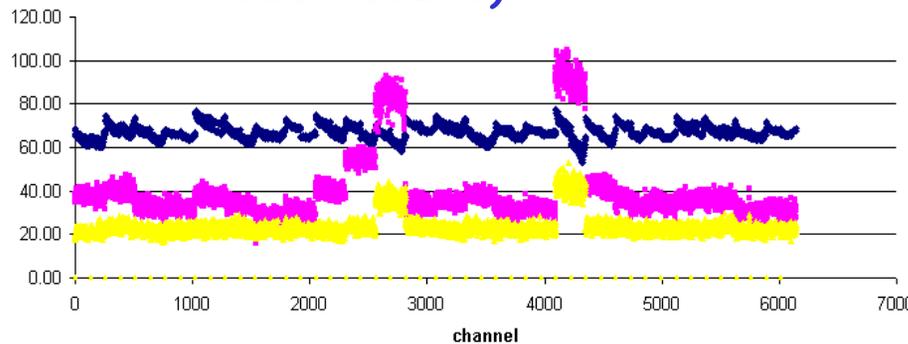
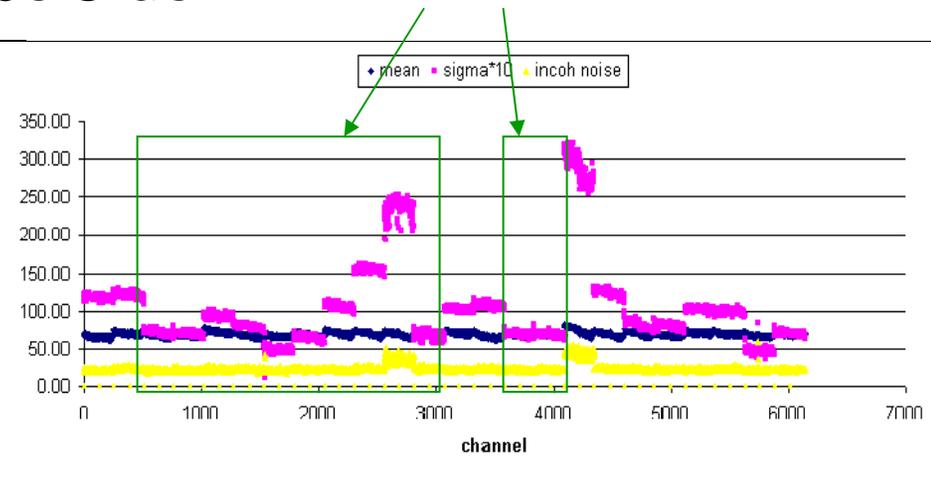
Shielding power line

- Half of power lines are shielded (ferrites are removed for these lines)
 - Get worse, not only the corresponding AC but all AC's in the same side

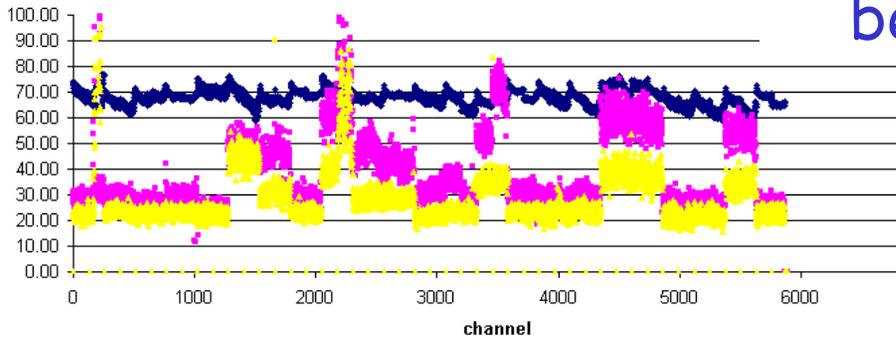
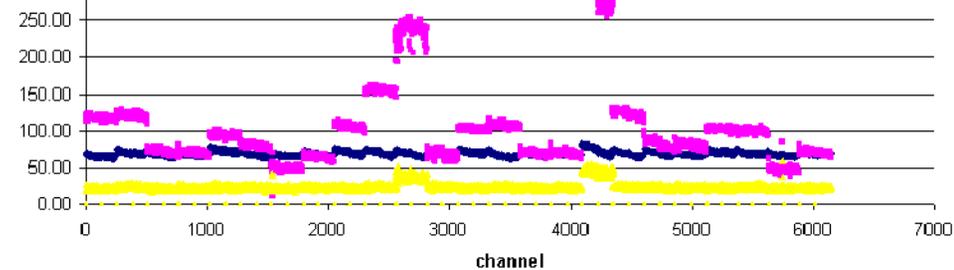
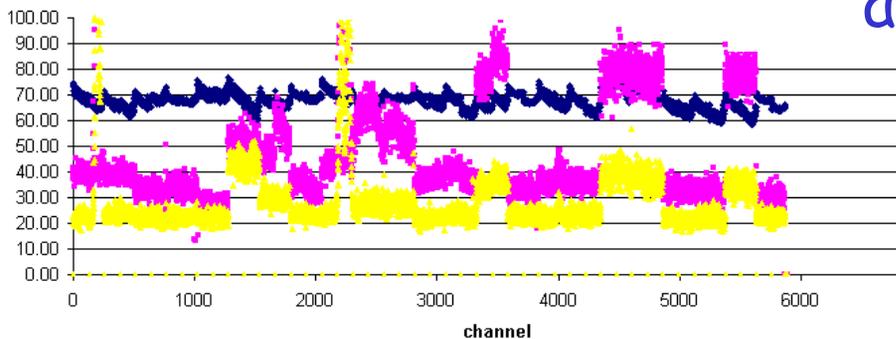
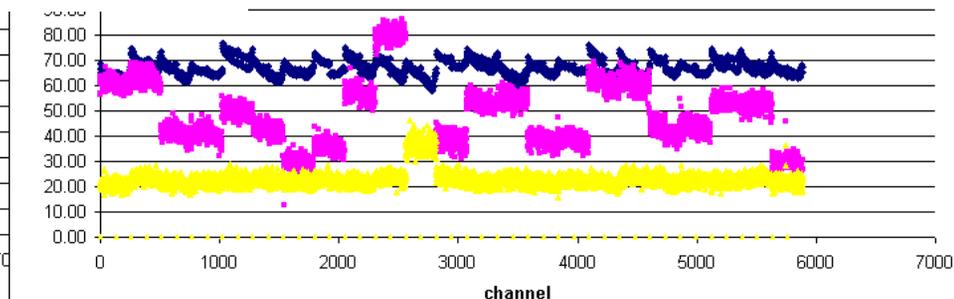
Swapping power supply (ferrite after fuse panel)

- Inputs to fuse panel are swapped → changed
 - power supply and/or cables from PS to fuse

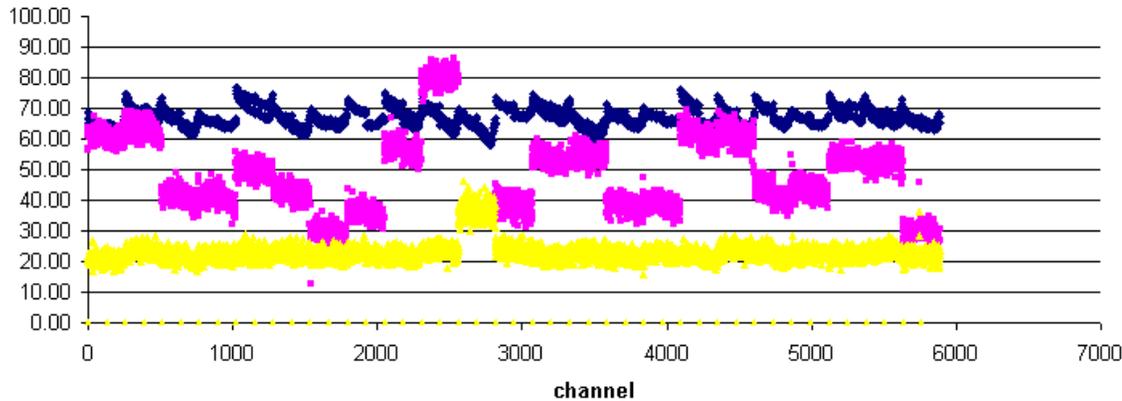
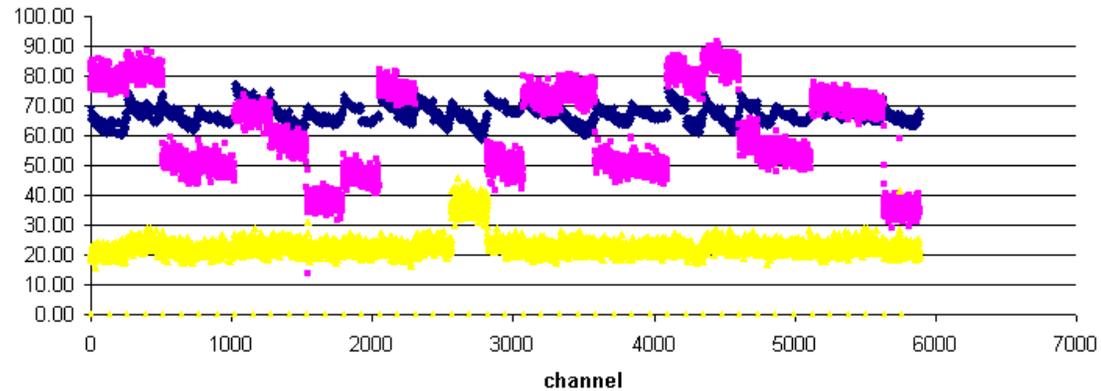
Effect of sense wires

- Some effects, but no improvement so far

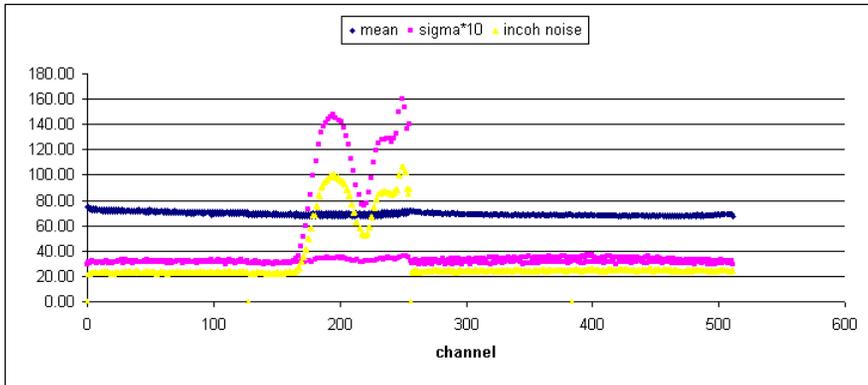
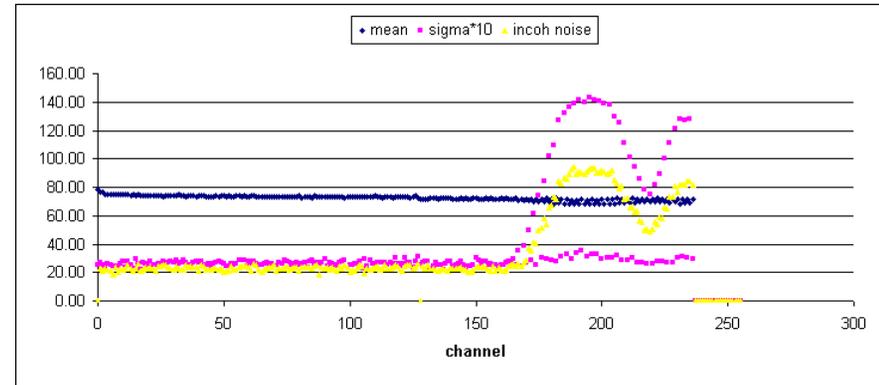
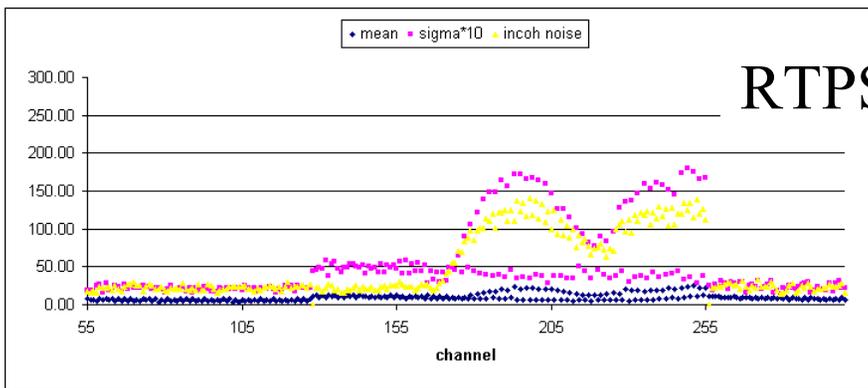
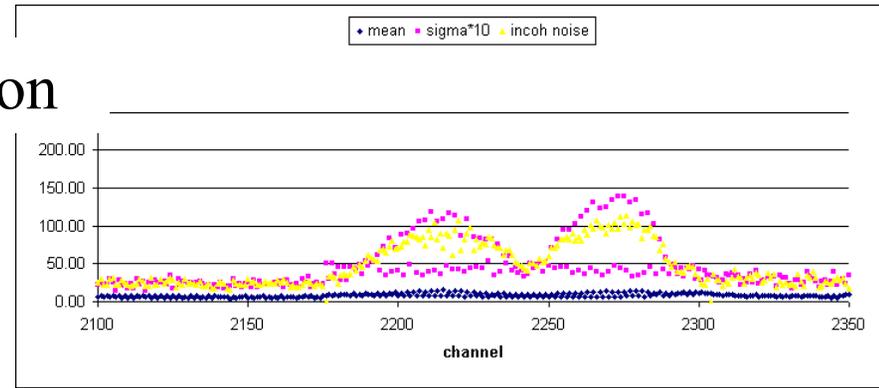
Noise related to RTD

- Two modules see the noise image of RTD

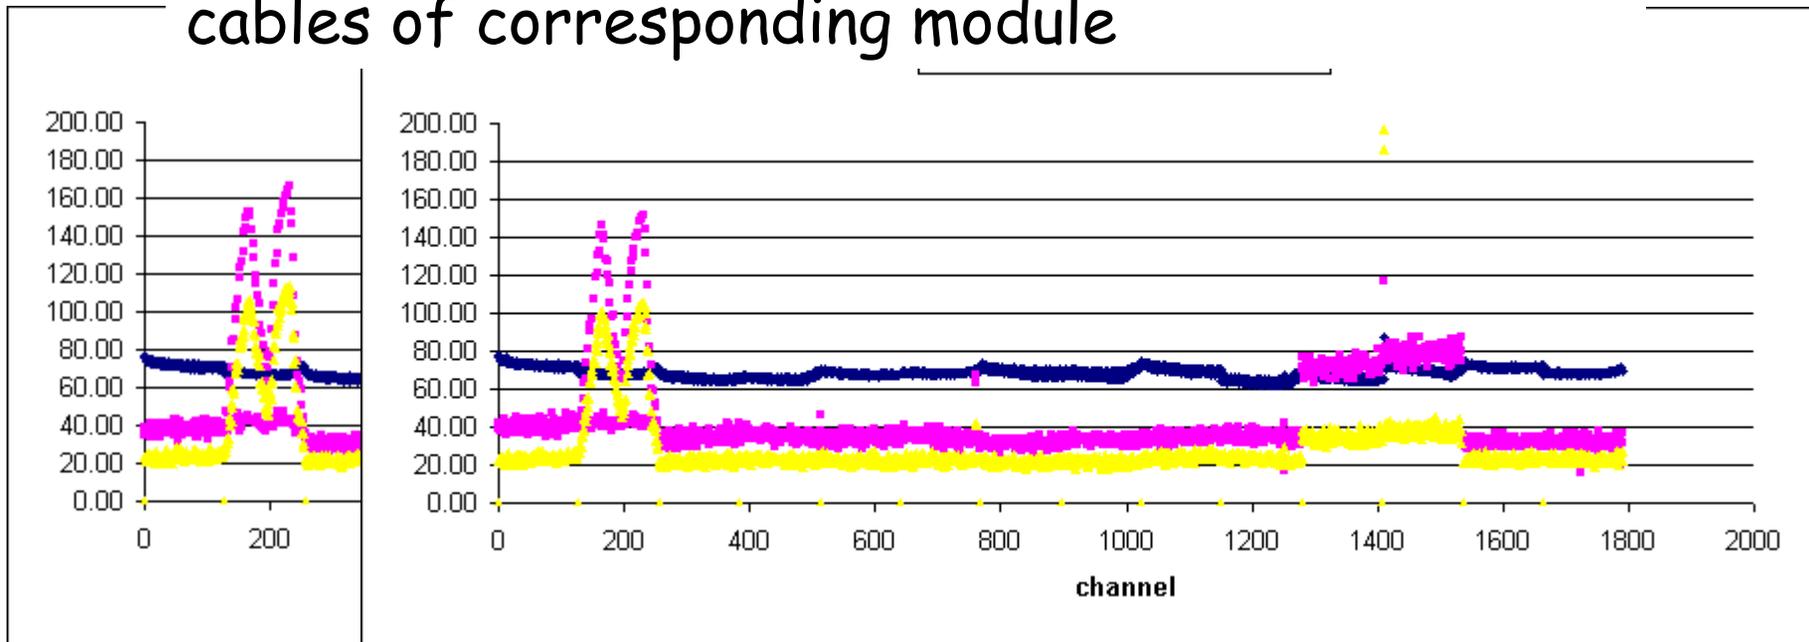
Effect of clock cable

before and after shielding clock and clock-bar cables of corresponding module

- Seems slightly better, but not significant
- need to shield all the clocks???

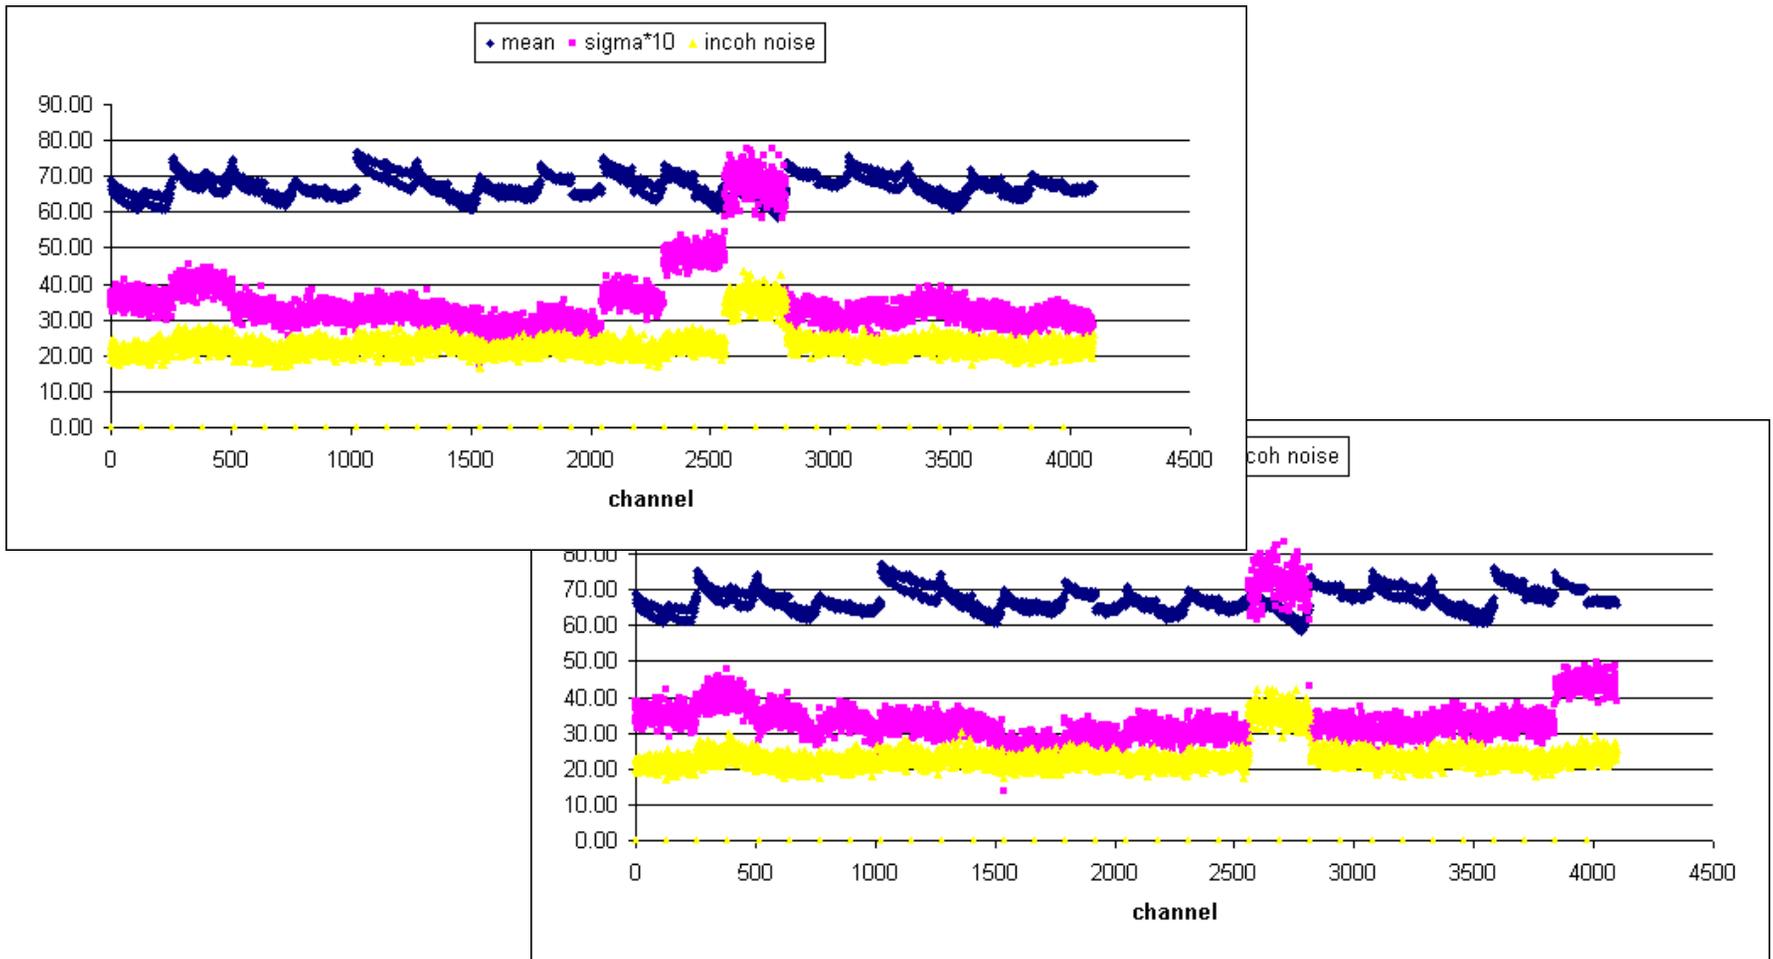
Noisy module

- There exists a noisy module with unknown reasons
