Shutdown Status

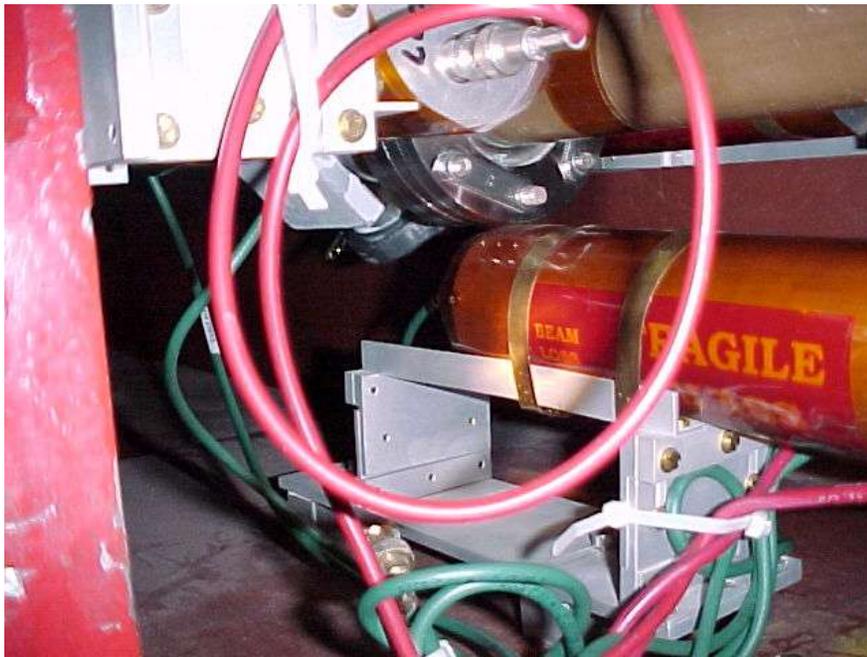
- Major goal of the first week was North & South **beam pipe spool removal**. Accomplished by AD with D0 mechanical support.
- Had to be flexible, things didn't go exactly as planned
 - (+) Beam pipe was able to be removed without opening EF's
 - (-) Opening EF South for Pixel survey, SEC beam pipe end got caught up on the bottom BLM. Pushed BLM off its mount
 - (-) Added a day of leak checking beam pipe before proceeding (+)
 - (+) Able to fix known platform ground short w/o lifting platform

← **SEC beam pipe (stationary)**

← **BLM moved this direction with EF (until it meets the flange.)**

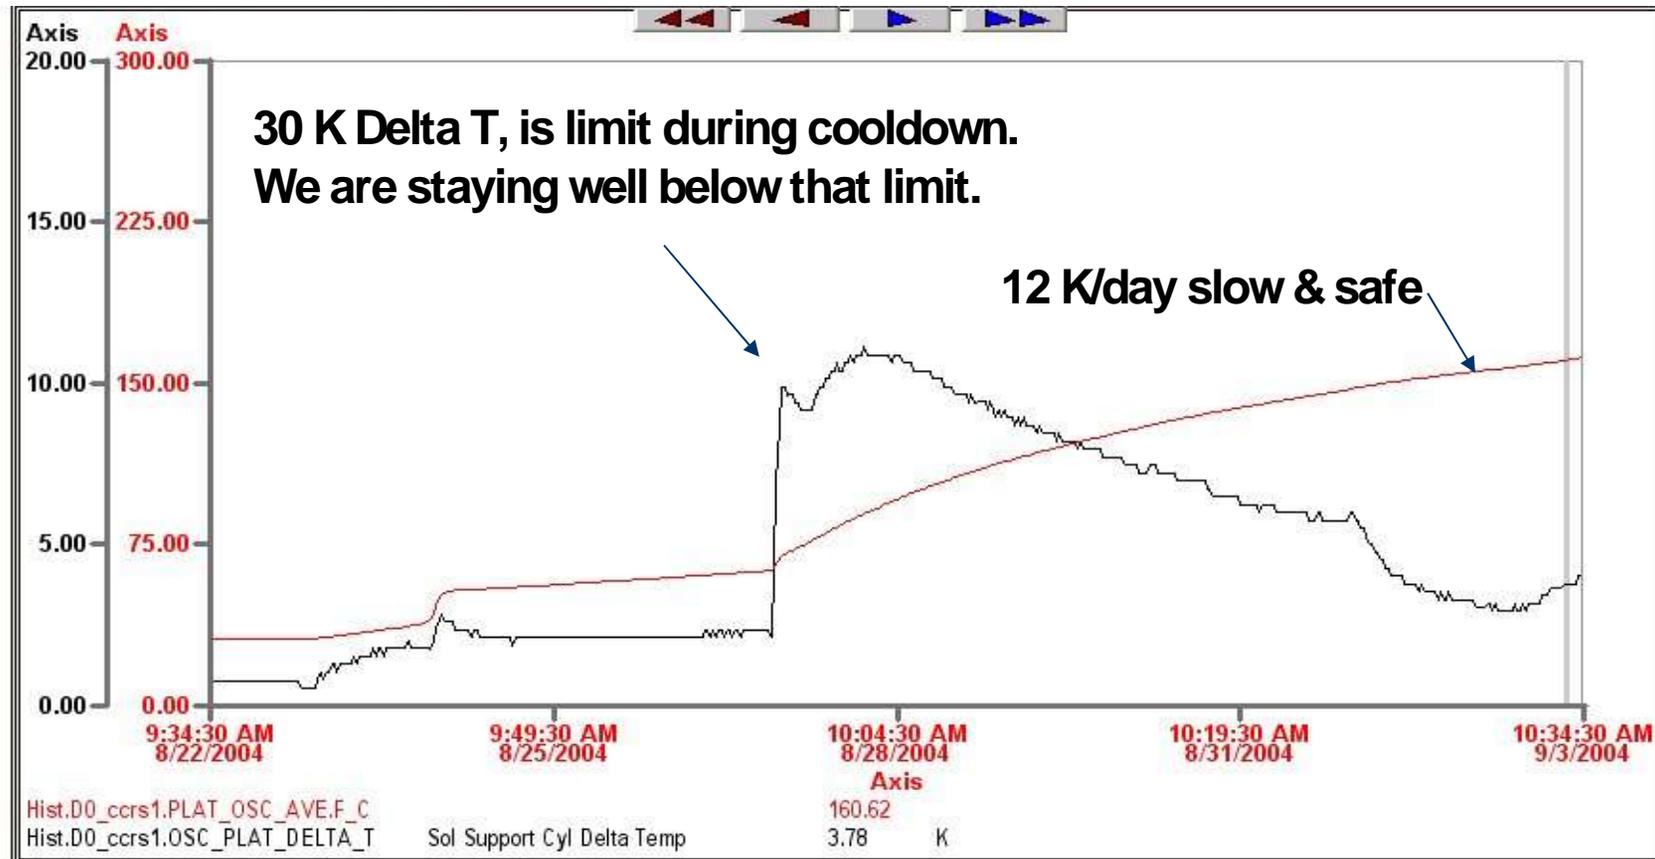
Solenoid Warmup –

Started small warming flow Friday, Aug 27

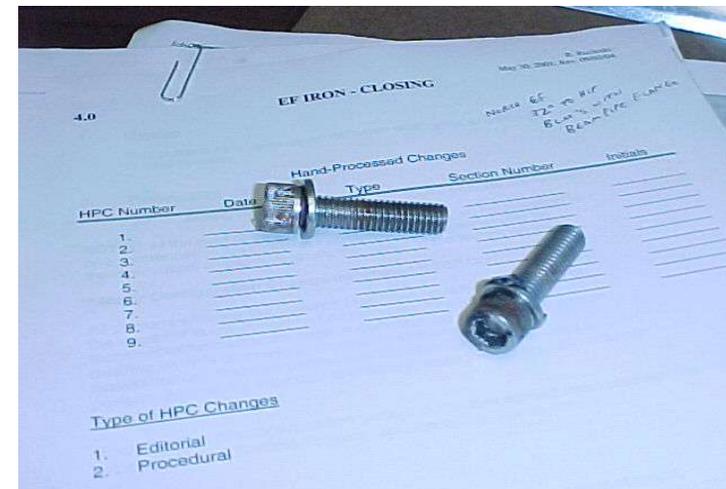
- Goal is to **reduce noise in calorimeter, improve calorimeter performance, and reduce vulnerability to outside noise sources**
- **Found (and fixed) seven grounding violations so far**
- Platform transformer grounding fault and replacing shim packing under southwest pedestal already reduced rate of a special “noise” trigger from >1kHz to below 1Hz in the presence of welding activity
- Since Thursday, disconnected AC power to the detector, removed safety ground, and use a high current power supply to energize the detector ground relative to the building earth ground
- ODH system: screws touching platform iron – fixed
- Raised the platform on Friday
 - ◆ Southwest platform stand: metallic lock washer instead of insulator – fixed

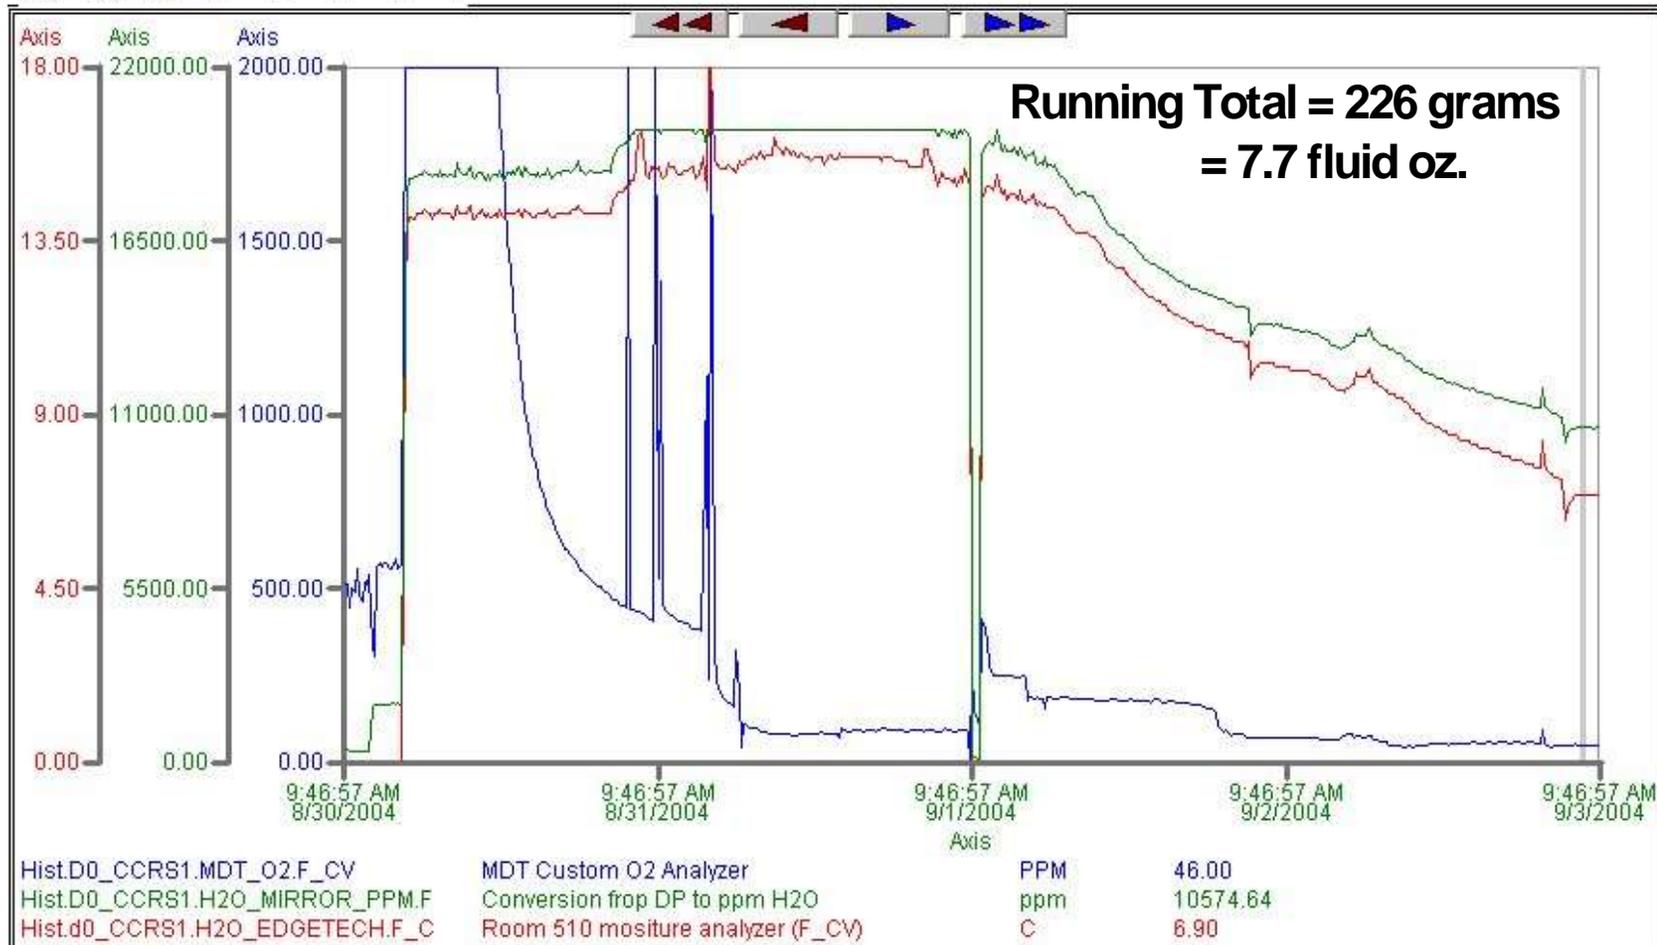
East VLPC cryostat cassette space drying:
Hygrometer on exhaust of a GN2 purge allows water removal to be trended and quantified. (10 scfh purge rate)
