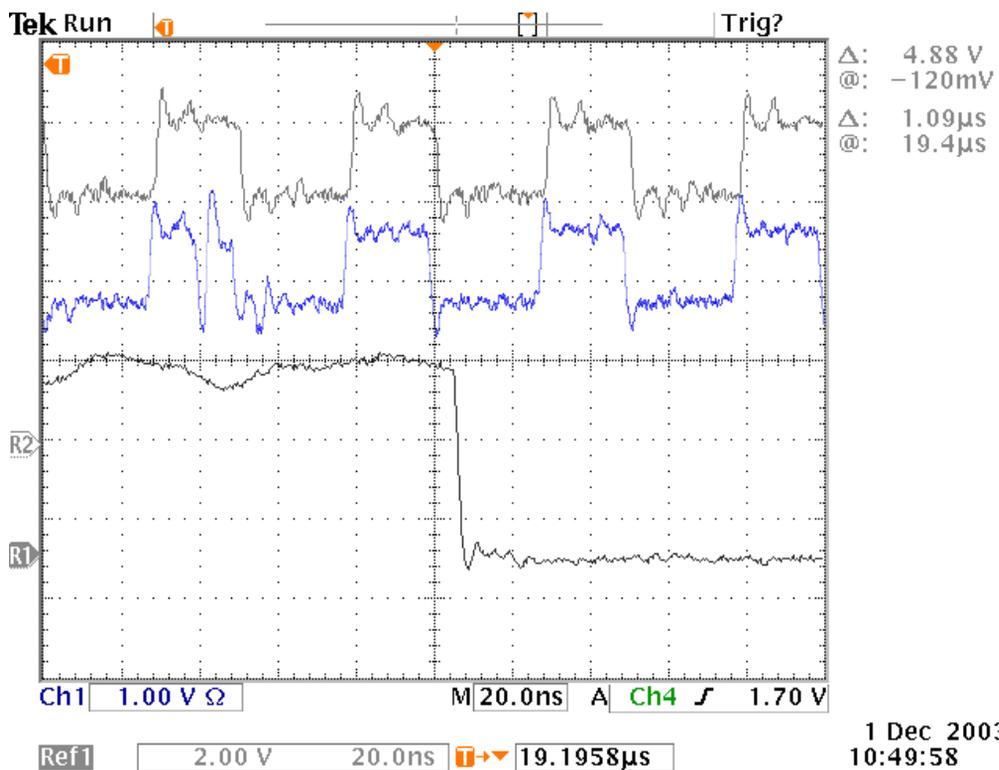
# Early end of readout

- Caused by a glitch in the readout clock going to the SVX

Blue trace is SVX clock, Bottom trace is the resultant Priority-Out.

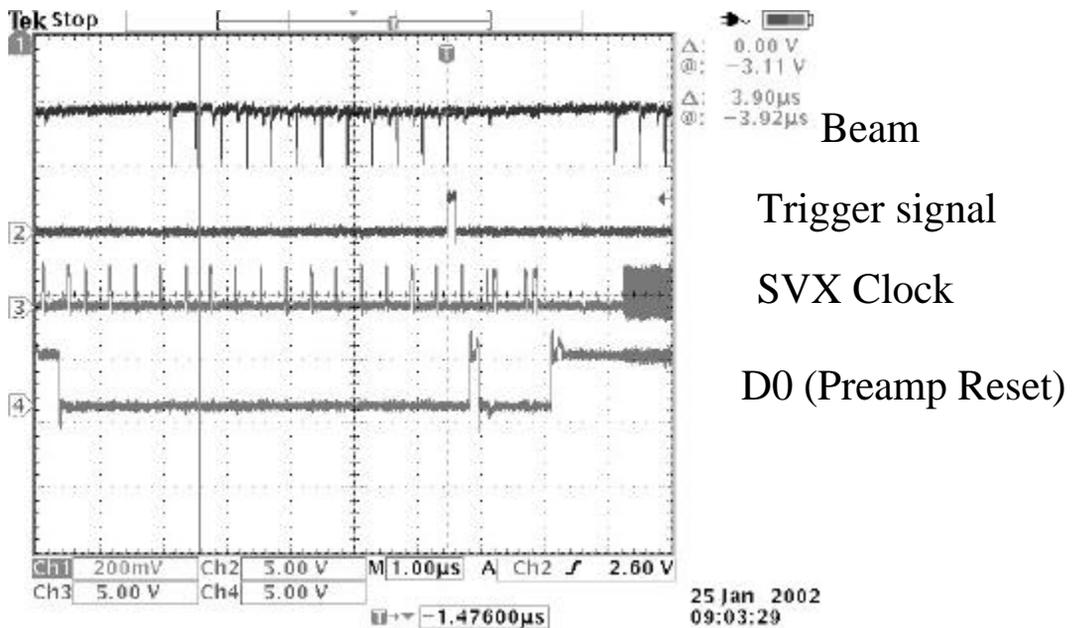
# No charge seen in correct pipeline

- **Cause: Presence of Preamp Reset (data line D0) occurs near end of Acquire cycle, adversely affecting “ring counter.”:**

- **Fix logic to prevent preamp reset during this time**

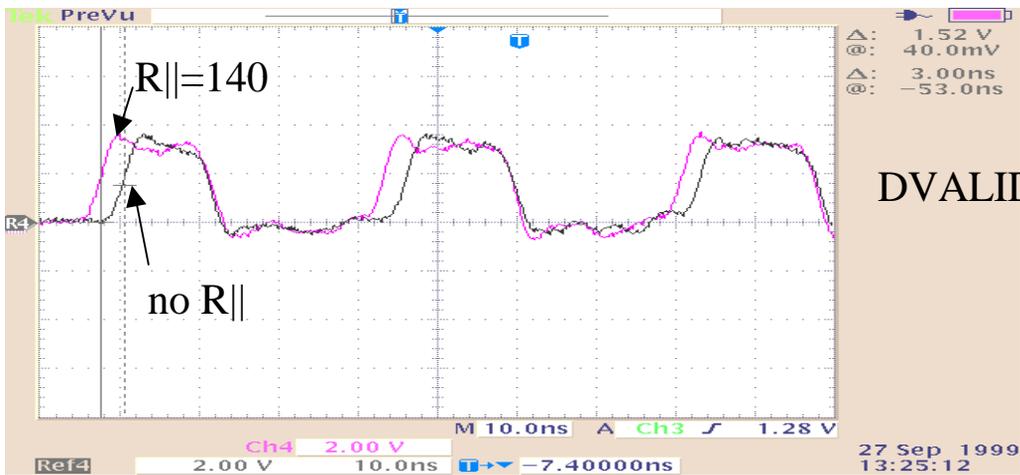
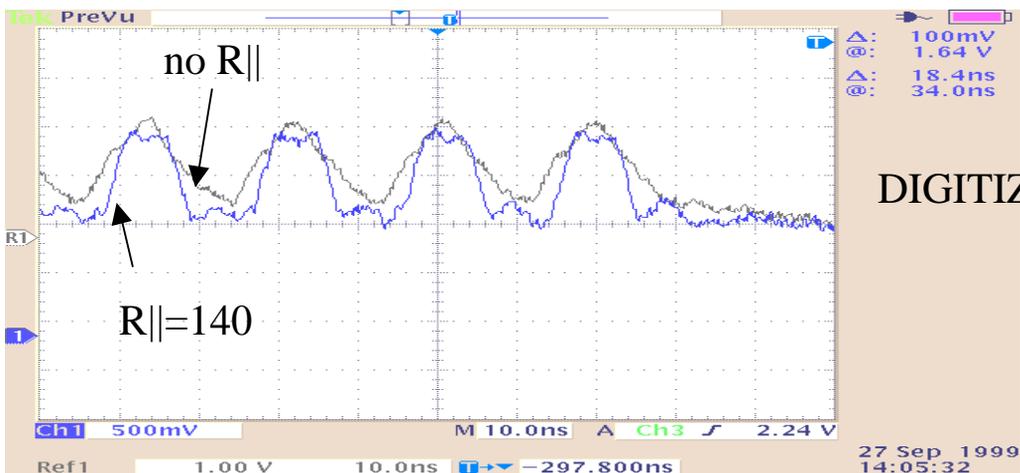
# Too narrow DVALID

1st few DVALID cycles delivered by the SVX narrower than nominal 18.8 ns (at 53 MHz). One of the reasons is bad CLK quality for unterminated CLK line. 1st DVALID width improves from 11ns to 14ns by adding 140Ohm parallel resistor between CLK-CLKB at HDI. Still 1st DVALID narrower than nominal. Associated with SVX driver limitations when trying to drive the 75 Ohm data bus at beginning of readout. Improvement by CLK and/or data bus precharging only marginal.

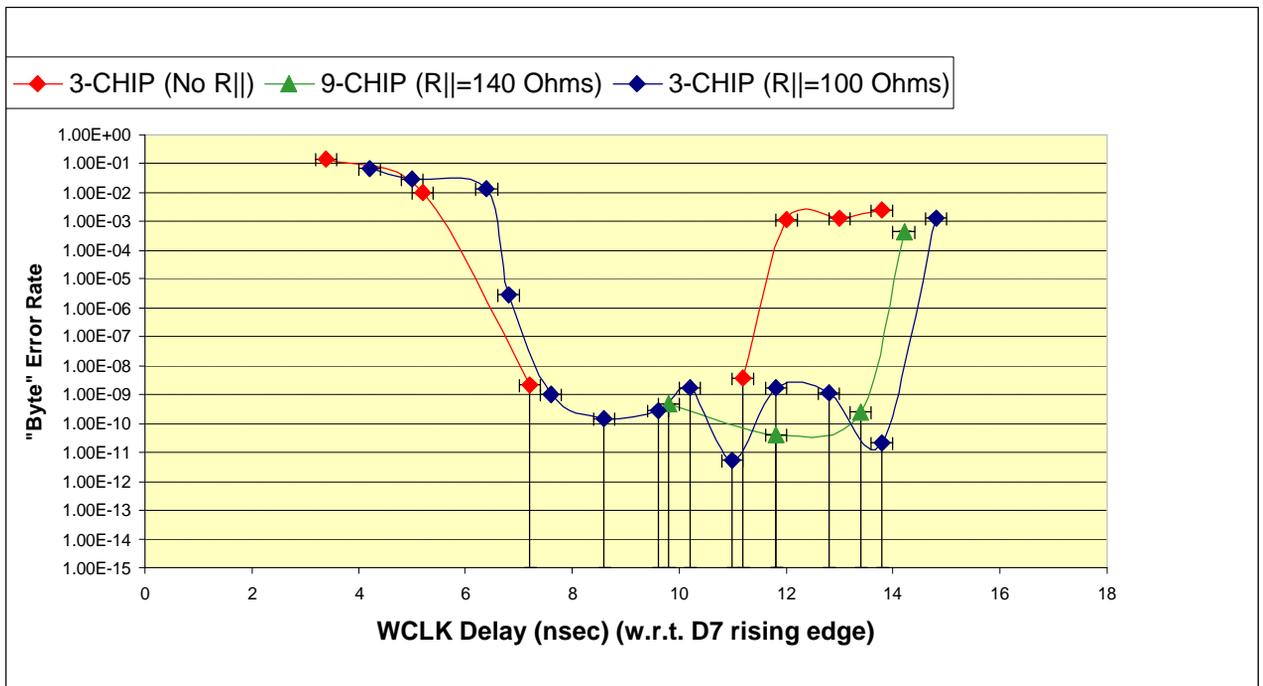
# Data Strobing at Sequencer FIFO

Significant improvement in dynamic range for data strobing at the sequencer FIFO by properly terminating CLK lines at the HDI ( $R_{||} = 140$  Ohms between CLK-CLKB).

1st DVALID width lower for a 9-chip HDI as compared to a 3-chip HDI presumably due to larger capacitive load.

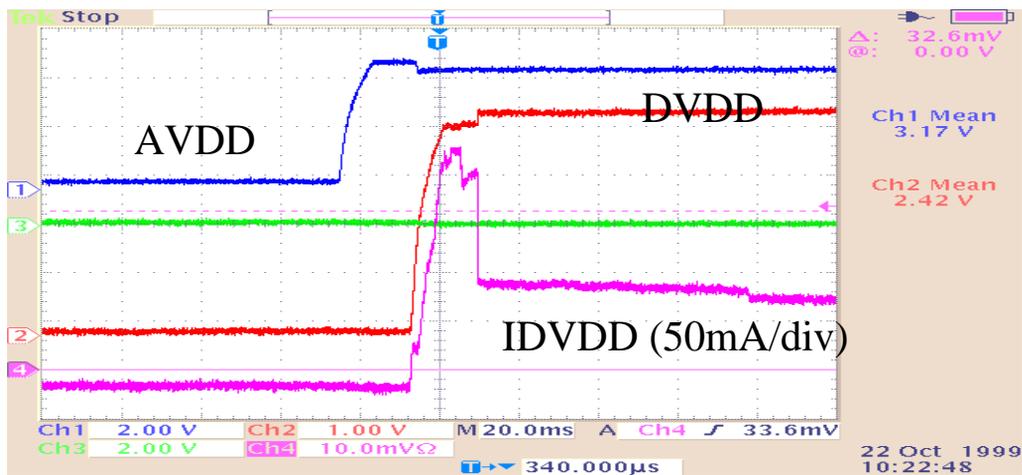
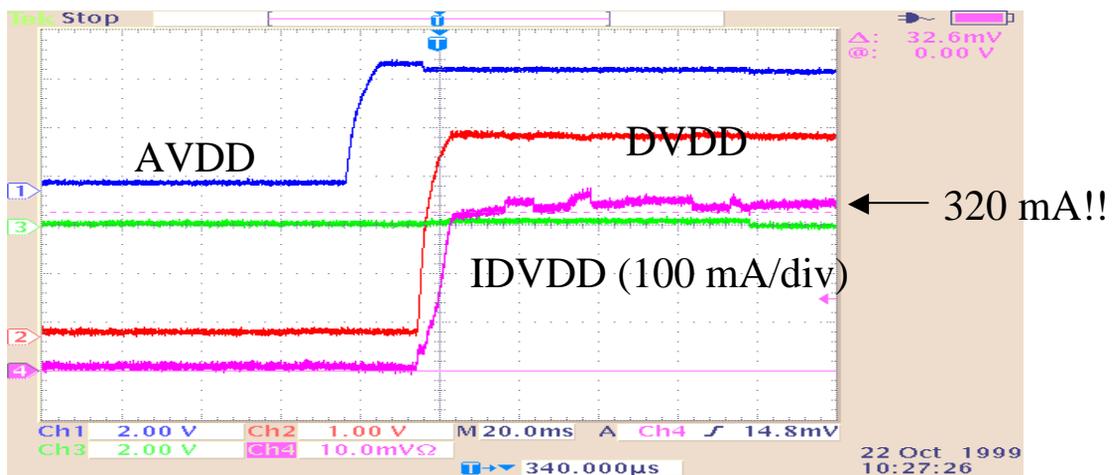
# SVX current draw

Large IDVDD draw at turn on. Seems to be a chip feature.  
For instance, for a 9-chip HDI onto low-mass cable:

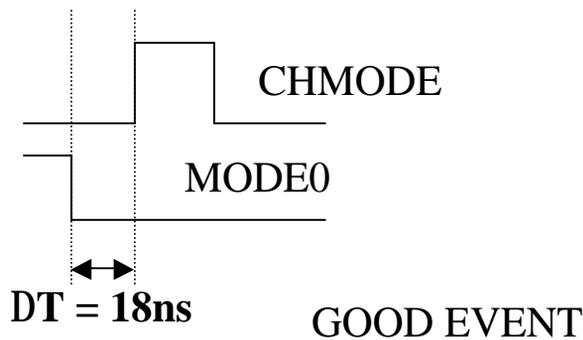
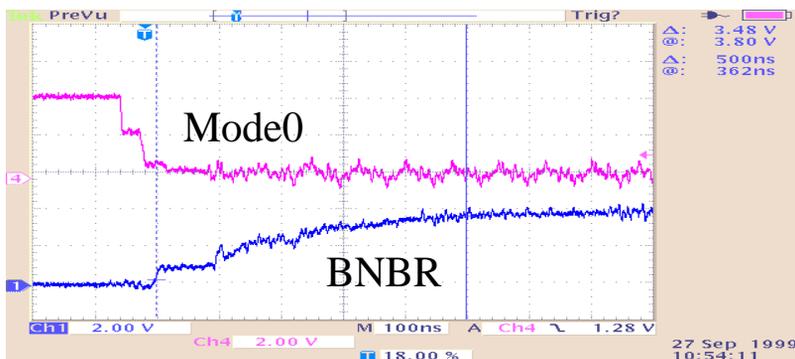
# BNBR problem

Aborted readout (BNRB goes LOW) just ~100ns after strobing readout. Typically happening in the first 1-2 events after power-up (high DVDD current mode). Need BNBR comparator threshold at KSU IB low enough so as to not get stuck, because the chip will recover by itself if it is allowed to get next readout. Can also happen if readout not properly strobed. This is cured by moving the CHMODE pulse AFTER the falling edge of MODE0:

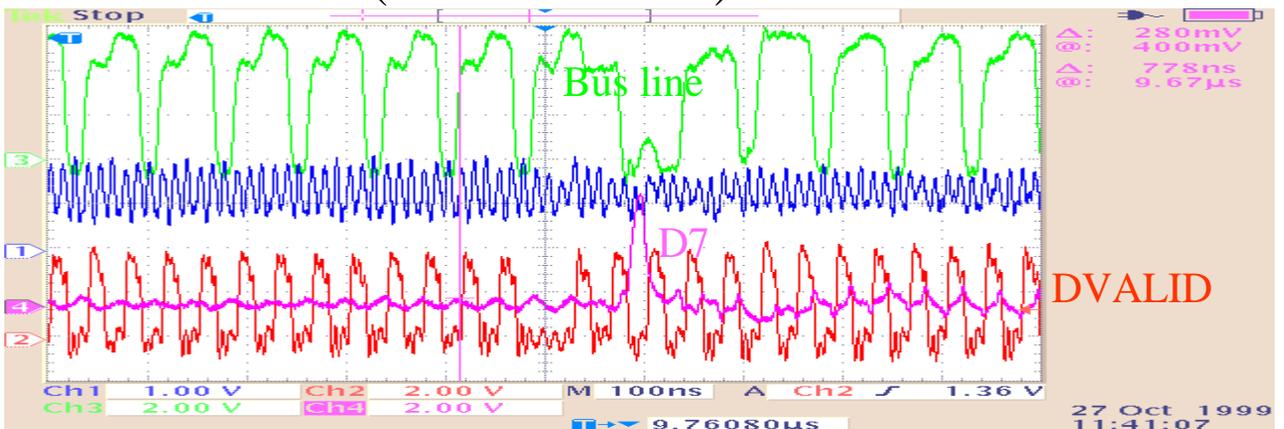
## 9-chip HDI readout at beginning of 3rd chip

Normal readout (DVDD=4.70 V)

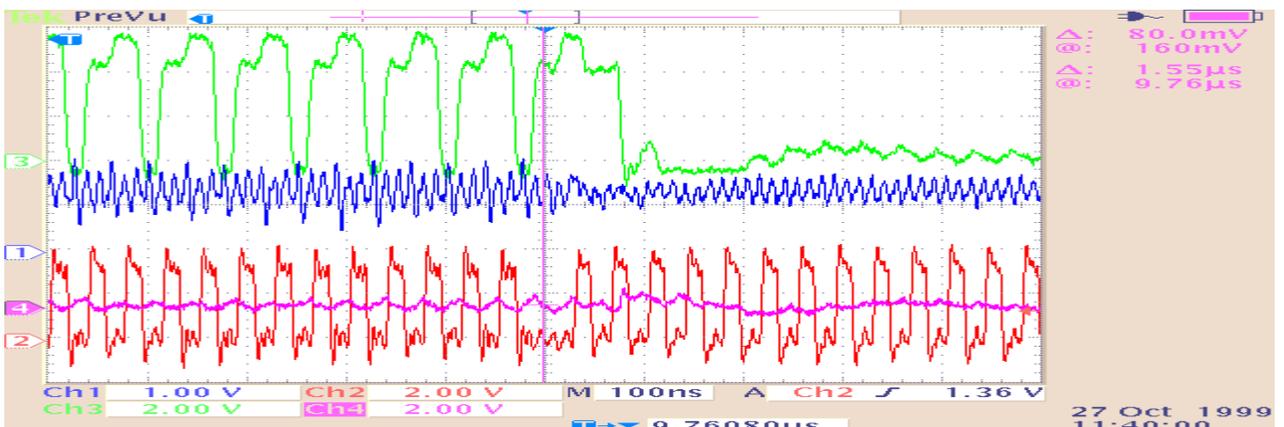
Chip will enter in perpetual readout mode due to failure in properly strobing DIGITIZE. Had to lower series resistance for CHMODE and MODE1 at KSU IB sending end in order to get sharper edges. However, the real fix was to extend CHMODE falling edge by +18.8 ns with respect to nominal. The failure was observed when increasing DVDD (changing thresholds at SVX receiver).

Perpetual readout (DVDD=4.85 V)

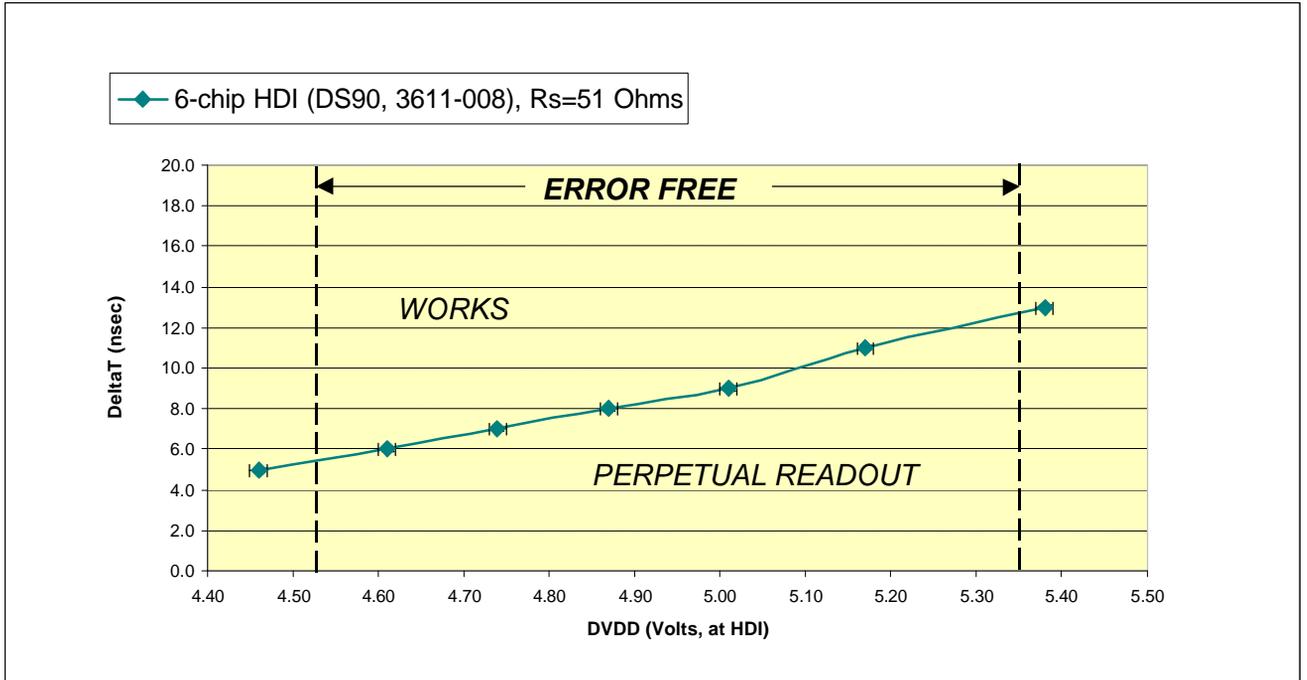
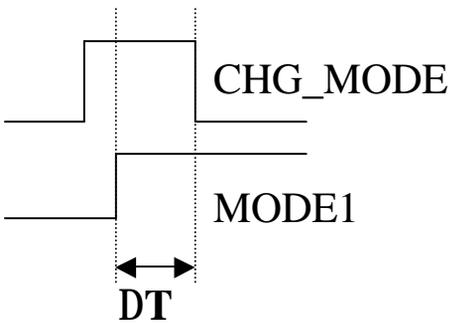
# PERPETUAL READOUT problem (cont'd)

To prove that it is a timing problem...

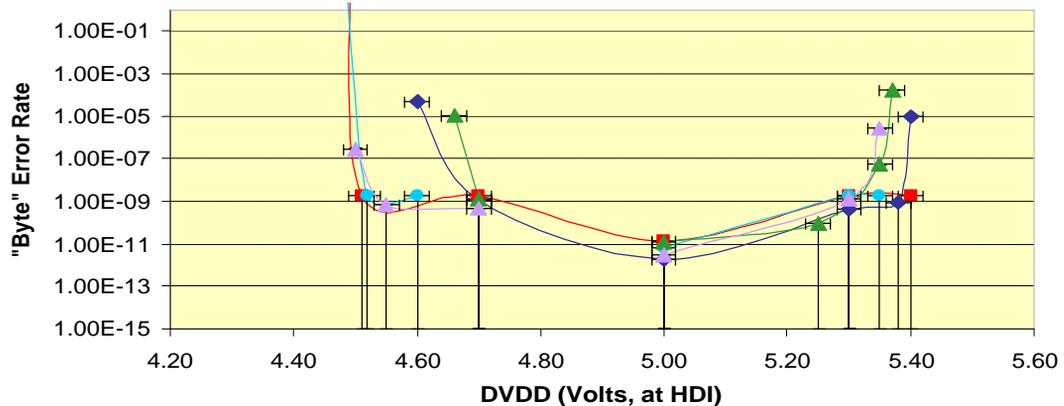
# DVDD range

Finite DVDD operating range (after fixing BNBR and PERPETUAL READOUT problems) for the digital part of the chip (we run with fixed data, with normal pedestals the operating range might be different, need to study it).

**Rs = 51 Ohms for CNTRL lines at IB, AVDD = 5.0 Volts (at HDI)**

- ◆ 9-chip HDI (3953-35), R|| = 140
- 6-chip HDI (H-DISK, 116-C-J3), R|| = 140
- 6-chip HDI (DS90, 3611-008) R|| = 140, doubled CHG\_MODE
- ▲ 6-chip HDI (F-DISK, FA-008), R|| = 140
- ▲ 8-chip HDI (F-DISK, FA-023), R||=140

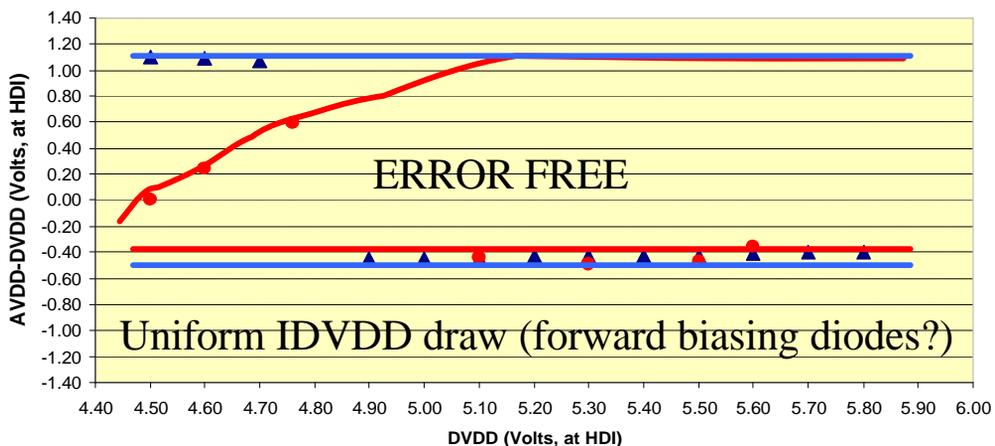
- ▲ 3-chip HDI (R||=140), Rs=51
- 9-chip HDI (R||=100), Rs=51
