Outline

12/12/02 Run2B Si Tracker Workshop

Michael Merkin - Moscow SU

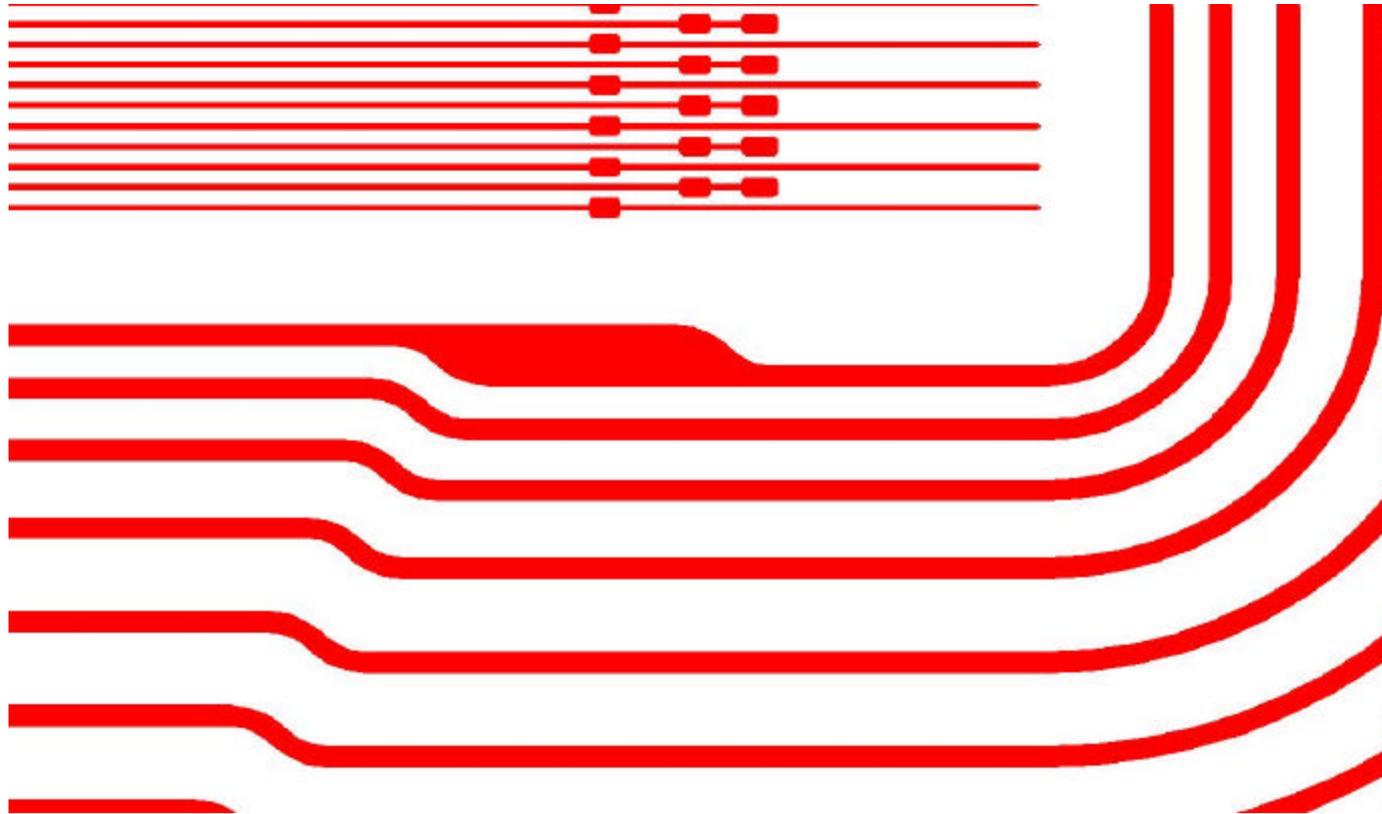
L0 and L1 Sensors Masks

Standard P⁺-implant

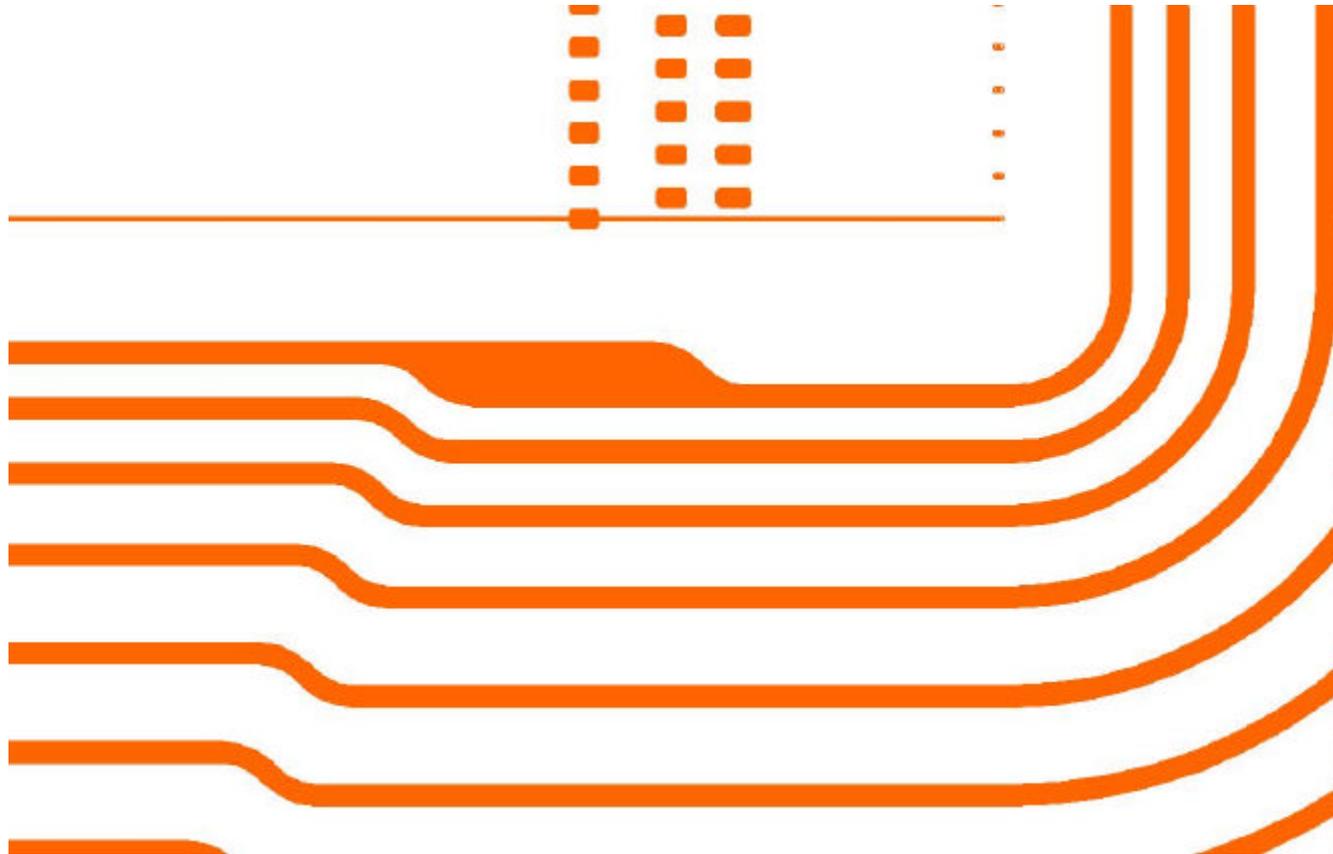
L0 and L1 Sensors Masks

Additional mask

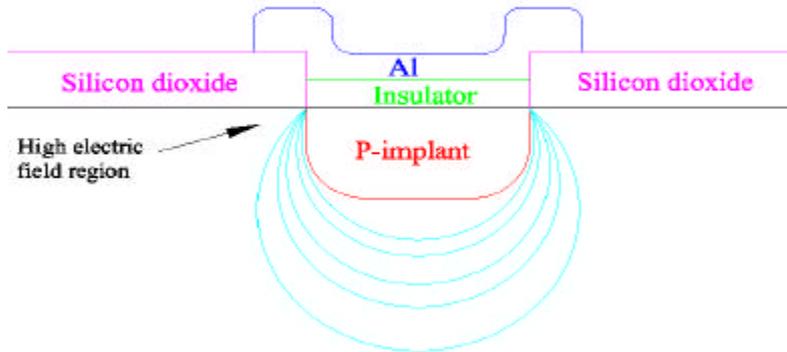
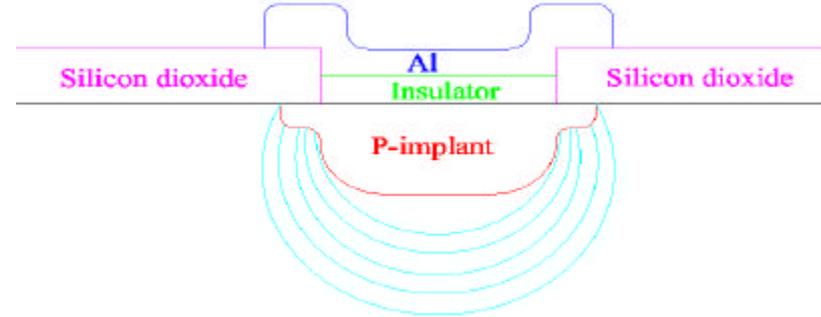
L0 and L1 Sensors Masks

X and Y strip implantation cross-sections
