Week in Review: 01/20/03 -01/26/03

Ron Moore – FNAL

- Found obstacle in AP-1 line
- Replacing corroded Tevatron dipole stands

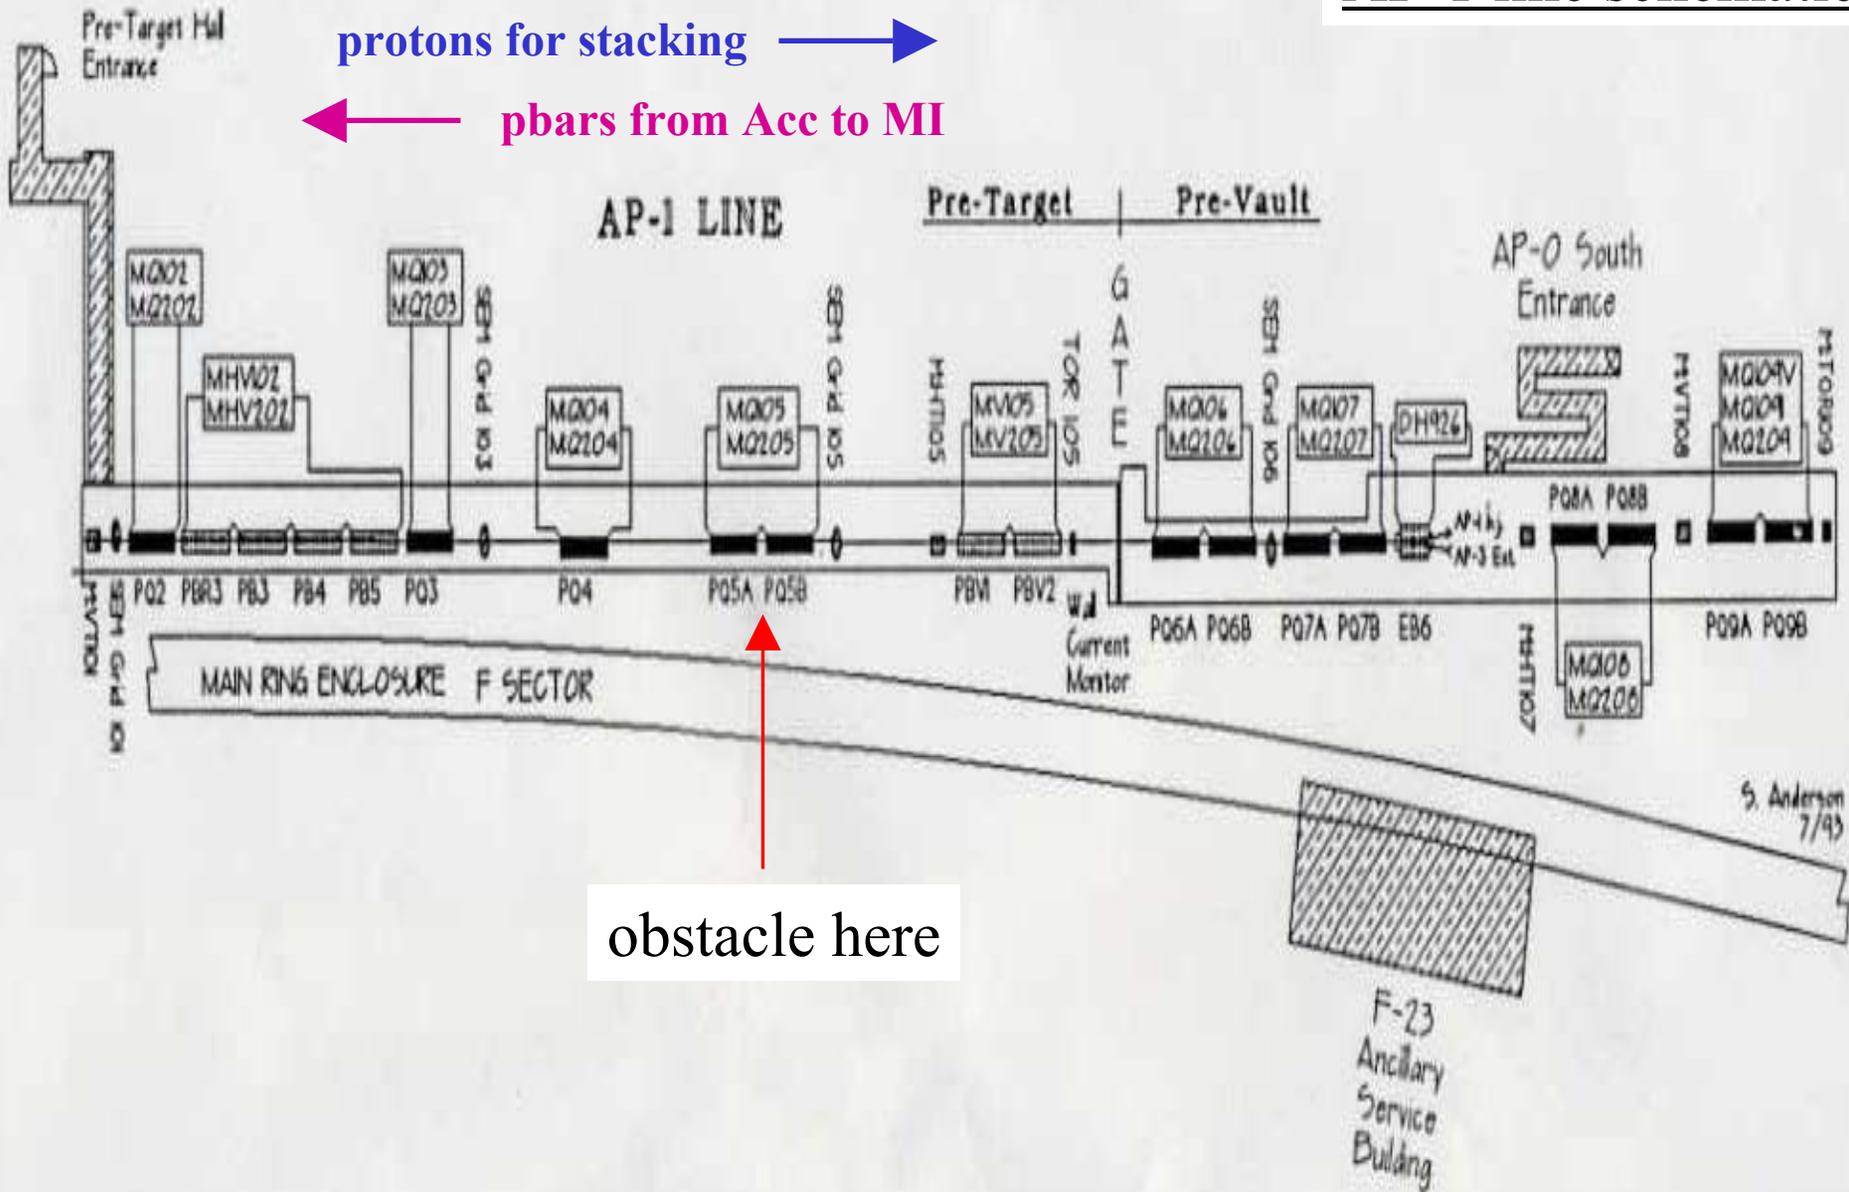
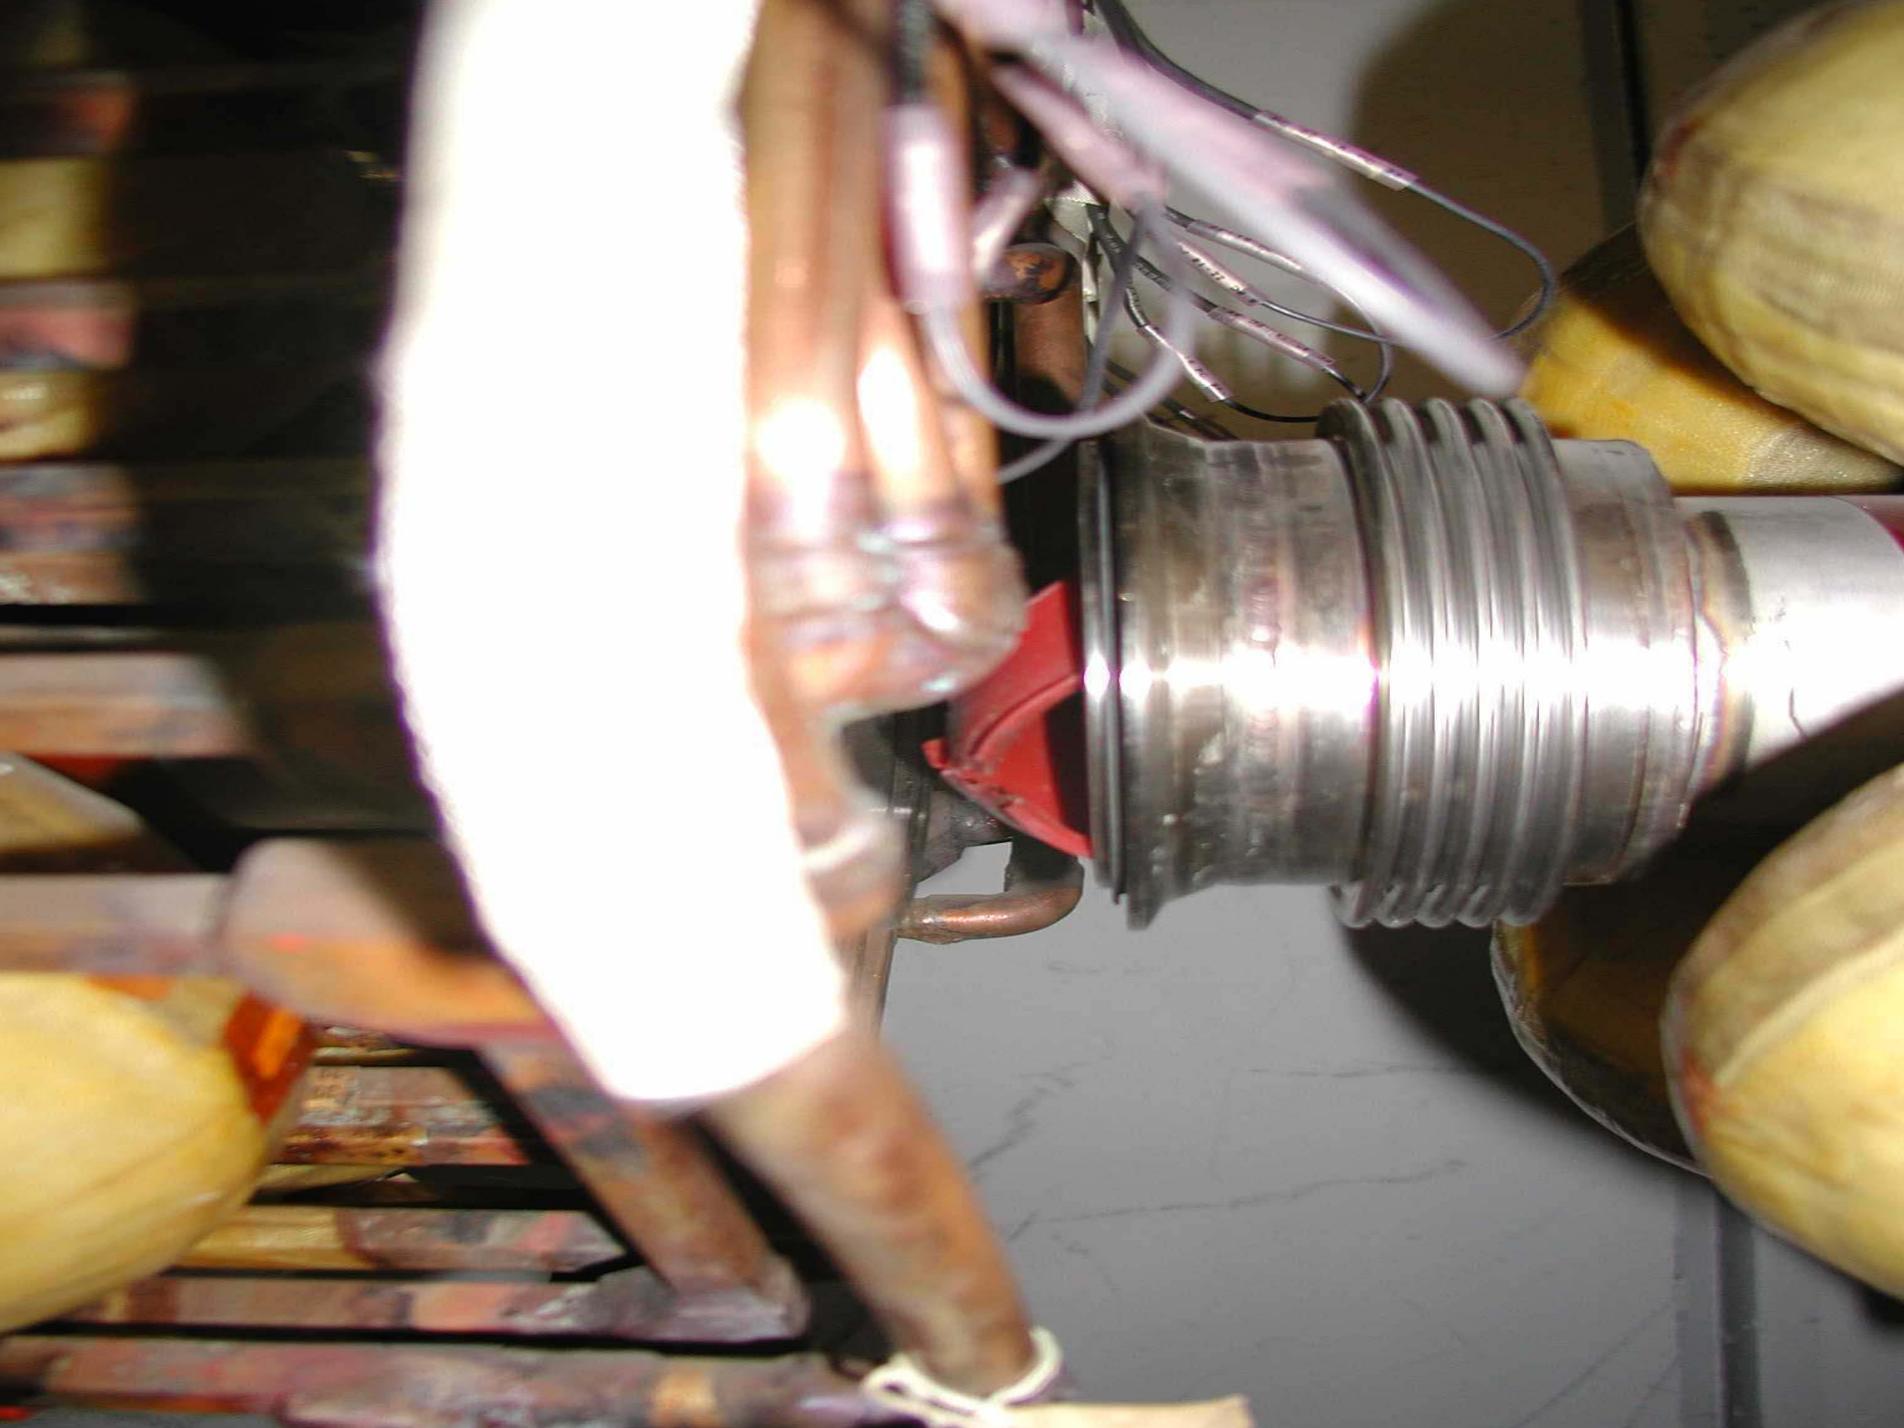
Plastic beampipe cap removed from AP-1 line on 1/21

Protons came out of page; pbars went into page

- Thought to have been there many years...
 - Hard to notice once hole was formed
- Red cap moved during vacuum incident in Nov.
 - Beam no longer through hole \Rightarrow problem appears
- After removal, expect reduced pbar emittance growth between Accumulator and Main Injector
 - Perhaps slightly smaller pbar emittances in Tev, too
 - No earth-shattering improvements expected

- Found and removed red plastic pipe cap in AP-1
 - Been there for a long time
 - Source of proton losses during stacking, pbar emittance growth during shots
